# **Special Crash Investigations Remote Vehicle Fire/ Child Restraint System Investigation**

**Vehicle: 1998 Ford Explorer**

**Location: Arizona**

**Incident Date: April 2012**

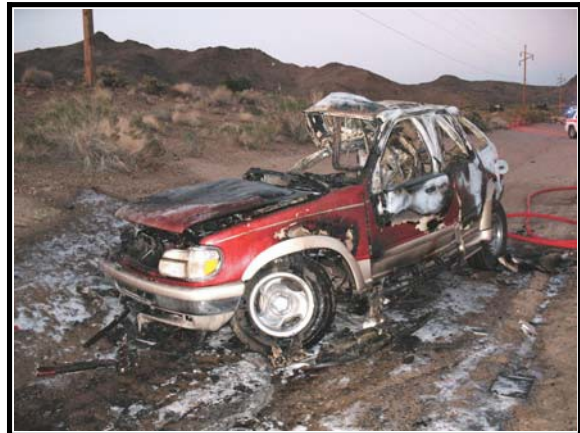
**Figure 1.** 1998 Ford Explorer (police photo)

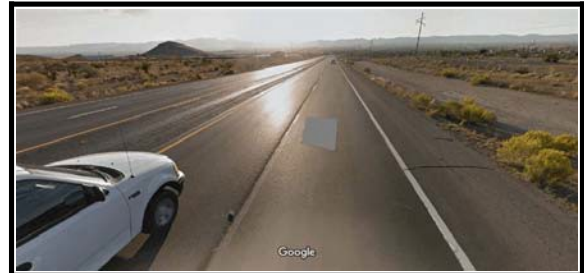
**Figure 2.** Crash site looking west (Google photo)

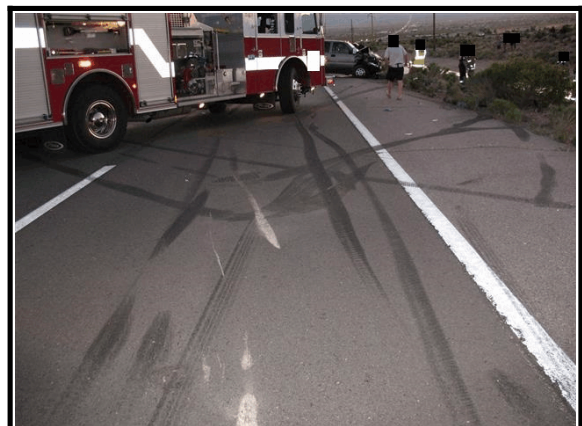
**Figure 3.** Area of impact looking west (police photo)

The front plane of the GMC struck the right plane of the Ford in an angled configuration in the first westbound lane from the right (Event 1) (**Figure 3**). Following the impact, the Ford was displaced to the left relative to its direction of travel and departed the roadway on the north edge while traveling in a clockwise rotation. It traveled down a slight embankment and came to rest facing west on level ground on the roadside facing west (**Figure 4**). After coming to rest, a fire began in the engine compartment of the Ford (Event 2). The GMC continued to travel westbound while in a clockwise rotation. During this movement the trailer separated from the vehicle. The GMC came to rest 20 m (65 ft) west of the point of impact (**Figure 5**). The vehicle was facing north with the front tires on the north shoulder. The trailer rolled after being separated from the GMC and came to rest on its right side on the north roadside.

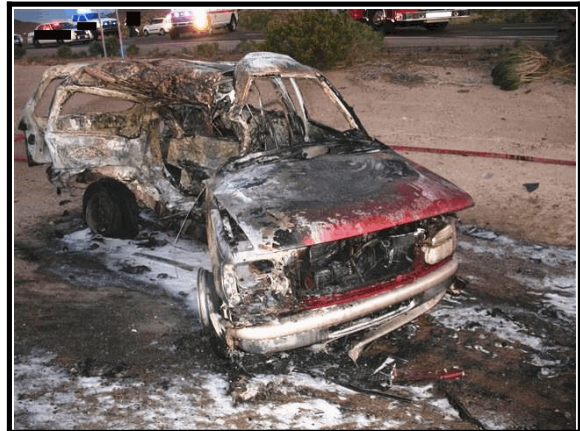
Given the witness statements and police report, the investigation determined the fire began in the engine compartment of the Ford almost immediately following the crash and within a few minutes spread to the occupant compartment. The Ford sustained severe fire damage to the exterior and interior. Apparently, the CRS used by the second row occupant of the Ford remained in the vehicle and was destroyed by fire. No mention was made in the police report regarding the CRS being taken from the vehicle and it was not visible in the on-scene images. Both vehicles were towed due to damage.

**Figure 4.** 1998 Ford Explorer, final rest position looking south (police photo)

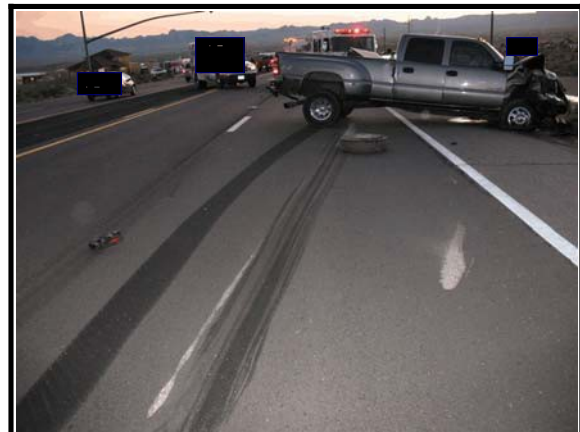
**Figure 5.** 2007 GMC 3500 final rest, looking west (police photo)

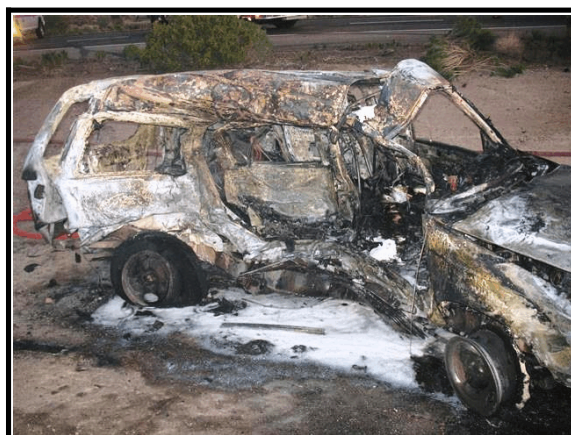
Exterior images of the Ford taken by police were used to conduct a partial exterior vehicle inspection. The vehicle sustained direct contact damage to the right plane caused by the impact with the GMC. This damage was caused by direct contact damage during the vehicle-to-vehicle impact, the subsequent fire and post-crash activities (**Figure 6**). The crush damage from the initial vehicle-to-vehicle event appeared in images to be located primarily beginning at the right A-pillar and extending to the right C-pillar. The vehicle was severely bowed to the right by the impact and induced damage was present on the right, front, back and top planes. The estimated Collision Deformation Classification (CDC) for the Ford in Event 1 was 02RZAW4. Thermal damage included burned paint on all planes, scorched sheet metal, melted plastic components and melted tires.

**Figure 6.** 1998 Ford Explorer, exterior damage looking south (police photo)

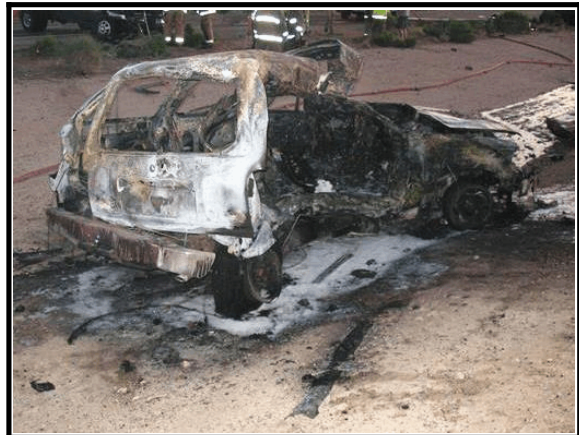
The Ford sustained catastrophic interior damage caused by impact forces and the post-impact fire. The vehicle also sustained integrity loss to the front, left, right, and back planes. All side glass was disintegrated either at impact with the other vehicle, during the fire or during post-crash activities. The right front side door was removed during post-crash activities. Both rows of seats were destroyed by fire. Few components in the occupant compartment were recognizable in the police photos (**Figure 7**). Intrusion as seen in photographs was present in the right aspect of the front and second rows and included the right roof side rail, front and second row door panels, right B-pillar and right sill.

**Figure 7.** 1998 Ford Explorer, interior damage looking west (police photo)

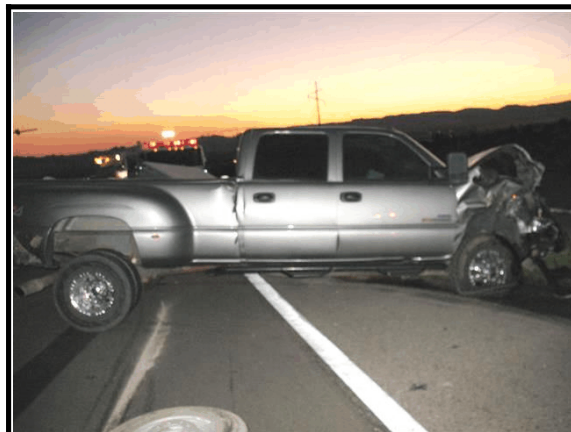
**Figure 8.** 2007 GMC C3500 at final rest (police photo)

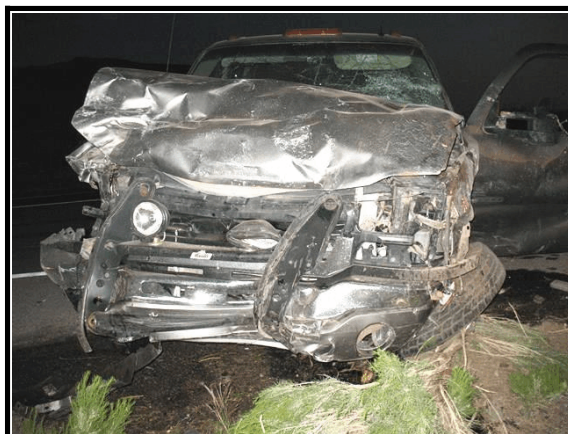
The GMC sustained direct contact damage to the front plane caused during the impact with the Ford. Crush damage was distributed across the front plane and induced damage was present on the left and right front fenders and hood. The estimated CDC for the GMC in Event 1 was 11FDEW2 (**Figure 9**). The police report stated the trailer tongue separated from the GMC during the crash causing the trailer to be displaced from the vehicle and subsequently overturned coming to rest on the roadside.

**Figure 9.** 2007 GMC C3500 front plane damage (police photo)
