DOT HS 812 551

# **Special Crash Investigations On-Site Guardrail End Treatment Impact Investigation Vehicle: 2005 Chevrolet Cobalt Location: Missouri Crash Date: May 2016**

**INDIANA UNIVERSITY**  
**TRANSPORTATION RESEARCH CENTER**  
**ON-SITE X-LITE GUARDRAIL END TREATMENT INVESTIGATION**  
CASE NUMBER - IN16014  
LOCATION - MISSOURI  
VEHICLE - 2005 CHEVROLET COBALT  
CRASH DATE - MAY 2016

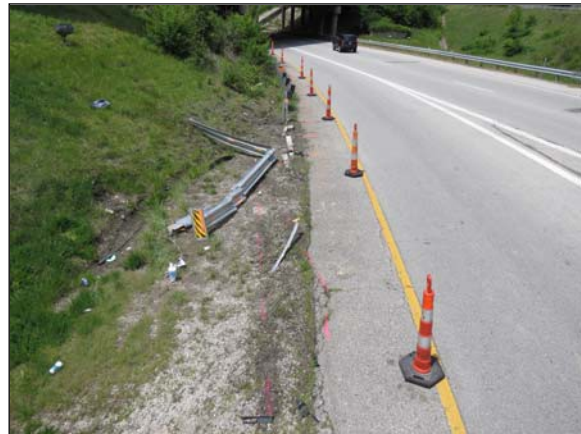
This report covers an on-site investigation of a passenger vehicle impact to an X-Lite telescoping guardrail end treatment (**Figure 1**) that is of interest to the Federal Highway Administration (FHWA). This crash was identified by an engineer with the Missouri Department of Transportation (MoDOT), who submitted photographs of the vehicle and the damaged guardrail end treatment to the FHWA. The FHWA determined that the guardrail end treatment and crash type were of interest. This Special Crash Investigation (SCI) was then initiated by the National Highway Traffic Safety Administration (NHTSA) in May, 2016 and assigned to the SCI team at the Indiana University Transportation Research Center on the same date. This crash involved a 2005 Chevrolet Cobalt (**Figure 2**). The crash occurred in May 2016 at 2308 hours, in Missouri and was investigated by a local police agency. The guardrail, crash scene, and the Chevrolet were inspected in May, 2016. A partial interview with the owner (and friend of the driver) of the vehicle was conducted in August, 2016.

**Figure 1:** Overview of crash scene with X-Lite guardrail end treatment (detached)

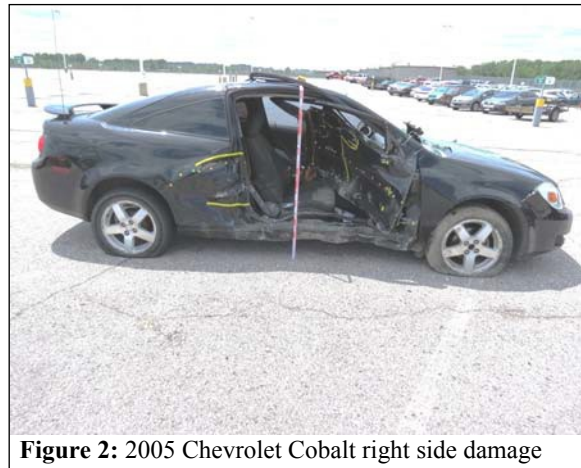
**Figure 2:** 2005 Chevrolet Cobalt right side damage

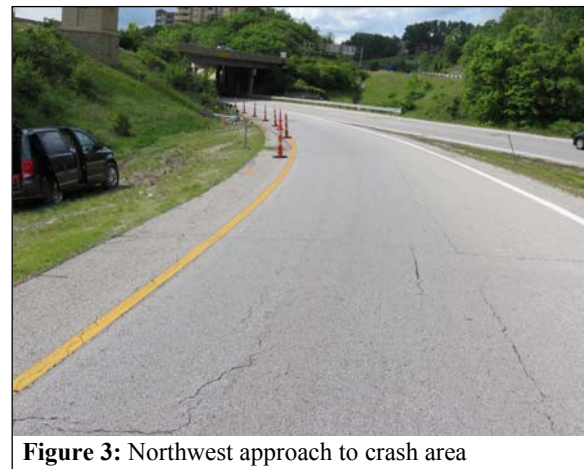
The Chevrolet was traveling northwest on the exit ramp (**Figure 3**) and the driver intended to negotiate the left curve and merge onto a northwestbound roadway. For unknown reasons, the Chevrolet began to rotate counterclockwise and departed the west (left) roadside.

**Figure 3:** Northwest approach to crash area

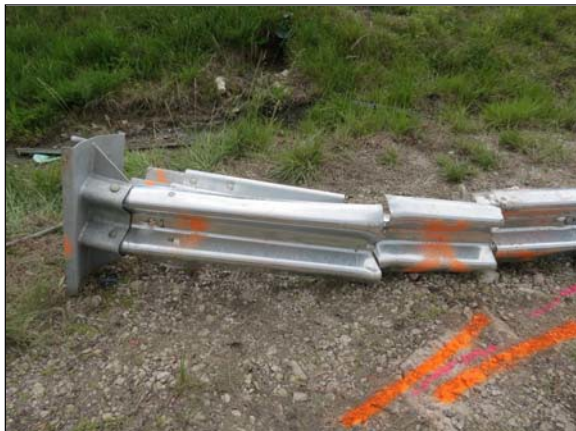
**Figure 4:** Guardrail panels 1 and 2, cut by rescue personnel

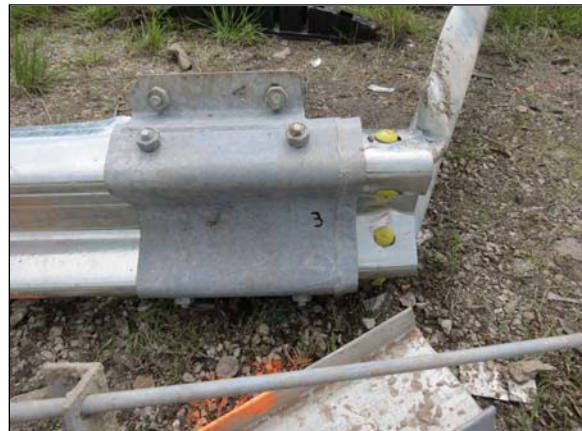
**Figure 5:** End of guardrail panel 2, beginning of panel 3. Note unsheared splice bolts

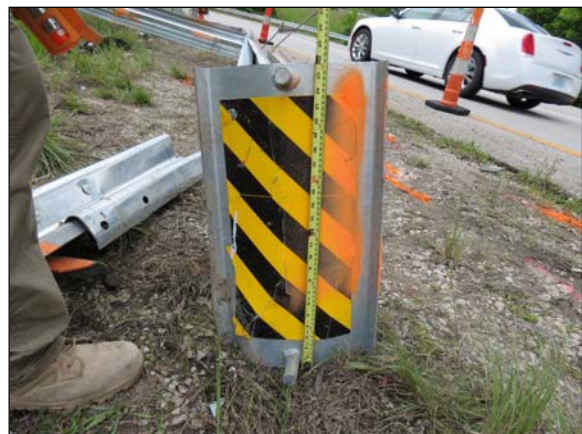
The right plane of the Chevrolet impacted the X-Lite head, which was mounted directly onto the end of a 3.8 m (12.5 ft) long section of guardrail. During an end impact, the three 3.8 m (12.5 ft) long sections of W-beam guardrail are designed to “telescope” downstream from the impact head, dissipating energy through friction. Special yellow shear bolts are installed at guardrail splices at the downstream ends of panels 2 and 3 (Posts 5 and 7), facilitating the telescoping action. During this crash, the first section of guardrail slid to within 15 cm (5.5 in) of the downstream end of the second guardrail panel (Post 3). However, the shear bolts at the downstream end of the second guardrail section (Post 5) did not shear and the guardrails did not slide any further (**Figure 5**). The X-Lite impact head measured 35 cm (13.8 in) wide and 61 cm (24.0 in) high (**Figure 6**) and is designed to be mounted to the end of the guardrail at Post 1.

**Figure 6:** X-Lite impact head

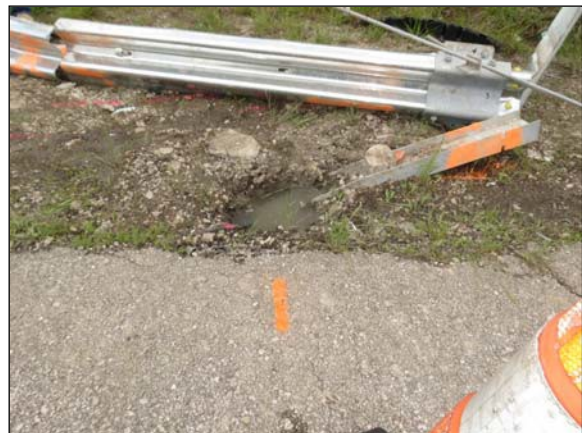
**Figure 7:** Post 1, view is toward field side

Post 1 (**Figure 7**) collapsed in the downstream direction nearly to the ground and detached from the damaged guardrail. The ground strut was detached. Post 2 was also bent downstream approximately 60 degrees from vertical and was detached from the damaged guardrail. The ground strut was still attached near the base of the post. Post 3 had a composite block-out still firmly

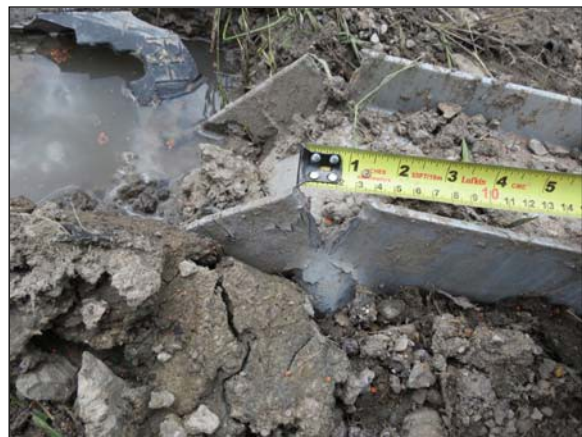
attached and the post was bent downstream, flush to the ground and detached from the damaged guardrail. The bending of posts 1-3 was facilitated by the crimps near the bottom of the posts (**Figure 8**). Block-outs were present on Posts 3-12. Post 4 was displaced downstream approximately 20 degrees from vertical and detached from the damaged guardrail. Based on photos in the police reconstruction report, the right plane of the Chevrolet was in contact with this post at final rest. The composite block-out was still attached by the connecting bolt but was not flush against the post (**Figure 9**) and the connecting bolt pulled through the bolt hole. Post 5 and its block-out were undamaged. Compliant to manufacturer specification, there was no connection bolt installed at this post. The shear bolts at this post that spliced rails 2 and 3 together did not shear during the crash. Post 6 was undamaged and the connection bolt pulled through the guardrail. Post 7 was undamaged. The third of the 3.8 m (12.5 ft) long sections of X-Lite guard rail was bolted to this post. Maintenance crews unbolted the shear bolts and separated the damaged guardrail from this post. Undamaged guardrail remained but was unconnected at this post. Posts 8-12 were undamaged and undamaged guard rail was connected at each post. Steel block-outs were installed at Posts 9, 11, and 12 and there was a composite block-out at Post 10. All three lengths of X-Lite guardrail, each 3.8 m (12.5 ft) in length and 11.4 m (37.5 ft) in total length, were damaged. There was one kink (see **Figure 5**) which occurred at the splice of guardrail panels 2 and 3. The “In-Service End Treatment Evaluation Data Collection Form” is attached to the end of this report as Attachment A.

**Figure 8:** Crimp at base of Post 3

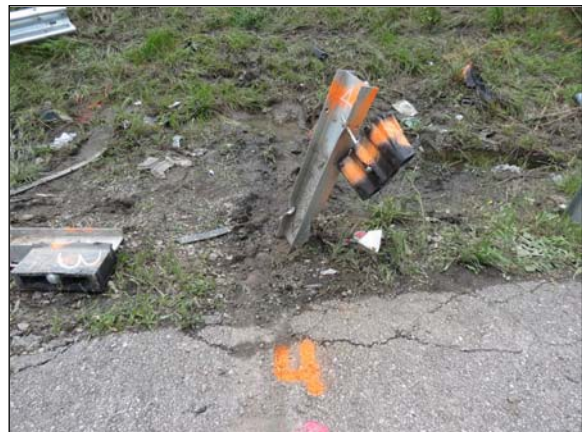
**Figure 9:** Post 4 (final rest of vehicle)

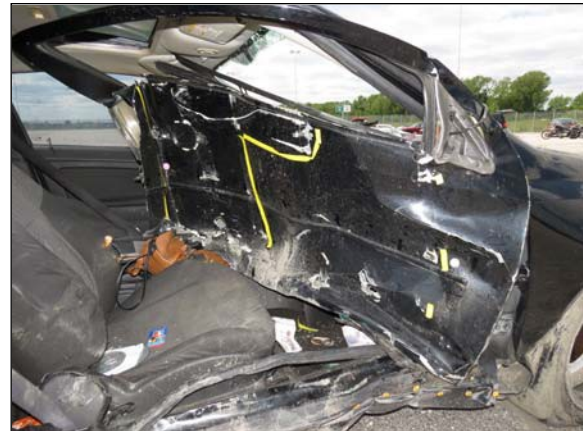
**Figure 10:** Intruded right door

The Chevrolet sustained direct damage to the right plane during the impact with the X-Lite guardrail head. The right door, sill, B-pillar, and side panel rear of the B-pillar were directly damaged (**Figures 10 and 11**). The direct damage started 46 cm (18.1 in) rear of the right front axle and extended 166 cm (65.3 in) rearward. The Field L was 174 cm (68.5 in). Crush measurements were taken at the sill and mid- door levels and averaged where necessary, according to NASS vehicle measurement protocol, since there was latch/striker failure. The maximum crush to the door was 97 cm (38.2 in), occurring 5 cm (2 in) forward of C3. The residual averaged crush values were  $C_1 = 0$  cm,  $C_2 = 29$  cm (11.4 in),  $C_3 = 49$  cm (19.3 in),  $C_4 = 27$  cm (10.6 in),  $C_5 = 6$  cm (2.4 in),  $C_6 = 0$  cm.

The interior of the Chevrolet sustained severe damage from intrusion. The most severe intrusions into the front row involved the right front door and window frame, which intruded laterally 88 cm (34.6) and 68 cm (27.1 in), respectively. The steel guardrail and X-lite head intruded laterally into the passenger compartment 84 cm (33 in). The front right seat back and seat base were also displaced to the left 21 cm (8.3 in) and 10 cm (3.9 in), respectively by the intruding door. No discernable evidence of occupant contact was observed.

The right door sustained a latch/striker failure during the impact with the X-Lite guardrail head. The left door remained closed and operational. All non-fixed glazing was closed at the time of the crash. According to a witness, the driver was partially ejected through the windshield glazing near the right A-pillar. At the SCI inspection, the windshield glazing was found to be cut along the A-pillar and windshield header by rescue personnel, likely done to facilitate removal of the driver. The right front glazing disintegrated during the crash and the remainder of the glazing was undamaged.

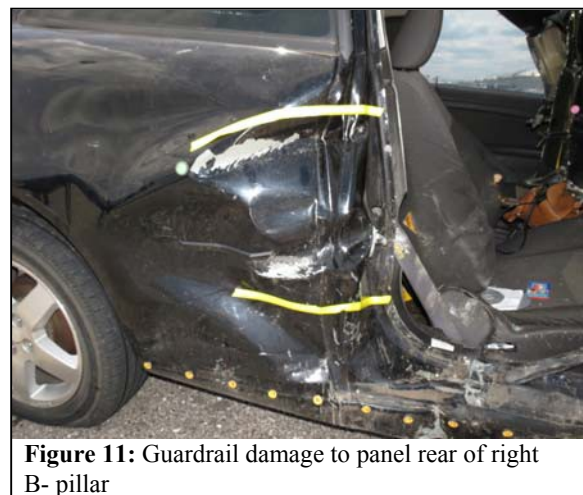
**Figure 11:** Guardrail damage to panel rear of right B-pillar

**Damage Classification Event 2:** The CDC was 03RPEW6 (80 degrees). The severity of the damage was severe.
