DOT HS 812 569

# **Special Crash Investigations On-Site Inflatable Curtain Air Bag Non-Deployment Investigation**

**Vehicle: 2013 Ford Edge**

**Crash Date: November 2015**

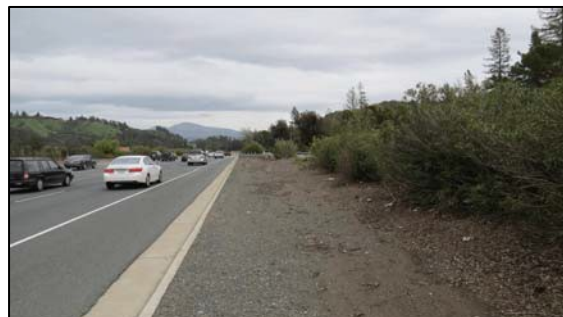
**Figure 3.** Roadway departure, looking east

The Ford departed the roadway on the right and impacted a concrete curb with both front tires (**Figure 3**). The EDR reported a longitudinal delta-V of -8.98 km/h (-5.58 mph) and a lateral delta-V of 3.03 km/h (1.89 mph). The driver's frontal air bag deployed and both front row seat belt pretensioners actuated. Based on the air bag deployment times, it would appear that the reported Delta-Vs did not cause the deployment and actuations. The values reported were locked at 300 ms per the 563 regulations. The deployments and actuations occurred 726 ms after AE. The close proximity of the curb impacts was probably a confounding factor. After impact, the driver steered to the left and then back to the right as vehicle traveled approximately 73 m (239

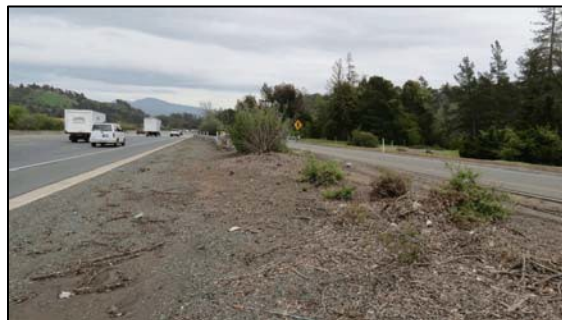
**Figure 4.** Impact with oleander bushes, looking east

ft). The vehicle's front plane then struck and over-rode a series of oleander bushes (**Figure 4**). The Ford began a clockwise rotation, tripped, and began a left-side leading rollover. The EDR reported the beginning of the left-side roll at 2.2 seconds after impact. The roll angle increased to -32.36 degrees at 3.1 seconds and maintained a similar roll angle until the 5-second buffer was filled. The vehicle rolled onto its left side and then onto its roof.

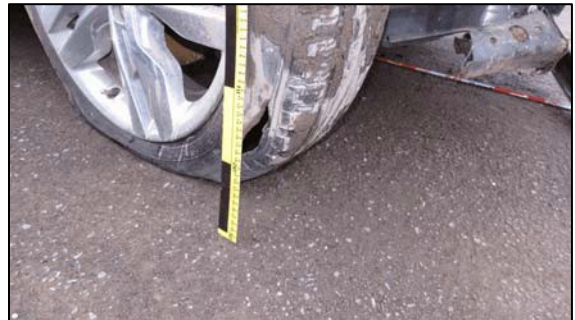
**Figure 5.** Right front tire, 2013 Ford Edge

The Ford sustained moderate damage to the front tires/wheels during the impact with the concrete curb (Events 1 and 2). The right front tire sidewall was cut (**Figure 5**) and left front rim was deformed (**Figure 6**). The Collision Deformation Classifications (CDCs) for the right and left wheels were 12FRWN3 and 12FLWN3, respectively.

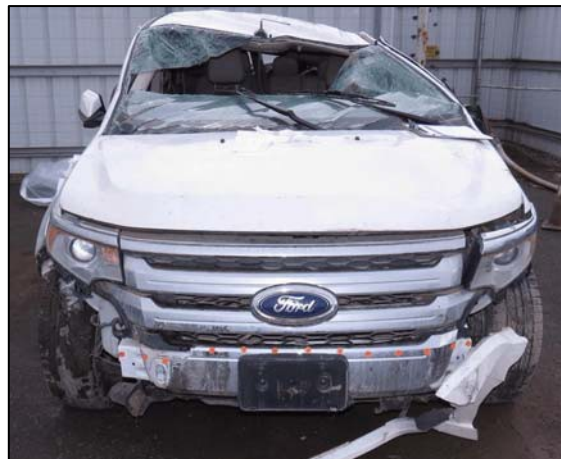
**Figure 7.** Frontal damage, 2013 Ford Edge

The Ford sustained minor contact damage to the front bumper fascia from the impact with the line of oleander bushes (Event 3). The direct damage consisted of minor scuffing across the front plane. The bumper fascia was displaced at both ends of the bumper backing bar (**Figure 7**). The Field L began at the left bumper corner and extended 111.0 cm (43.7 in) to the right.

Six crush measurements were taken at the bumper backing bar as follows: C1 = 1.0 cm (0.4 in), C2 = 2.0 cm (0.8 in), C3 = 1.0 cm (0.4 in), C4 = 0 cm, C5 = 0 cm, C6 = 0 cm. The calculated Principal Direction of Force (PDOF) was 345 degrees. The CDC was 12FDEW1.

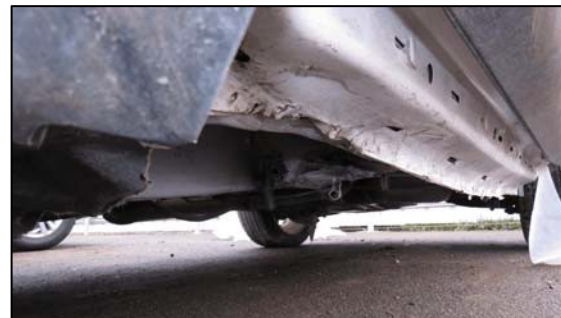
**Figure 8.** Left frame rail damage, 2013 Ford Edge

During the rollover (Event 4), the Ford sustained direct damage to the left frame rail (**Figure 8**) and to the top plane. The damage to the top plane included the hood and roof (**Figure 9**). The damage extended from roof side rail to roof side rail and measured 133.0 cm (52.3 in) wide and extended from the hood edge rearward to the rear spoiler and measured 410.0 cm (161.4 in). The maximum vertical crush was located at left windshield header and measured 12.0 cm (4.7 in). The maximum lateral crush was located at the left A-pillar and measured 10.0 cm (3.9 in). The CDC was 00TDDDO2.

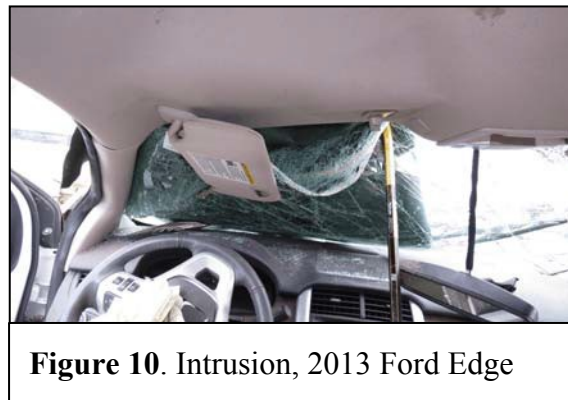
**Figure 10.** Intrusion, 2013 Ford Edge

The Ford sustained minor interior damage as a result of intrusions, occupant contacts, and integrity loss (**Figure 10**). The vehicle sustained vertical intrusions to the front row at the left A-pillar [4.0 cm (1.6 in)], left windshield header [8.0 cm (3.1 in)], middle windshield header [1.0 cm (0.4 in)], left roof side rail [5.0 cm (1.9 in)], and left roof [8.0 cm (3.1 in)]. There were also vertical intrusions to the second row at the left C-pillar [15.0 cm (5.0 in)] and left roof side rail [9.0 cm (3.5 in)]. The left rear door and hatch were jammed shut. The laminated glazing to the windshield and left front window was cracked and the tempered glazing at the left rear and hatch was disintegrated. There was loading evidence documented to the driver's and front right passenger's seat belts.

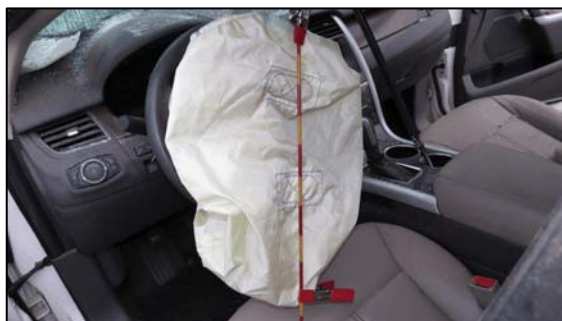
**Figure 11.** Driver's air bag, 2013 Ford Edge

Both stages of the driver's frontal air bag deployed from the steering wheel hub during the impact with the curb (**Figure 11**). The air bag measured 45.0 cm (17.7 in) side to side and 53.0 cm (20.8 in) top to bottom. The EDR reported that the occupant size classification for the front passenger position as Child Size = Yes, and it is presumed that the passenger frontal air bag was suppressed.
