DOT HS 812 571

# **Special Crash Investigations On-Site Office of Defects Investigation**

## **Air Bag Non-Deployment Investigation**

**Vehicle: 2009 Saturn  
Outlook**

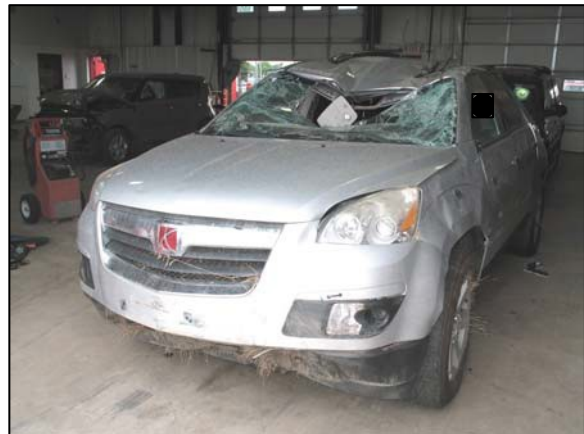
**Figure 1:** 2009 Saturn Outlook

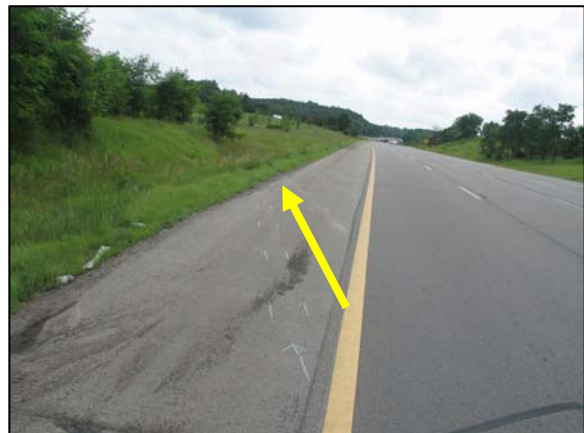
**Figure 2:** Northeast roadway departure

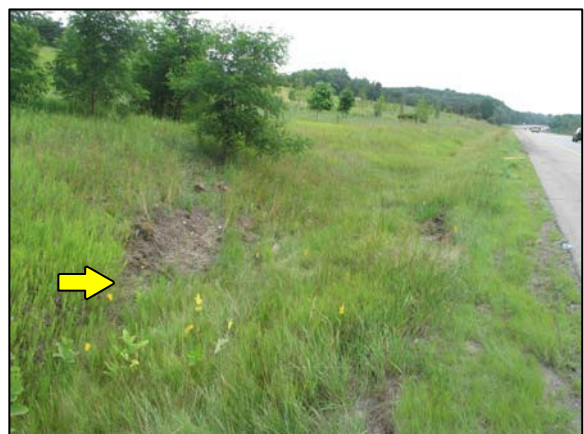
The front plane struck the back slope of the ditch (**Figure 3**, event 1). The force direction was in the 2 o'clock sector and the impact resulted in no frontal air bag deployments. The WinSMASH barrier algorithm calculated the total delta-V as 8 km/h (5 mph). The longitudinal and lateral velocity changes were -5 km/h (-3 mph) and -6 km/h (-4 mph), respectively. The results

**Figure 3:** Front/undercarriage impact with back slope of ditch. Looking northeast.

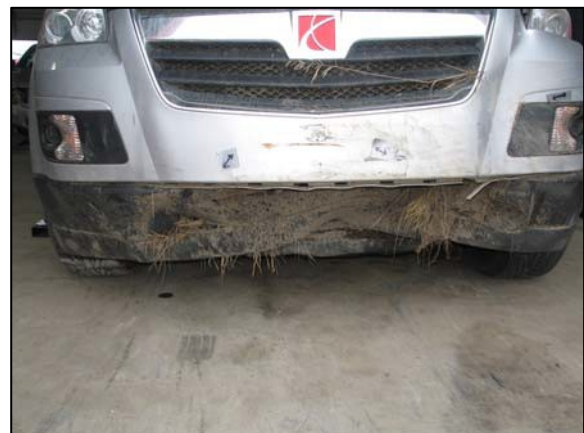
*Exterior Damage Event 1:* The Saturn sustained damage to the front plane during the impact with the back slope of the ditch. The direct damage extended across the entire front plane and included the bumper fascia and the front undercarriage (**Figure 4**). The direct damage and Field L were 174 cm (68.5 in). There was dirt and grass embedded in the structures under the bumper and there were scratches to the bumper fascia. There was no crush to the bumper bar.

*Damage Classification Event 1:* The Collision Deformation Classification (CDC) was 02FDLW1 (50 degrees).

**Figure 4:** Front bumper fascia/undercarriage damage

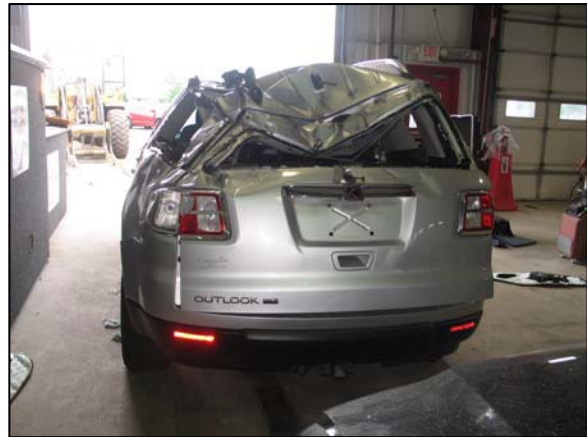
*Exterior Damage Event 2:* Both side planes sustained minor damage and the roof sustained severe damage during the rollover. The direct damage on the left side began at the front bumper corner and extended 415 cm (163.4 in) rearward on the fender, A-pillar, front door, roof side rail, C-pillar, D-pillar, and quarter panel. The direct damage on the right plane began on the fender and extended 400 cm (157.8 in) intermittently on both doors, B-pillar, C-pillar, roof side rail, and D-pillar. Direct damage to the top plane began at the middle of the left A-pillar and extended the full length and width of the roof. The maximum lateral crush was 14 cm (5.5 in), occurring to the left D-pillar (**Figure 5**). The maximum vertical crush (**Figure 6**) was 32 cm (12.6 in), occurring at the left backlight header.

**Figure 5:** Maximum vertical crush at left D-pillar

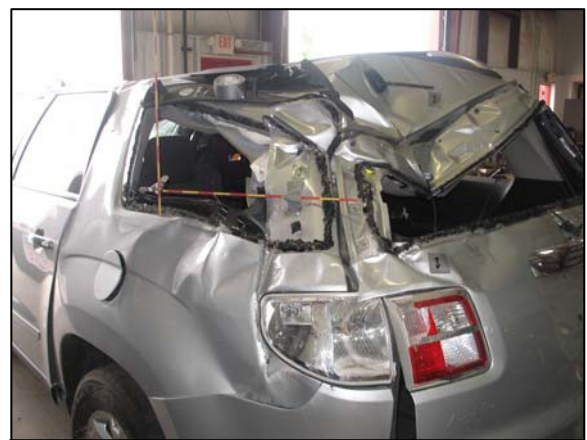
*Damage Classification Event 2:* The CDC was 00TZDO4.

**Figure 6:** Maximum vertical crush

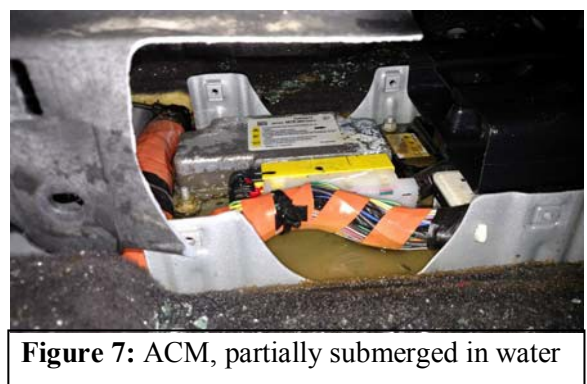
Attempts to image the Saturn's EDR with version 16.1.1 of the Bosch Crash Data Retrieval (CDR) software via the Data Link Connector (DLC) were unsuccessful. The air bag control module (ACM) and rollover sensor (ROS) were accessed and were found to be partially submerged in water (**Figure 7**), since the vehicle had been stored outdoors, uncovered. The vehicle was moved inside a garage for inspection. The ACM and ROS were then removed from the vehicle and allowed to dry for several hours. Attempts to image both modules were again unsuccessful. The ACM and ROS modules were removed from the inspection site with the authorization of the insurance company and allowed to dry for several days. Both modules were then successfully imaged and reported with version 17.7.1 of the CDR software. The EDR report for each module stated that no events were recovered. The EDR reports for both modules are attached to the end of this report as **Appendices A and B**. GM subsequently imaged both modules.

**Figure 7:** ACM, partially submerged in water

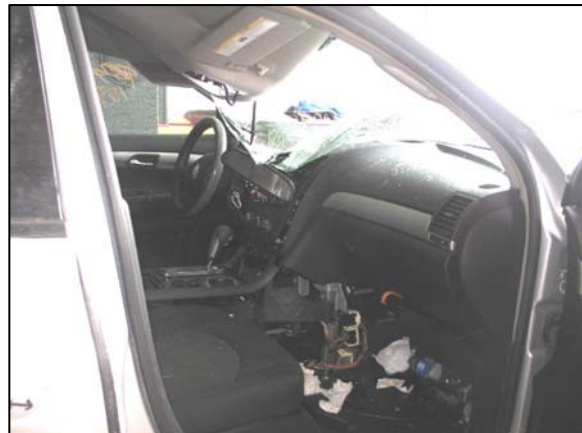
The interior of the Saturn sustained severe damage from intrusion of the occupant compartment. The most severe intrusions in the driver's and front right occupant positions involved the roof (**Figure 8**), which intruded vertically 21 cm (8.3 in) and 13 cm (5.1 in), respectively). The most severe intrusion occurred at the cargo area where the roof intruded vertically 33 cm (13 in). The glove box door was scratched from possible contact by the front right occupant's left knee. There was no other discernable evidence of occupant contact and no deformation to the steering wheel.

**Figure 8:** Intruded roof at first seating row
