DOT HS 812 584

**Special Crash Investigations
On-Site Air Bag
Non-Deployment
Crash Investigation
Vehicle: 2004 Lexus GX470
Location: Massachusetts
Crash Date: August 2017**

SPECIAL CRASH INVESTIGATIONS
CASE NO: CR17027
OFFICE OF DEFECTS INVESTIGATION
ON-SITE AIR BAG NON-DEPLOYMENT CRASH INVESTIGATION
VEHICLE: 2004 LEXUS GX470
LOCATION: MASSACHUSETTS
CRASH DATE: AUGUST 2017

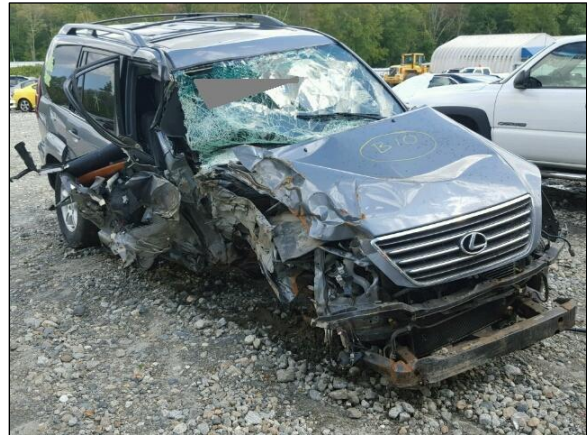
Figure 1: Front right oblique view of the 2004 Lexus GX470.

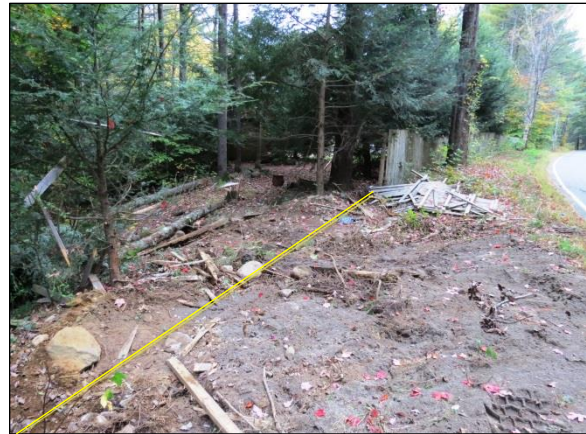
Figure 3: West-facing view of the crash site and location of multiple overlapping events. Note that the yellow line in the image represents the original location of the wooden fence.

in the image, excavation at the crash site hindered the SCI investigator's ability to reconstruct the crash scene and explicitly identify each specific impact event sustained by the Lexus during the crash sequence. Note that the yellow line in the image represents the original location of the fence.

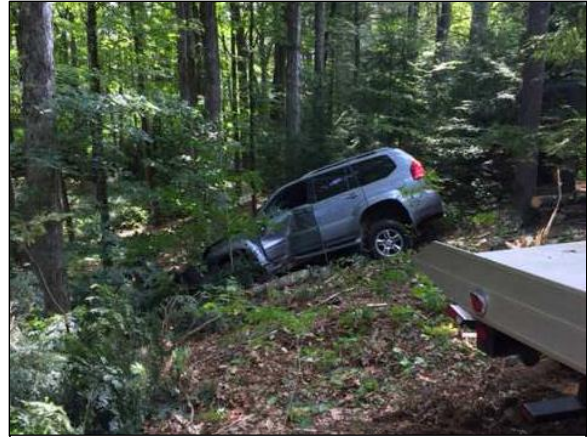
Figure 4: South-facing view from the old wooden fence line of the Lexus at final rest (*on-scene image provided by the investigating law enforcement agency*).

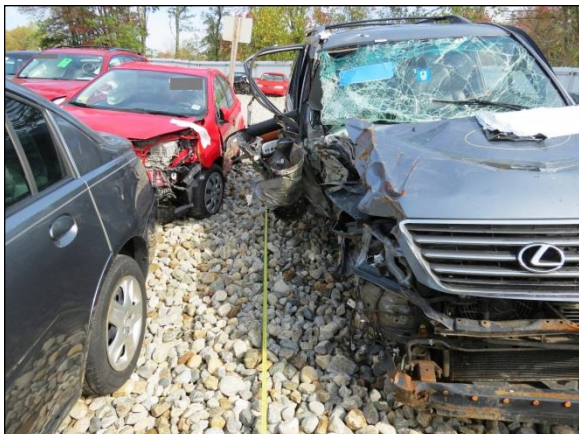
The third impact event with the multiple large-diameter trees produced severe deformation to the front right corner and right plane of the Lexus. Although the damage overlapped prior impact damage, the extent of the damage along the right plane began at the right front bumper corner and extended to beyond the right A-pillar. The right front fender and right A-pillar were deformed rearward, and the right front door was completely collapsed. Front plane damage included the separation of the bumper fascia and minor deformation to the bumper beam. Crush to the bumper beam was observed with direct contact damage primarily outboard of the right frame rail. There was also minor deformation to the right aspect of the hood. **Figure 6** depicts a view from the front plane down the right side, while **Figure 7** depicts a lateral view of the right plane and Event #3 deformation.

Figure 6: View of the Event #3 damage pattern to the 2004 Lexus GX470 sedan.

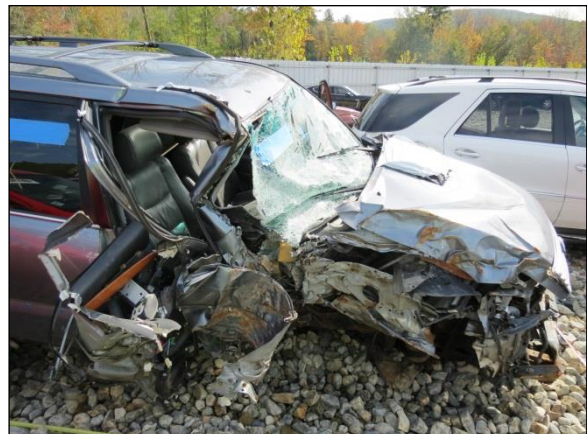
Figure 7: Damage pattern to the forward half of the Lexus' right plane.

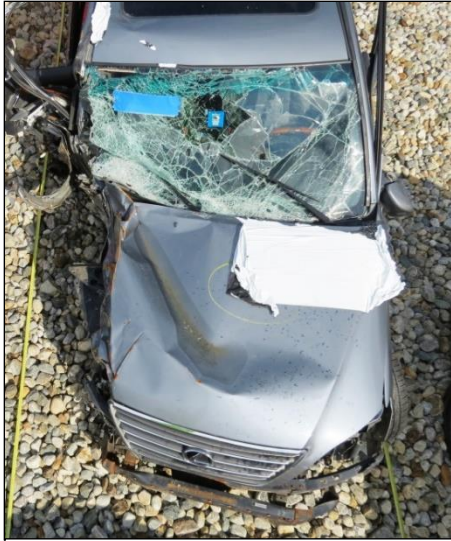
Direct contact began 50 cm (19.7 in) right of center and extended to the right front bumper corner. From a front plane perspective, the width of the direct and induced damage (Field-L) for the crush profile measured 150 cm (59.1 in) from bumper corner to bumper corner. This produced the following resultant measurements: C1 & C2 = 0 cm (0 in), C3 = 5 cm (2.0 in), C4 = 11 cm (4.3 in), C5 = 16 cm (6.3 in), and C6 = 35 cm (13.8 in). Maximum crush was located at the right front bumper corner. The CDC assigned for the Event 3 impact with the large-diameter trees was 12FRAE7. WinSMASH calculations could not be performed because the yielded status of the

Figure 8: Overhead view of the Lexus’ front crush profile and deformation pattern.

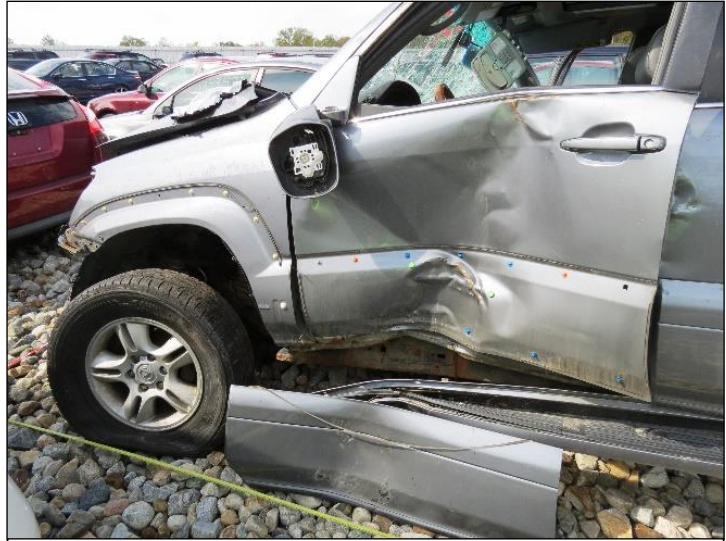
Figure 9: View of the left plane damage pattern to the Lexus from the Event 4 tree impact.

Damage associative to Event #4 was located on the left plane, in the area of the driver’s door. This consisted of a distinct U-shaped deformation pattern to the vehicle that began on the running board and at sill level, extending diagonally upward and rearward to the beltline (**Figure 9**). Although the directional nature of the pattern began at 315 cm (124.0 in) on the baseline and extended 95 cm (37.4 in) rearward to 220 cm (86.6 in) on the baseline, the overall maximum width of the damage pattern measured just 26 cm (10.2 in) wide. The most significant crush was observed at sill level, with a maximum depth of 10 cm (3.9 in). An accurate residual crush profile of the damage could not be obtained due to the inability to completely close and latch the driver’s door. The CDC assigned to the damage pattern of the Event 4 tree impact was 09LPAN2. No WinSMASH calculation was performed because the yielded status of the impacted tree was beyond the scope of the model’s capabilities, and would not have produced representative results.

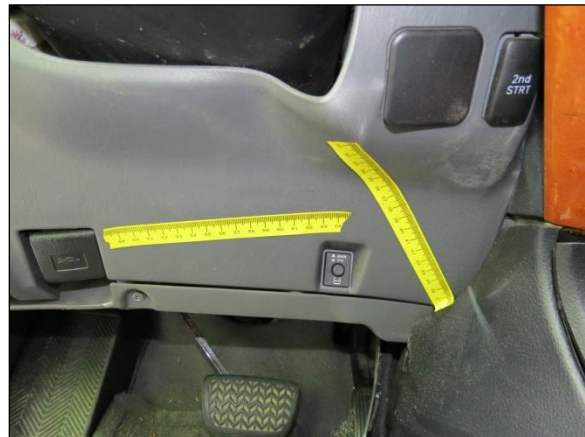
The only discernable occupant contact evidence in the Lexus was an area of scuffing and deformation to the left lower instrument panel (**Figure 10**). This contact was attributed to loading by the driver's knees during the multiple event crash sequence. The windshield was fractured by crash forces, but not contacted by the occupant or holed. The fully-opened left front glazing and partially-opened right front glazing were both disintegrated by crash forces. All other glazing remained intact. The right front door was completely collapsed and crushed in the damage/deformation pattern on the right plane. All other doors remained closed during the crash and were operational at the time of the SCI vehicle inspection.

Figure 10: Deformation and scuffing on the left lower instrument panel from loading by the driver's knees.

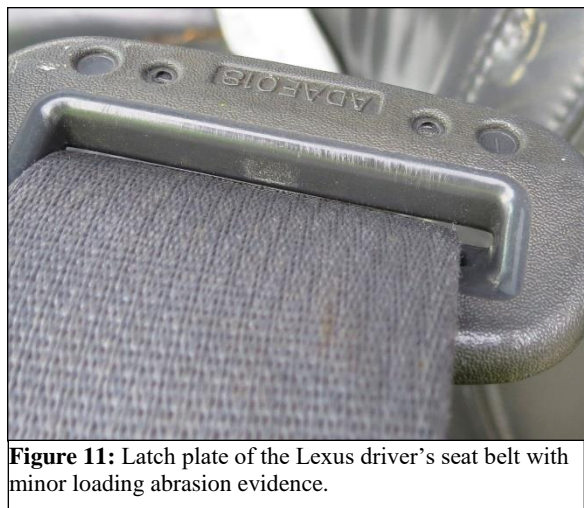
Figure 11: Latch plate of the Lexus driver's seat belt with minor loading abrasion evidence.

latch plate was located from 85 to 90 cm (33.5 to 35.4 in) above the lower anchor. There was also an area of loading abrasions on the webbing that corresponded to the D-ring, located 180 to 185 cm (70.9 to 72.8 in) above the lower anchor. Minor abrasions along the belt path in the polymer surface of the latch plate further evidenced the driver's use of the system (**Figure 11**). It was apparent to the SCI investigator that the driver was restrained by the seat belt at the time of the crash.

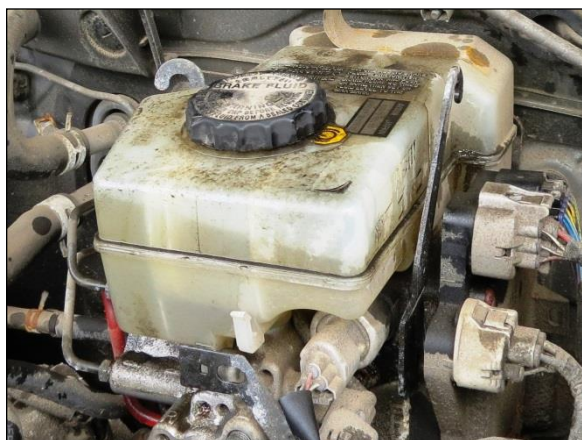
The SCI investigator inspected the vehicle's braking system, and observed that the fluid reservoir was nearly empty. After tracing the distribution lines of the system, the SCI investigator identified that separation of the entire right front wheel assembly had separated the brake line from the caliper. The SCI investigator clamped the severed hose connection closed using a pair of vice grips, and then refilled the reservoir using brake fluid purchased at an auto parts retail store. The new fluid did not immediately mix with the old fluid in the reservoir, and a layering effect occurred that showed the original level and refilled level (**Figure 12**). The SCI investigator then pumped the brake pedal with his foot approximately 12 to 14 times in an attempt to pressurize the system. By the final pumps, pressure returned to the system, and resistance was felt immediately upon depressing the pedal.

Figure 12: View of the layered brake fluids (dark – old, light – new) following refill of the reservoir by the SCI investigator.

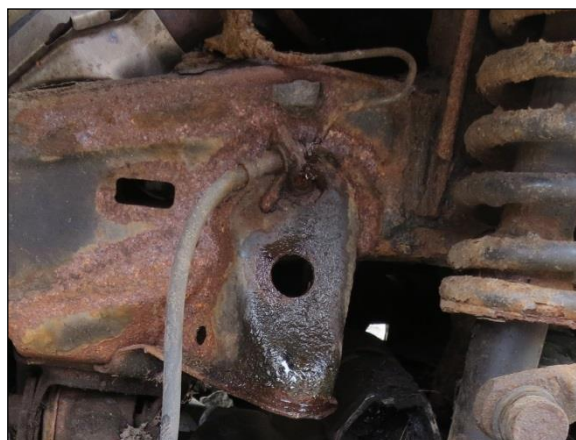
Figure 13: View of the corroded connection and leaking brake fluid during the SCI brake system test.

The successful pressurization of the system by the SCI investigator indicated that the Lexus' braking system was still intact, and was capable of performing properly. Recognizing that the severed line to the right front caliper simply drained the system post-crash, the SCI investigator again traced the distribution lines of the now pressurized system in an attempt to locate an anomaly. The SCI investigator located a severely corroded connection adjacent to the right front axle

position that was now leaking steadily from the pressurized system. Brake fluid dripped consistently from tiny holes in the circumference of the corroded joint, and quickly produced a large visible area of leaked fluid (**Figure 13**).

It was apparent to the SCI investigator as a result of the inspection that the driver’s allegations concerning the loss of response from the Lexus’ brake system were likely valid. The evidence indicated that a corroded connection allowed a slow but consistent leak of fluid from the system.

The driver stated during interview that there had been no indication of braking system deficiency prior to the crash. As the driver operated the vehicle, fluid continued to leak from the system and slowly reduced the volume in the reservoir. This ultimately led to the development of a depressurization of the system once the volume became too low, which triggered the illumination of the warning light on the instrument cluster. The depressurized system was unable to respond to the driver’s depression of the brake pedal, thus confirming her allegation and resulting in her inability to control the vehicle’s speed.
