# **Special Crash Investigations On-Site Crash Avoidance Forward Collision Warning Investigation**

**Vehicle: 2014 Honda Accord**

**Location: Kansas**

**Crash Date: April 2016**

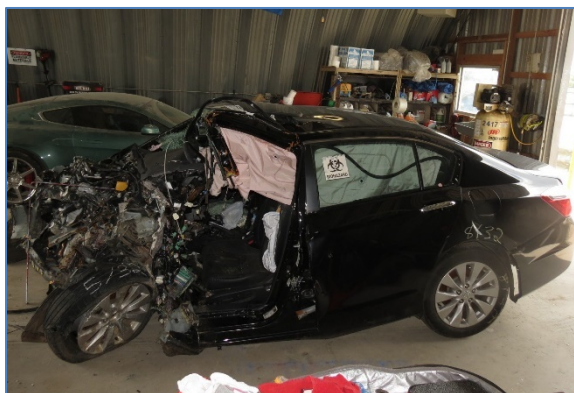
**Figure 1:** The damaged 2014 Honda Accord

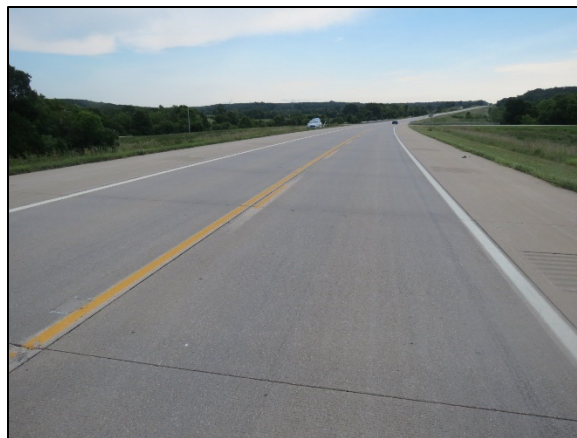
**Pre-Crash:** The Honda was northeast-bound in a right curve (**Figure 2**). The GMC was southwest-bound in a left curve and was traveling behind an uninvolved vehicle. According to the statement to police by the driver of the uninvolved vehicle, the Honda drifted into her lane and passed directly behind her vehicle and into the path of the GMC. It is not known if the Honda's LDW system issued a warning prior to the vehicle crossing the centerline or if the FCW system issued a warning prior to the crash. See the Crash Avoidance Features discussion in this report.

**Figure 2:** Northeast-bound approach of the Honda

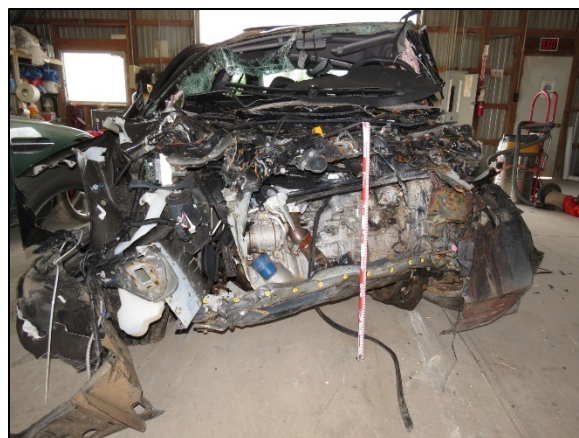
**Crash:** The front plane of the Honda (**Figure 3**) struck the front plane of the GMC (**Figure 4**). The force direction on the Honda was in the 12 o'clock sector and the impact resulted in deployment of the driver's frontal, left-seat-mounted side impact, and left IC air bags. The damage and trajectory algorithm of the WinSMASH program calculated the total delta-V for the Honda as 104 km/h (65 mph). The longitudinal and lateral velocity changes were -104 km/h (-65 mph) and 0 km/h, respectively. The calculated impact speed was 100 km/h (62 mph).

**Figure 3:** Damage to the front plane of the Honda from the impact with the front plane of the GMC

The Honda sustained direct damage to the front plane during the impact with the front plane of the GMC. The direct damage began at the left corner of the Honda's front bumper and extended 121 cm (47.6 in) across the front plane. The Field L was 107 cm (42.1 in) and began at the same location as the direct damage. Two sets of crush measurements were taken since the crush at the upper radiator frame level exceeded that at the bumper level. The maximum residual crush at the upper radiator frame level was 121 cm (47.6 in) occurring at the left corner of the radiator frame. The maximum residual crush at the bumper level was 83 cm (32.7 in) occurring at the left bumper corner. The crush values at both levels were averaged as required by the crush measurement protocol and the averaged crush values were:  $C_1 = 102$  cm (40.1 in),  $C_2 = 90$  cm (35.4 in),  $C_3 = 75$  cm (29.5 in),  $C_4 = 62$  cm (24.4 in),  $C_5 = 57$  cm (22.4 in),  $C_6 = 44$  cm (17.3 in).

The Collision Deformation Classification (CDC) was 12FDEW5 (0 degrees).

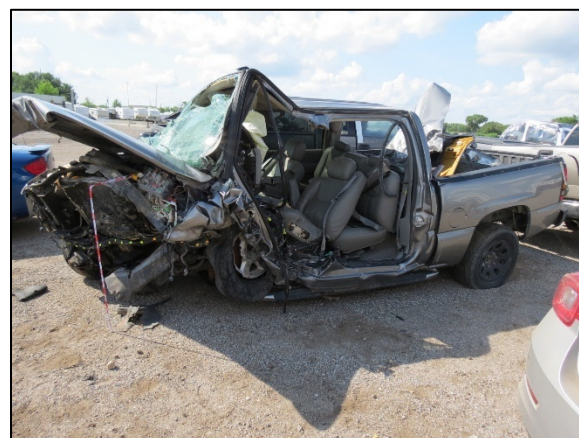
**Figure 4:** Left side view of the damage to the GMC from the impact with the Honda

The GMC sustained direct damage to the front plane during the impact with the front plane of the Honda. The direct damage began at the left corner of the front bumper and extended 153 cm (60.2 in) across the front plane. The Field L was also 153 cm (60.2 in). The bumper was displaced from the vehicle, so the crush measurements were taken at the lower radiator support level and the maximum residual crush was determined to be 153 cm (60.2 in) occurring at the left bumper corner. The crush values were:  $C_1 = 153$  cm (60.2 in),  $C_2 = 113$  cm (44.5 in),  $C_3 = 92$  cm (36.2 in),  $C_4 = 76$  cm (29.9 in),  $C_5 = 60$  cm (23.6 in),  $C_6 = 47$  cm (18.5 in).

The CDC was 12FDEW6 (0 degrees).

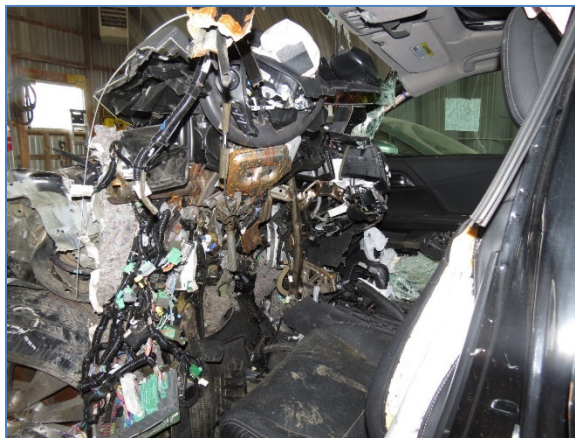
**Figure 5:** Damage to the Honda's instrument panel and steering assembly

The interior of the Honda sustained severe damage from 11 intrusions. The most severe intrusions in the driver's seating area involved the toe pan, instrument panel, and left A-pillar. The toe pan intruded longitudinally 54 cm (21 in). The left A-pillar and instrument panel were displaced by emergency responders to extricate the driver, so the extent of their intrusion was estimated to be 65 cm (26 in) based on the appearance of the damage. The steering wheel was completely collapsed from the unbelted driver's chest loading through the deployed frontal air bag and contacting the steering wheel. The center and left instrument panel were also deformed by contact from the driver's knees. The windshield glazing was cracked and largely displaced from the ve-

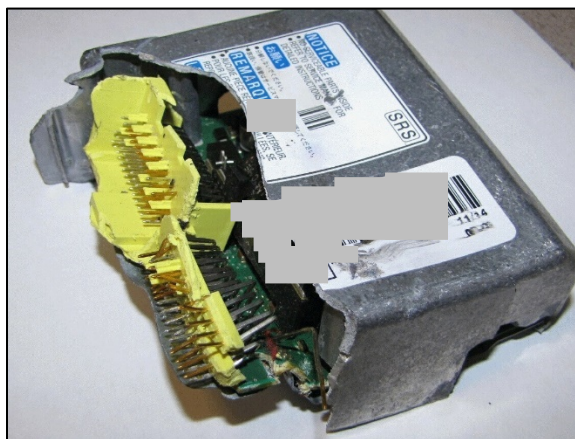
Attempts to image the Honda's EDR via direct connection to the ACM using version 16.6 of the Bosch Crash Data Retrieval software were unsuccessful since the ACM was severely damaged (**Figure 6**) in the crash. The damaged ACM was found during the SCI vehicle inspection separated from its electrical connection and anchor bolts. It was located under the center instrument panel, on the floor pan, near the cowl in the area where it would normally be bolted to the vehicle. The ACM's metal casing was fractured and the bolt mounting brackets were fractured and missing. The electrical connectors were also fractured. The deformation of the vehicle's cowl and floor pan in this area indicated that the ACM was damaged during the crash.

**Figure 6:** The Honda's damaged ACM
