DOT HS 812 624

October 2018

# **Special Crash Investigations On-Site Small Overlap/Oblique Impact Investigation Vehicle: 2014 Nissan Versa Location: Missouri Crash Date: August 2016**

Indiana University  
Transportation Research Center  
On-Site Small Overlap/Oblique Impact Investigation  
Case Number - IN16024  
Location - Missouri  
Vehicle - 2014 Nissan Versa  
Crash Date - August 2016

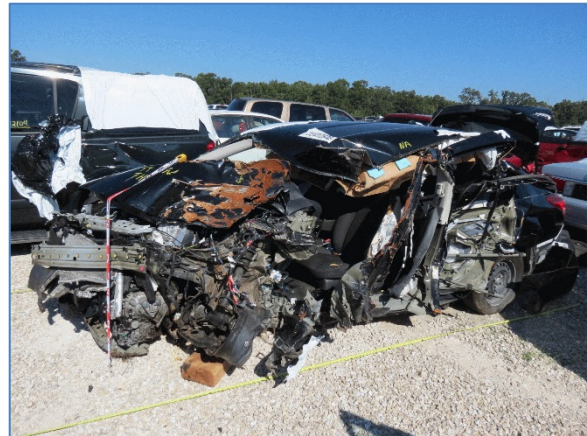
**Figure 1:** The damaged 2014 Nissan Versa

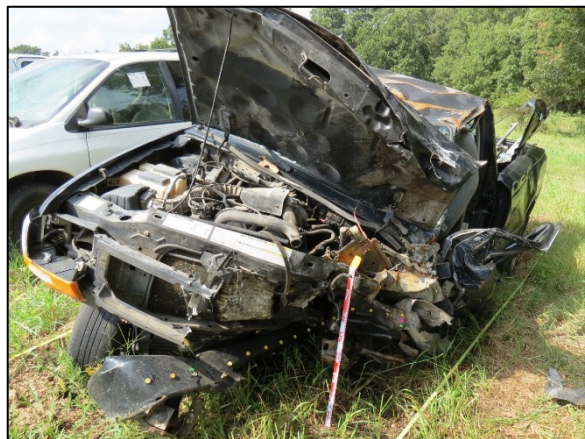
**Figure 3:** Damage to the front plane of the Ford

The Ford sustained direct and induced damage to the front and left planes from the impact with the front plane of the Nissan. The front bumper, hood, left turn lamp/head lamp assembly, left fender, and left front wheel were directly damaged. The direct damage began at the left corner of the front bumper and extended 108 cm (42.5 in) across the front plane. The Field L was 63 cm (24.8 in) long and began at the same location. Crush measurements were taken on the bumper and the maximum residual crush was 134 cm (53.0 in) occurring at  $C_2$ . The crush values were:  $C_1 = 126$  cm (46.6 in),  $C_2 = 134$  cm (52.7 in),  $C_3 = 134$  cm (52.8 in),  $C_4 = 129$  cm (50.8 in),  $C_5 = 77$  cm (30.3 in),  $C_6 = 16$  cm (6.3 in).

*Damage Classification Event 1:* The CDC was 12FDEW6 (0 degrees).

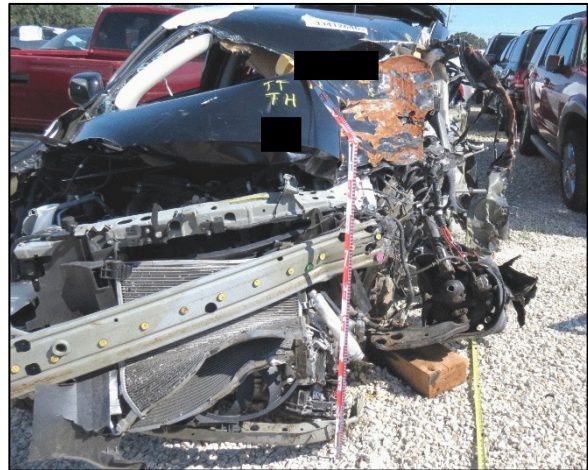
The front left of the Ford (**Figure 3**) struck the front left of the Nissan (**Figure 4**). The impact occurred 1.0 m (3.2 ft) into the Nissan's travel lane. The force direction on the Nissan was in the 12 o'clock sector and the impact resulted in a stage 2 deployment of the driver's frontal air bag. Both front seat-mounted side impact and IC air bags also deployed and both front seat belt pretensioners actuated. The EDR reported the maximum longitudinal and lateral velocity changes to the Nissan as -60 km/h (-37 mph) and 16 km/h (10 mph), respectively.

**Figure 4:** Damage to the front plane of the Nissan

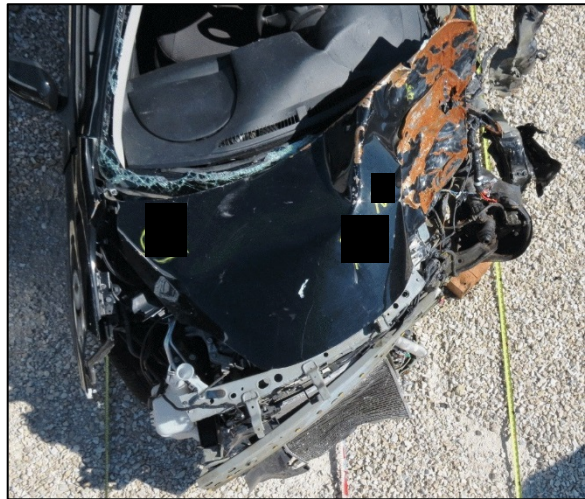
The entire front plane sustained direct and induced damage during the impact with the front plane of the Ford. The direct damage also extended down the left plane involving the fender, front wheel, A-pillar, roof, and left front door, which was displaced from the vehicle. The direct damage on the front plane began at the left corner of the front bumper and extended 50 cm (19.7 in) across the front plane. The Field L was 109 cm (42.9 in) long and began at the same location. Crush measurements were taken on the bumper bar and the maximum residual crush was 51 cm (20.1 in) occurring at C<sub>1</sub> (**Figure 5**). The crush values were: C<sub>1</sub> = 51 cm (20.1 in), C<sub>2</sub> = 47 cm (18.5 in), C<sub>3</sub> = 39 cm (15.4 in), C<sub>4</sub> = 26 cm (10.2 in), C<sub>5</sub> = 10 cm (3.9 in), C<sub>6</sub> = 0 cm.

**Figure 5:** Top view of crush to the front plane of the Nissan

*Damage Classification:* The Collision Deformation Classification (CDC) was 12FYEW3 (350 degrees).

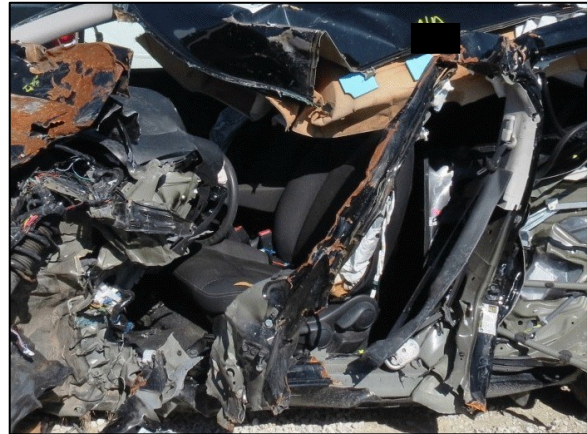
The interior of the Nissan sustained major damage from 13 intrusions. The most severe intrusions into the driver’s seating area involved the left instrument panel and windshield header, which intruded longitudinally 34 cm (13.4 in) and vertically 25 cm (9.8 in), respectively. The steering assembly was displaced from its instrument panel anchors and was found on the driver’s seat at the SCI vehicle inspection. It was estimated to have intruded longitudinally 25 cm (9.8 in). The upper left A-pillar was separated from the cowl and roof (**Figure 6**).

The impact also resulted in severe deformation of the left front door, which was displaced from the vehicle.

**Figure 6:** Damage to the Nissan’s left A-pillar, roof, and left front door frame
