DOT HS 812 638

# **Special Crash Investigations**

## **Remote Vehicle Fire**

#### **Vehicle: 2004 Jeep Grand**

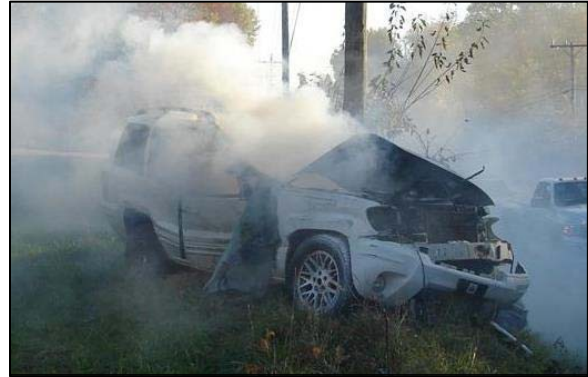
**Figure 1:** Police photo of the damaged 2004 Jeep Grand Cherokee

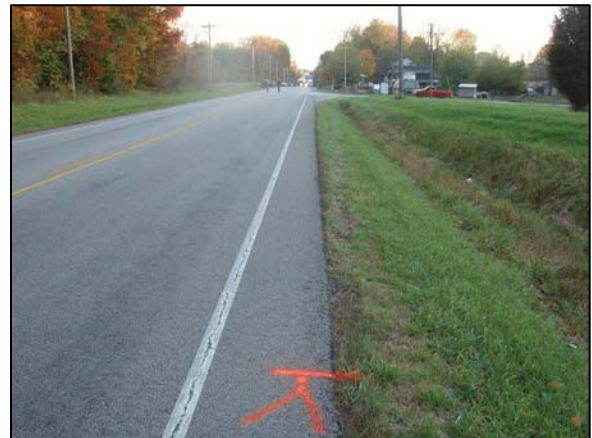
**Figure 2:** Police photo showing the Jeep’s road departure, view south

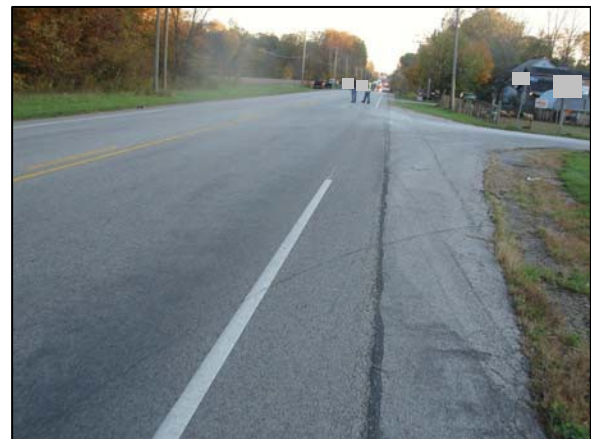
**Figure 3:** Police photo showing the area the Jeep reentered the roadway, view southeast

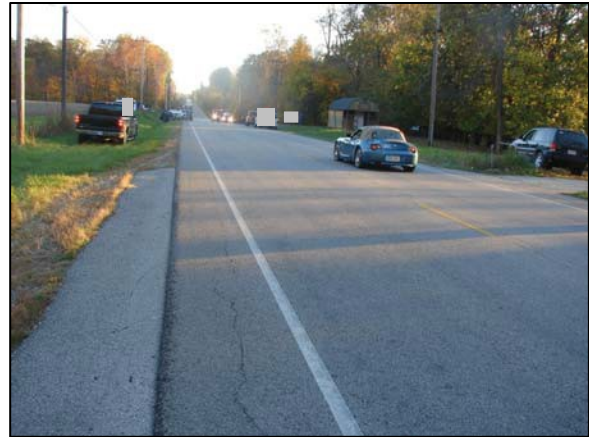
**Figure 4:** Police photo showing the Jeep's travel from east shoulder across northbound lane, view southwest

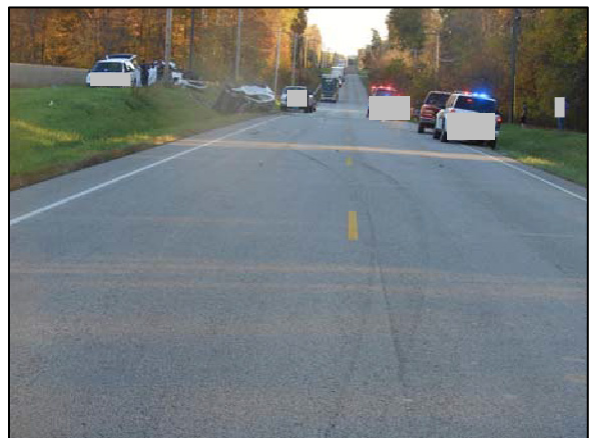
**Figure 5:** Police photo showing right side tire yaw marks from the Jeep as it approaches area of rollover, view south

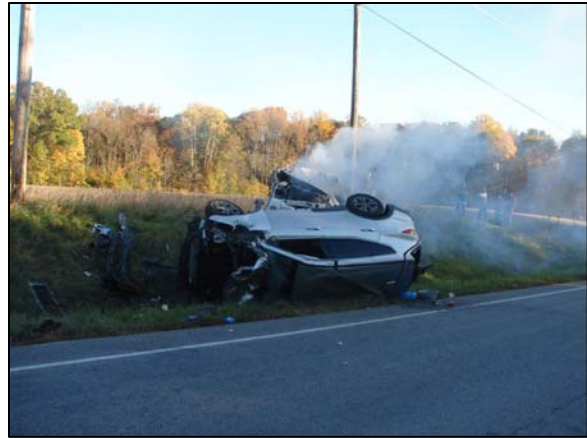
**Figure 6:** Police photo showing final rest positions of the Jeep and Hyundai, view southeast

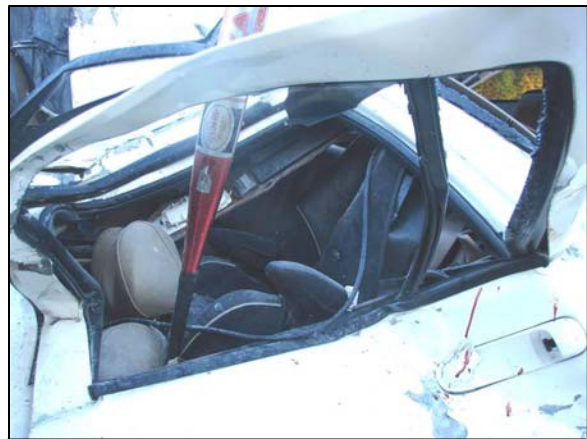
**Figure 7:** Area where second row left occupant was removed from Jeep

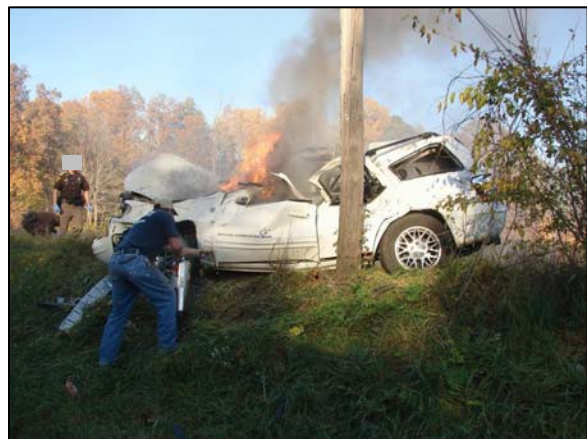
**Figure 8:** Police photo showing first fire fighter preparing to extinguish fire after it re-ignited

to extinguish the fire (**Figure 8**). The second fire fighter also obtained a hand-held fire extinguisher and assisted the first fire fighter. The first fire fighter estimated that the fire truck arrived on-scene 12 minutes after his arrival at the crash scene.

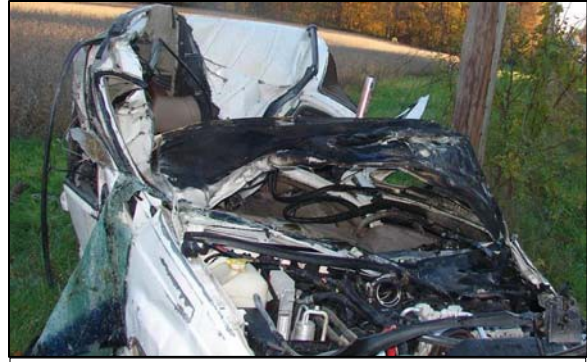
The origin of the fire was in the left cowl/instrument panel area suggesting that the likely cause of the fire was electrical. The majority of the fire damage appeared to have occurred in the left cowl and left rear area of the engine compartment (**Figure 9**). The severity of the fire was considered to be minor.

**Figure 9:** Area of fire damage to the Jeep

The interior of the Jeep sustained severe damage from intrusion to the roof. There also was lateral displacement of the left A-, B-, C-pillars, and the left roof side rail into the occupant compartment. The fire damage to the interior was minor. The top of the left instrument panel was burned and the steering wheel rim appeared to have been burned slightly. The driver’s seat back was displaced rearward. The left front and rear doors were jammed shut. The right side doors also appeared to be jammed shut. The glazing in all the left side windows, right front, and third right rear windows were disintegrated from impact forces. The windshield was cracked, holed, and out-of-place.
