DOT HS 812 643

# **Special Crash Investigations On-Site Child Restraint System Crash Investigation Vehicle: 2006 Nissan Pathfinder Location: Oregon Crash Date: January 2016**

**SCI Case Number: DS16002**

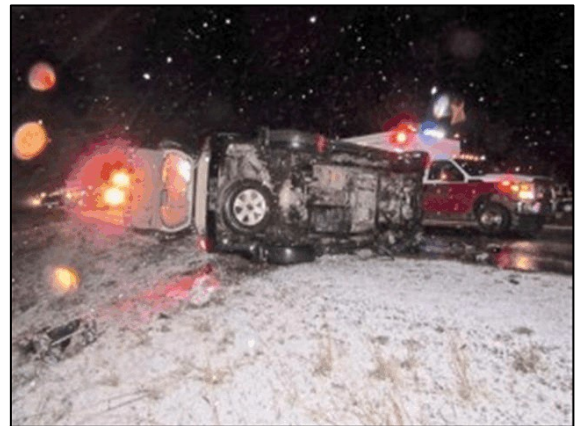
right side tires and rims engaged the ground with sufficient opposing lateral force to cause a right side leading trip rollover (Event 2). Gravel lodged between the right rear rim and tire suggested the trip point was on the gravel shoulder. The Nissan rolled three quarter-turns and came to rest facing south on its left side on the north shoulder of the roadway (**Figure 3**).

The Nissan came to rest 20.0 m (66.0 ft) northwest of the initial POI. The trip point was not documented and the estimated rollover distance was 14 m (46 ft).

**Figure 3.** 2006 Nissan Pathfinder on-scene (news image)

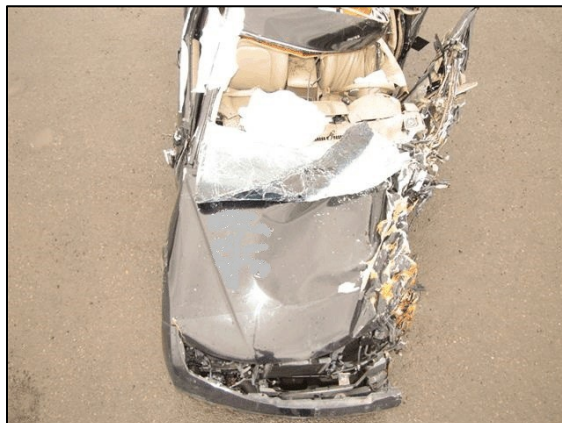
The vehicle sustained moderate severity damage to the top and left planes caused during the rollover event (**Figure 4**). Direct damage extended from roof side rail to roof side rail and measured 120.0 cm (47.2 in). The damage to the top plane extended longitudinally beginning at the leading edge of the hood and ending at the rear aspect of the roof rack. Maximum lateral crush was located at the left B-pillar and measured 12.0 cm (4.7 in). Maximum vertical crush was located on the left roof and measured 26.0 cm (10.2 in). The CDC for the Nissan in Event 2 was 00TDDO3. The OEM roof rack was fractured and displaced during the rollover. The hood was crumpled.

**Figure 4.** Exterior damage, 2006 Nissan Pathfinder

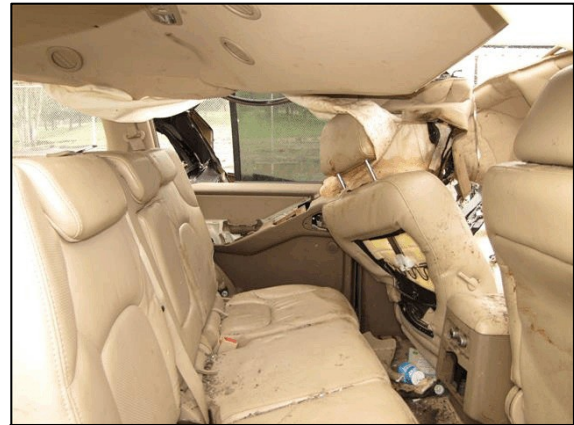
Vertical intrusion into the second row was documented at the left roof (13.0 cm [5.1 in]) (**Figure 5**), middle roof (22.0 cm [8.7 in]) and right roof (6.0 cm [2.4 in]). Lateral intrusion was documented at the left roof side rail (5.0 cm [2.0 in]) and left B-pillar (10.0 cm [3.9 in]).

**Figure 5.** Vertical intrusion of roof, 2006 Nissan Pathfinder

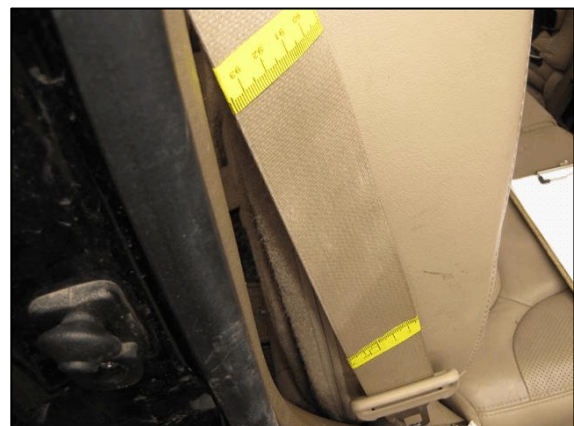
**Figure 6.** Second row right seat belt, evidence of occupant loading, 2006 Nissan Pathfinder

rear-facing CRS. The CRS was installed using the vehicle's lap and shoulder seat belt. The belt and CRS shell revealed loading evidence consistent with a rear-facing installation. The belt was scuffed beginning at 20.0 cm (7.9 in) above the stop button (**Figure 6**). The CRS installation is discussed further in the *Child Restraint System* section of this report.

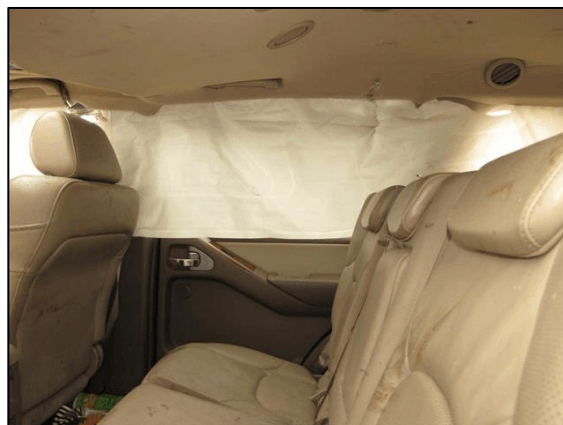
The left and right IC air bags deployed during the rollover from the left and right roof side rails above the three rows of occupant seating. The air bags measured 220.0 cm (86.6 in) x 57.0 cm (22.4 in) in their deflated state. At the forward aspect, they were configured with a sail and tether measuring 40.0 cm (15.7 in) and 14.0 cm (5.5 in) long, respectively. The left IC air bag was cut or torn away from the A-pillar at some time prior to inspection. It revealed blood deposits in the front row aspect from the driver. It is probable the driver loaded this air bag during the rollover. The right IC air bag was unremarkable. It is unlikely the rear-facing occupant seated in the CRS at the second row right position was contacted by the deployed right IC air bag (**Figure 7**).

**Figure 7.** Deployed right IC air bag, second row right seat position, 2006 Nissan Pathfinder

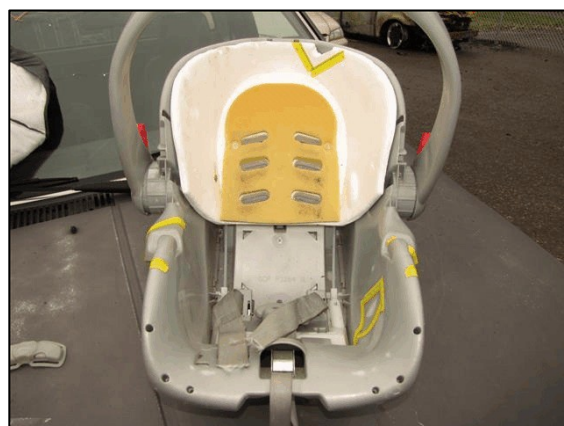
The vehicle seat belt webbing revealed evidence of occupant loading and the safety seat shell exhibited corresponding evidence of occupant loading. This evidence included discoloration of the plastic shell which is typically caused by stress at impact (**Figures 9 and 10**). The seat area revealed these discolored markings in the forward left and right sections as well as at the bottom edge of the right armrest. Additionally, the CRS foam was fractured at the upper aspect. No other damage was noted.

**Figure 9.** Graco Snugride 35 shell showing damaged areas

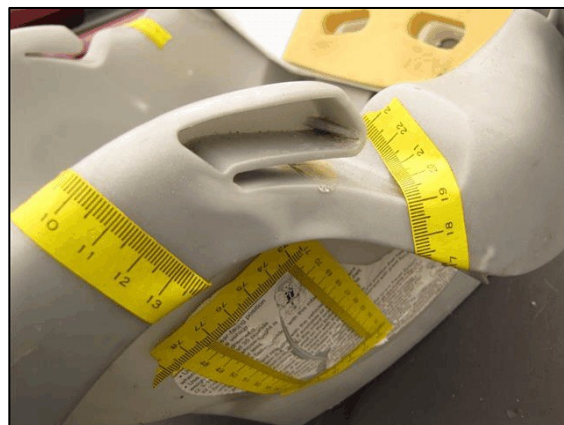
**Figure 10.** Occupant loading damage at rear-facing seat belt hook

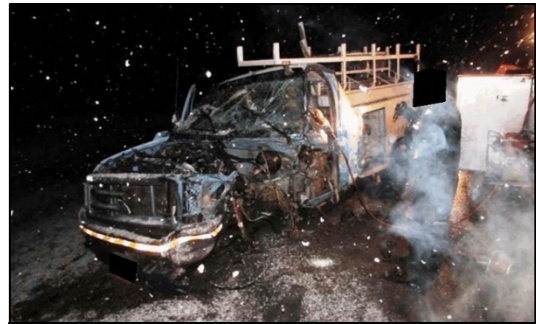
The Ford sustained moderate severity damage to the front and left planes during the impact with the Nissan in Event 1. The front bumper and left front fender were crushed, and the left front wheel and tire were displaced. The estimated CDC for the Ford in Event 1 was 12FLEE9.
