DOT HS 812 644

# **Special Crash Investigations Remote Vehicle Fire Child Restraint System Investigation Vehicle: 1995 Chevrolet Blazer Location: Kansas Crash Date: July 2013**

**INDIANA UNIVERSITY**  
**TRANSPORTATION RESEARCH CENTER**  
**REMOTE VEHICLE FIRE CHILD RESTRAINT SYSTEM INVESTIGATION**  
CASE NUMBER - IN17007  
LOCATION - KANSAS  
VEHICLE - 1995 CHEVROLET BLAZER  
CRASH DATE - JULY 2013

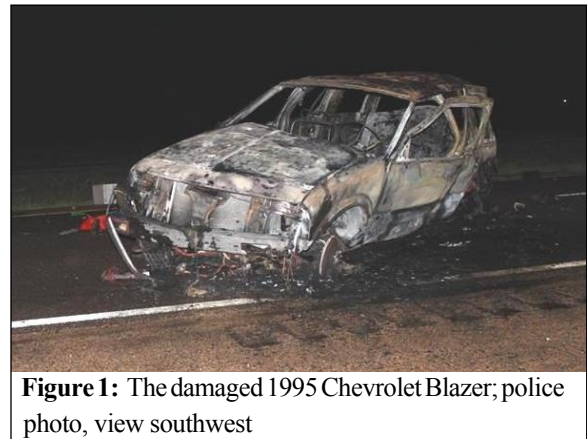
**Figure 1:** The damaged 1995 Chevrolet Blazer; police photo, view southwest

**Exterior Damage Events 1:** The Chevrolet sustained damage to both side planes and the top plane during the rollover. It appeared that the direct damage extended down the majority of the length of both sides. However, most of the paint was burned off the vehicle so minor scratches from ground contact could not be discerned. The damage to the top plane resided primarily on the roof. The hood also appeared to have some direct damage scratches related to rollover. Both left side wheels and the right rear wheel were displaced from the vehicle during the rollover. The right front wheel remained on the vehicle

**Damage Classification Event 1:** The Collision Deformation Classifications (CDC) was 00TDDO3. The severity of the damage was moderate based on the extent of the roof crush.

***Exterior Damage Event 2:*** The vehicle sustained major fire damage to the entire vehicle. Some paint remained on the lower portions of both right-side doors and quarter panel. The fire damage was severe since most of the combustible material was consumed in the fire. The source of the fire is not known.

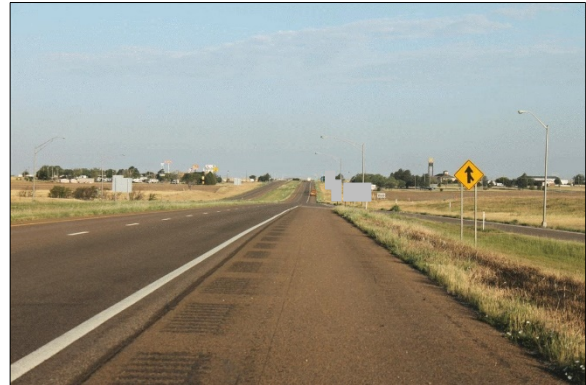
**Figure 2:** Police photo of northwest-bound approach of Chevrolet and non-contact vehicle

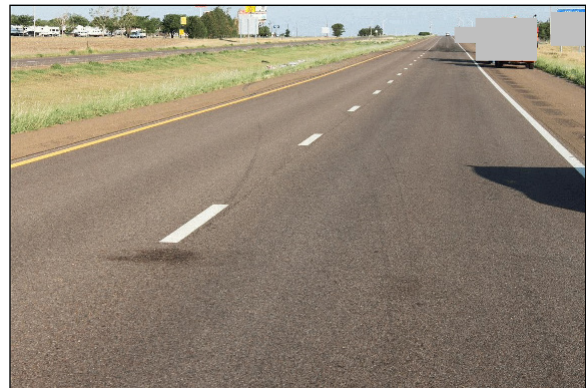
**Figure 3:** Police photo of Chevrolet's tire marks from driver's left steering maneuver, view west

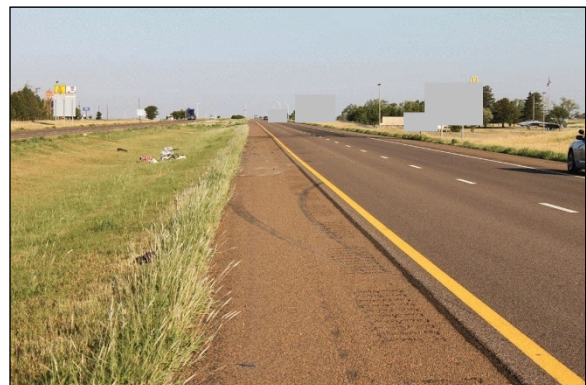
**Figure 4:** Police photo of Chevrolet's tire marks from driver's right steering maneuver and path to rollover, view northwest

**Crash:** The Chevrolet rolled over (event 1), left side leading, on the median shoulder and continued rolling over on the shoulder and then in a northwesterly direction across both northwest-bound lanes across a police-reported distance of 67.4 m (221 ft). The vehicle came to final rest upright in the right northwest-bound through lane heading northeast and caught fire (event 2). The reported rollover distance suggested that the vehicle rolled over an estimated 16 quarter turns.
