# **Special Crash Investigations**

## **Remote Vehicle Fire**

**Vehicle: 2005 Nissan**

**Armada**

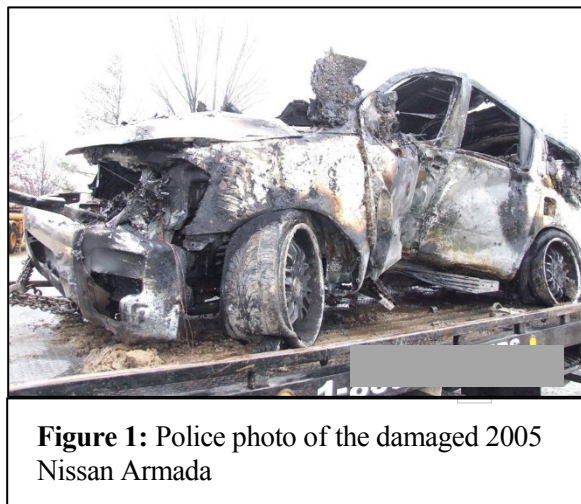
**Figure 1:** Police photo of the damaged 2005 Nissan Armada

*Exterior Damage Event 5:* The vehicle sustained fire damage to the entire vehicle. Some paint remained on the left fender and quarter panel since these surfaces were on the ground during the fire. The fire damage was severe since all the combustible material was consumed in the fire with the exception of the left front and rear tires. The source of the fire is not known.

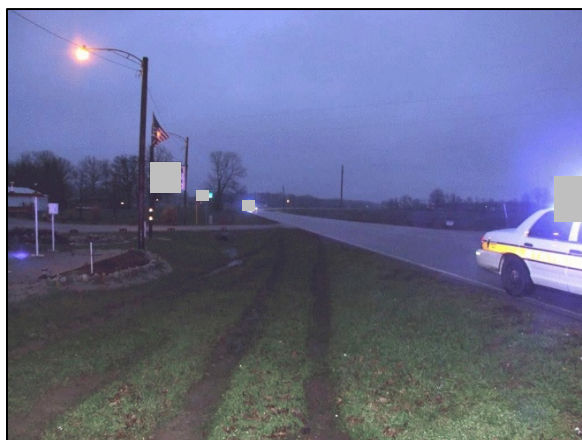
**Figure 2:** Police photo showing view back to Nissan’s approach roadway from vehicle’s off-road travel path, view southeast

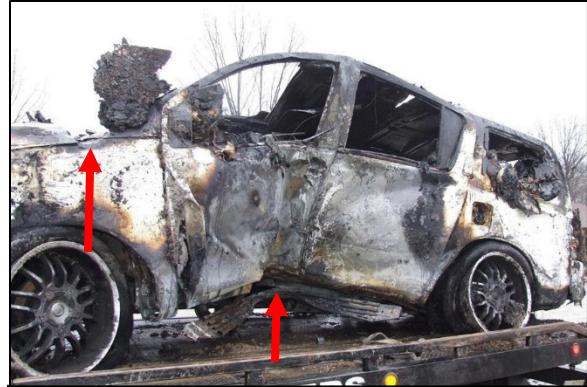
**Figure 3:** Police photo showing damage to top plane from post impact (left arrow) and damage to left plane from tree impact (right arrow)

*Exterior Damage Events 2 and 3:* The top plane of the vehicle was directly damaged during the rollover when it struck a steel property marker pole and telephone junction box. The damage was located on the top of left fender at the base of the left A-pillar. The hood in this area was probably also damaged, but could not be seen in the police photographs.

*Exterior Damage Event 4:* The left plane was damaged when it struck an estimated 36 cm (14 in) diameter tree during the rollover and just prior to coming to final rest. The direct damage was located on the left front door beginning at the B-pillar.

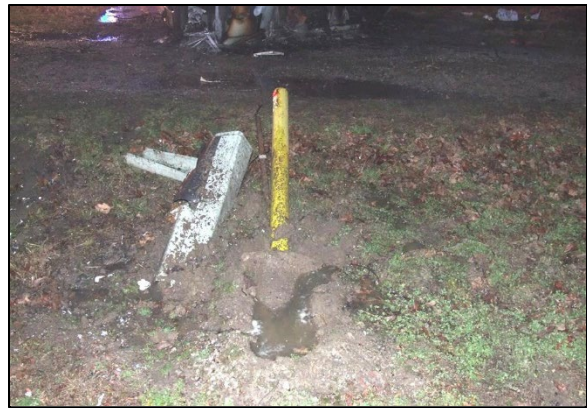
**Figure 4:** Police photo showing metal post and telephone junction box struck during rollover, and final rest position of Nissan, view west

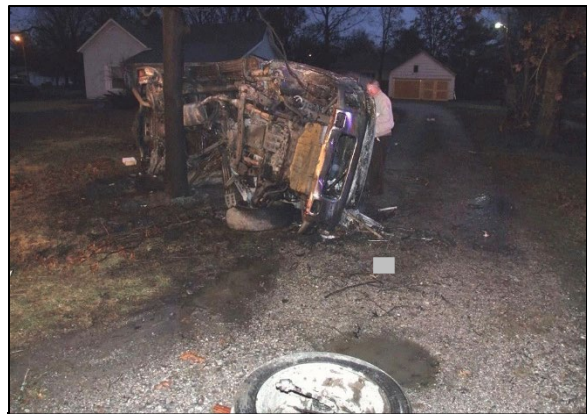
**Figure 5:** Police photo showing final rest position of the Nissan, view northwest
