DOT HS 812 725

Special Crash Investigations

Air Bag Non-Deployment Crash Investigation

Vehicle: 2017 BMW X5

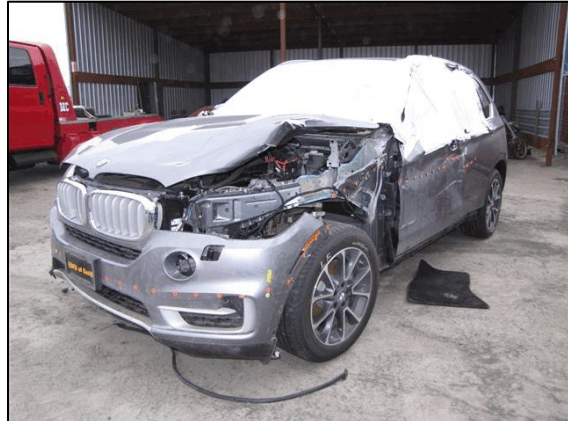
Figure 1. 2017 BMW X5

This report documents the on-site investigation of the non-deployment of side air bags in a 2017 BMW X5 (**Figure 1**) that was involved in a crash and the injuries sustained by the driver. The investigation was initiated in response to a driver notification sent to the National Highway Traffic Safety Administration's Office of Defects Investigation (ODI). The Special Crash Investigations (SCI) group assigned the case to Dynamic Science, Inc., in February 2017. The owner of the BMW indicated in the notification that the vehicle's side air bag did not deploy in the crash, causing a head injury to the driver. The investigation was intended to determine occupant restraint usage, kinematics, injury sources, and air bag deployment parameters for this vehicle. Based on all available data there was no evidence suggesting the vehicle was involved in any impact of sufficient severity to warrant a side air bag deployment.

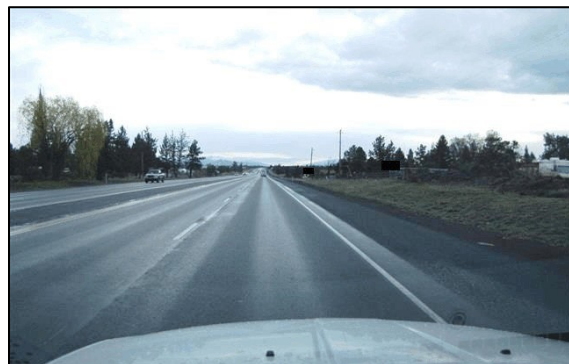
Figure 2. Crash site looking north

The crash occurred in the northbound lanes on a straight and level section of a divided north/south State highway (**Figure 2**). The roadway was asphalt surfaced and configured with two lanes each direction of travel separated by a painted divider. All lanes and the center divider measured 3.7 m (12.1 ft) wide. The lanes were delineated by a solid white painted fog line on the right, a dashed white painted stripe in the center, and a double solid yellow painted strip with a rumble strip on the left. The northbound lanes were bordered on the right edge by a paved shoulder measuring 3.0 m (9.8 ft) wide, a strip of ground measuring 10.8 m (35.4 ft), and a barbed wire fence. The posted speed limit for this roadway was 105 km/h (65 mph).

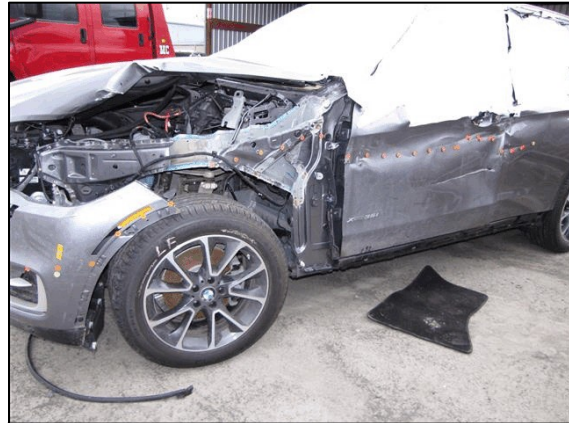
Figure 4. Left side view, 2017 BMW X5

The BMW sustained direct contact damage to the left plane (Event 2) and front plane (Event 3) during the crash. Direct damage caused during the initial vehicle-to-vehicle impact (Event 2) began at the front right bumper corner and extended 263 cm (103.5 in) rearward, ending 30 cm (12.0 in) aft of the right B-pillar. Twenty-six measurements were taken at mid-door level using the Nikon Total Station and the Faro Blitz program computed crush measurement in six increments as follows: $C_1 = 0$ cm, $C_2 = 3$ cm (1.2 in), $C_3 = 3$ cm (1.2 in), $C_4 = 12$ cm (5.5 in), $C_5 = 1$ cm (0.4 in), $C_6 = 0$ cm. Maximum crush was located at 40 cm (16 in) aft of the left front axle and the collision deformation classification (CDC) for the BMW in Event 1 was 11LYEW2 (**Figure 4**).

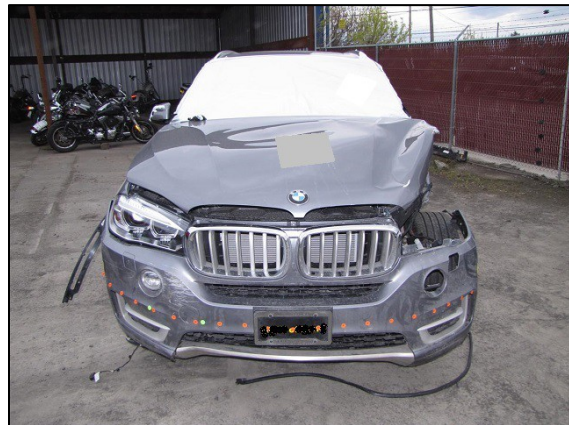
Figure 5. Front view, 2017 BMW X5

Direct damage caused during the fence impact (Event 3) was located on the right aspect of the front bumper beginning 30 cm (11.8 in) left of front right bumper corner and extending 20 cm (7.9 in) to the left. The Field L extended from bumper corner to bumper corner and measured 180 cm (70.9 in). Twenty-one measurements were taken at bumper level using the Nikon Total Station and the Faro Blitz program computed crush measurement in six increments as follows: $C_1 = 4$ cm (1.6 in), $C_2 = 0$ cm, $C_3 = 1$ cm (0.4 in), $C_4 = 0$ cm, $C_5 = 0$ cm, $C_6 = 0$ cm. Maximum crush was located at the front left bumper corner and the CDC for the BMW in Event 1 was 12FREN1 (Figure 5).

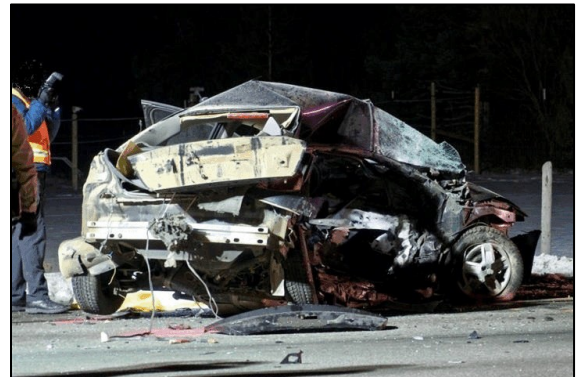
Figure 6. 2006 Saturn Ion at final rest looking east (online news photo)

According to the police report and on-scene images, the Saturn sustained direct damage to the right plane and induced damage to the front, back, left, and top planes (**Figure 6**).

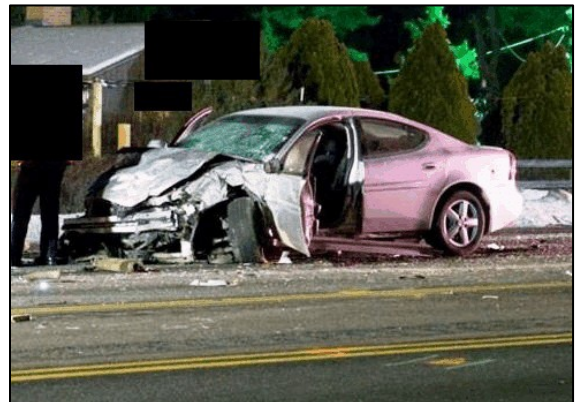
Figure 7. 2005 Pontiac Grand Prix at final rest looking east (online news photo)

According to the police report and on-scene images (**Figure 7**), the Pontiac sustained direct damage to the front plane and induced damage to the left plane.

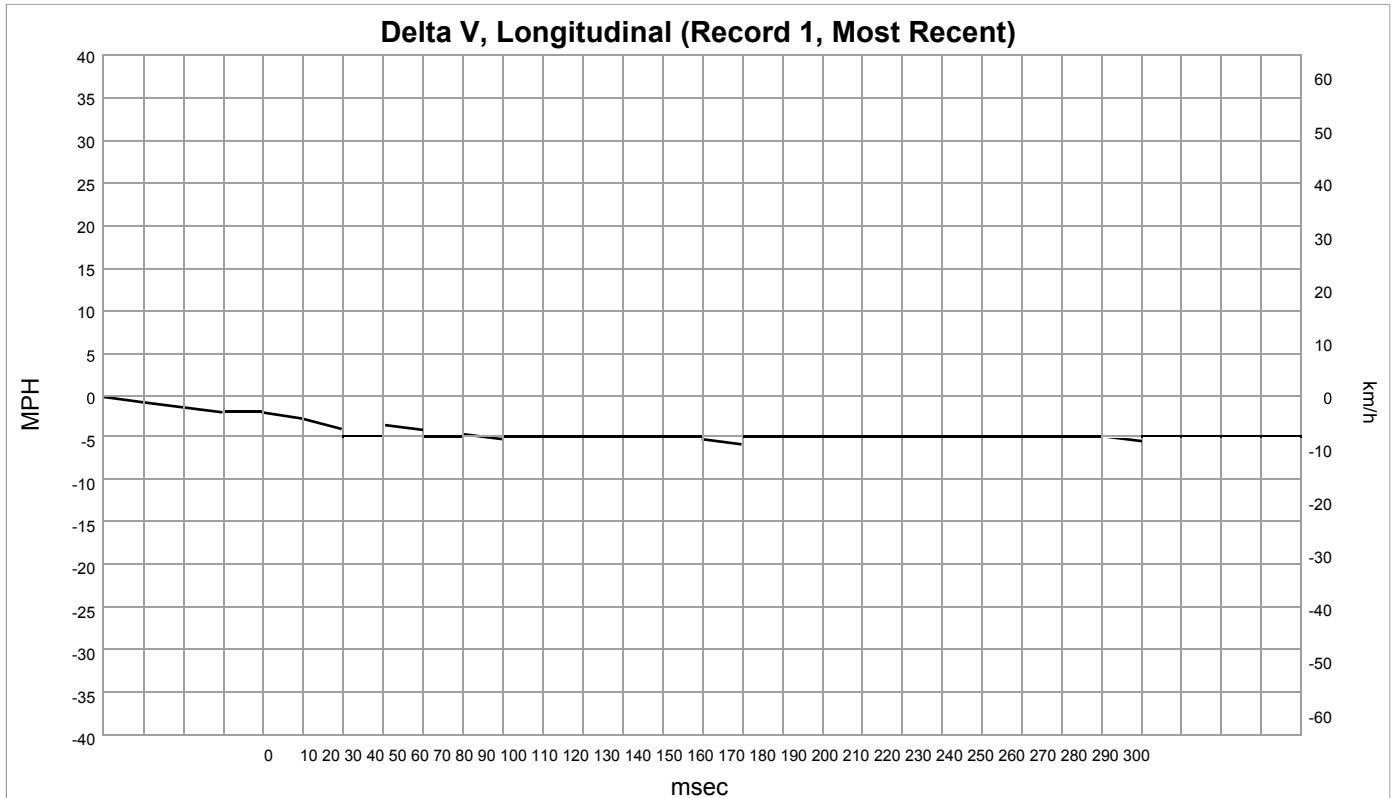
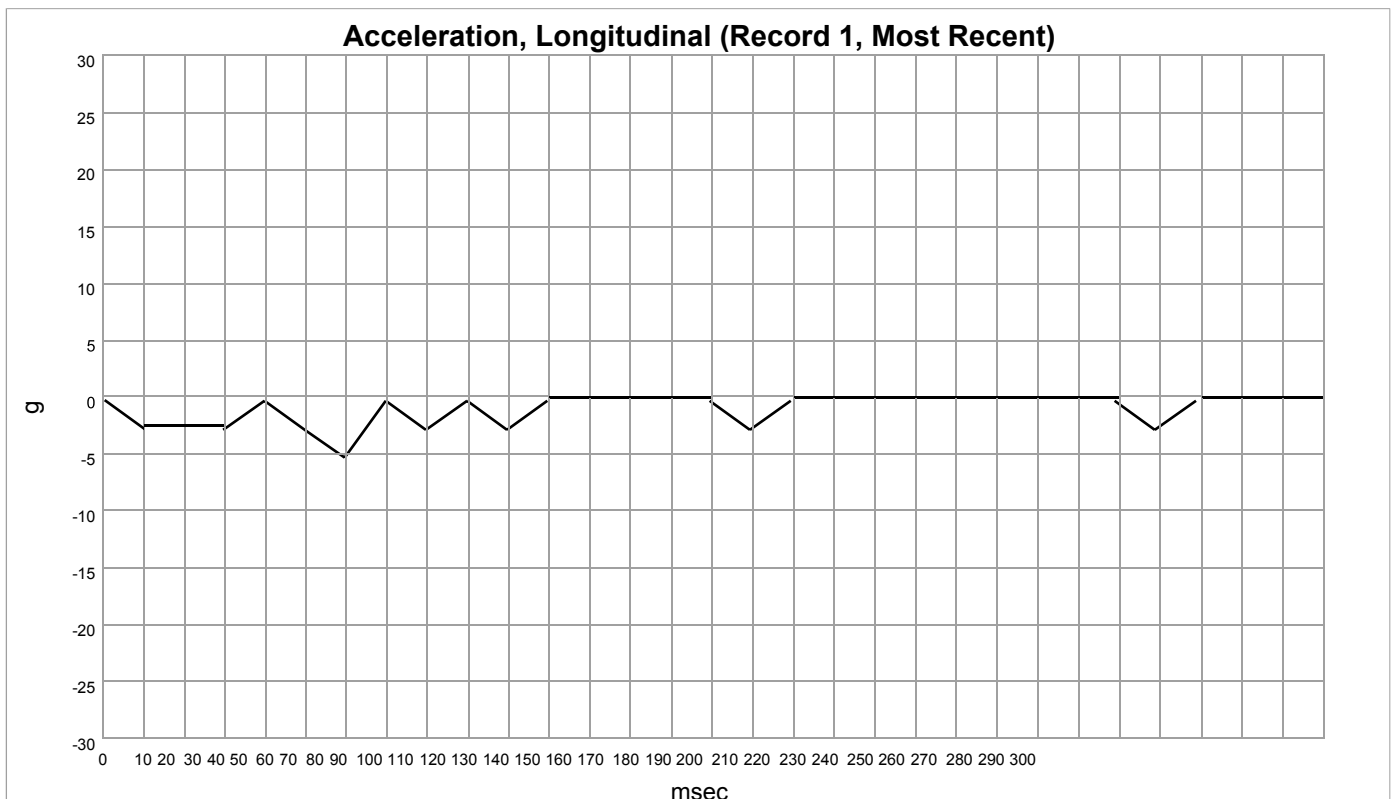
Longitudinal Crash Pulse (Record 1, Most Recent)

For Record 1, the event type was frontal, maximum longitudinal delta-V was -10.0 km/h (-6.2 km/h) and maximum lateral delta-V was -7.0 km/h (4.3 mph) at 65 ms. The pre-crash data at -1 second for this event was summarized as at Time Stamp -0.1 seconds as follows.

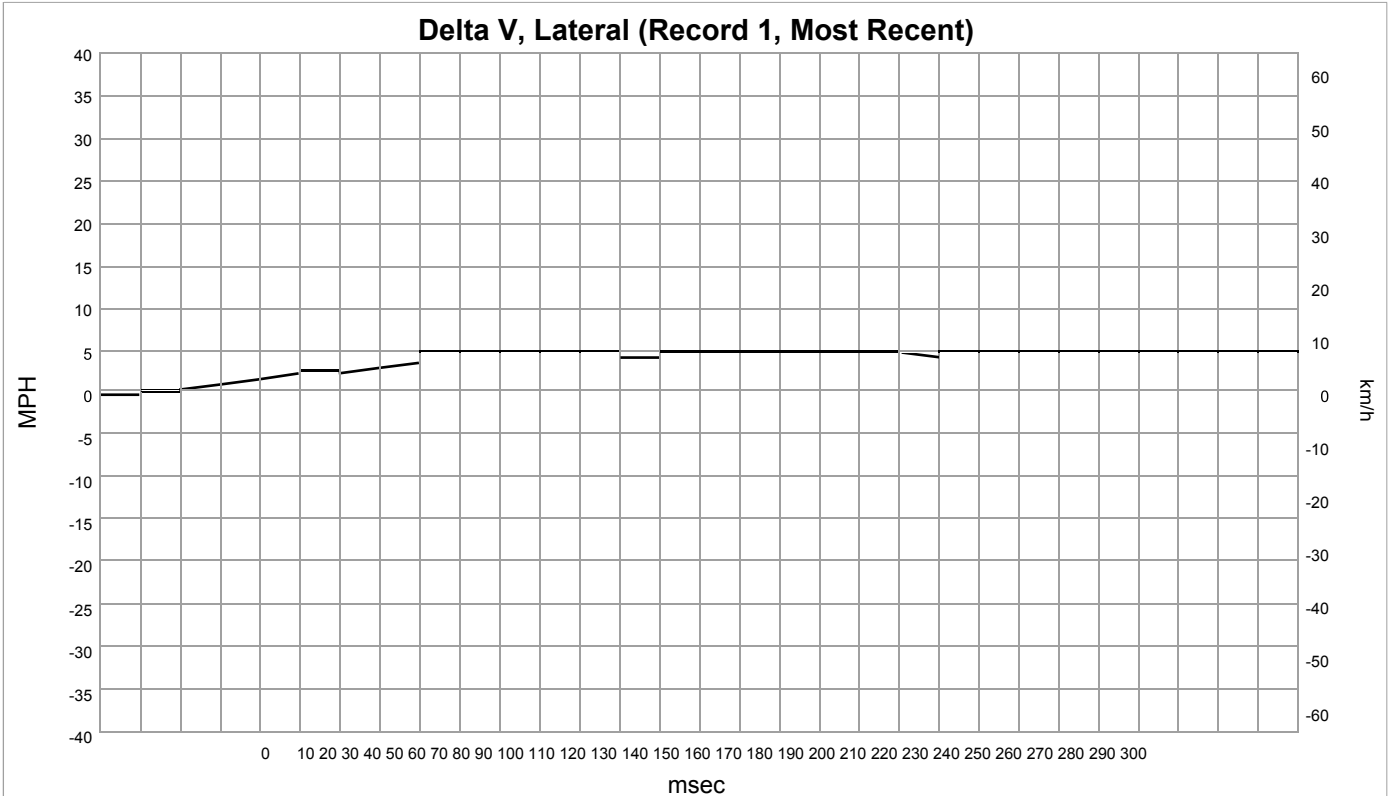
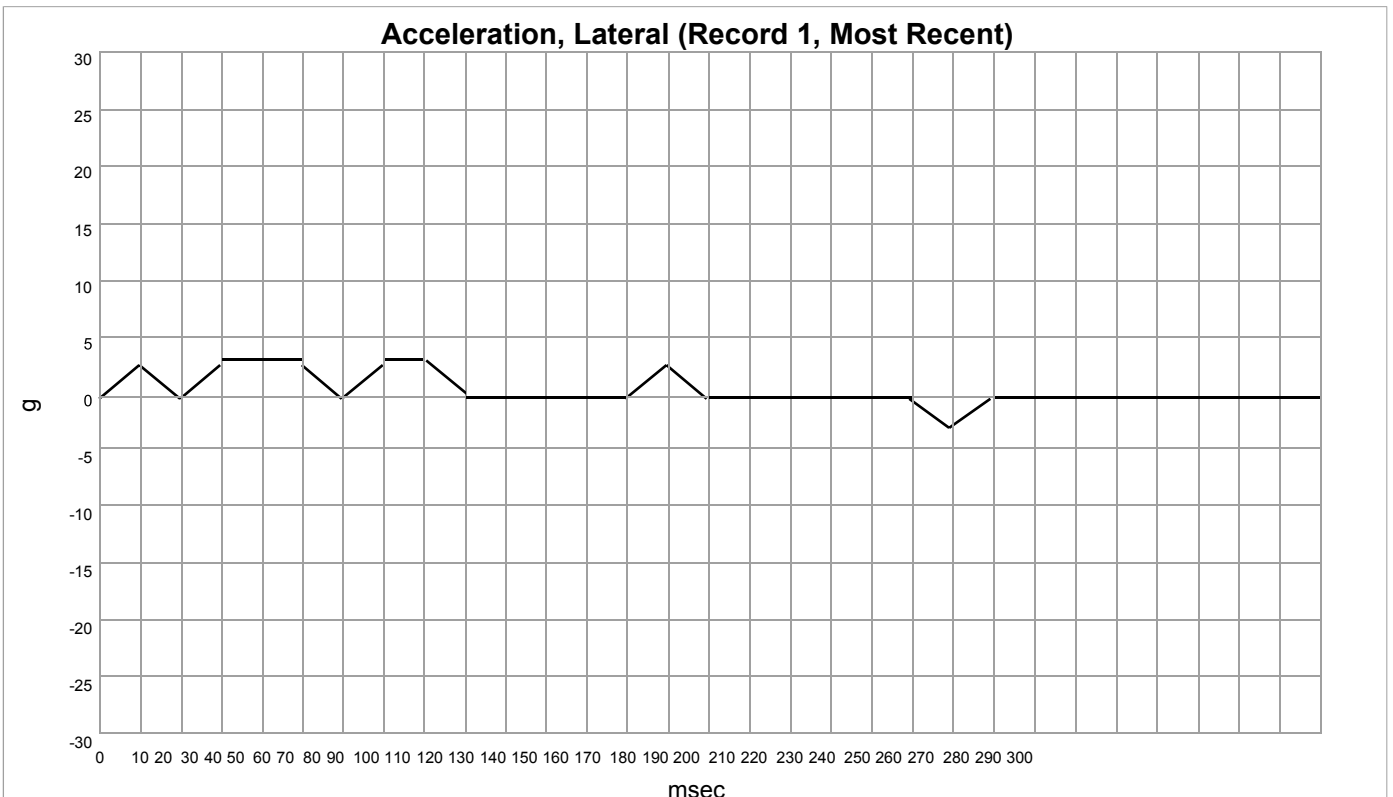
Lateral Crash Pulse (Record 1, Most Recent)

The EDR report did not reveal any diagnostic trouble codes (DTCs) or other evidence indicating the Supplemental Restraint System performed in a way other than intended. The relatively low lateral delta-V caused by the vehicle-to-vehicle impact was likely below the threshold for triggering a side air bag deployment.
