DOT HS 812 732

Special Crash Investigations On-Site Rollover Crash Investigation

**Vehicle: 2017 Mercedes-
Benz GLA 250**

Case Number: DS17016

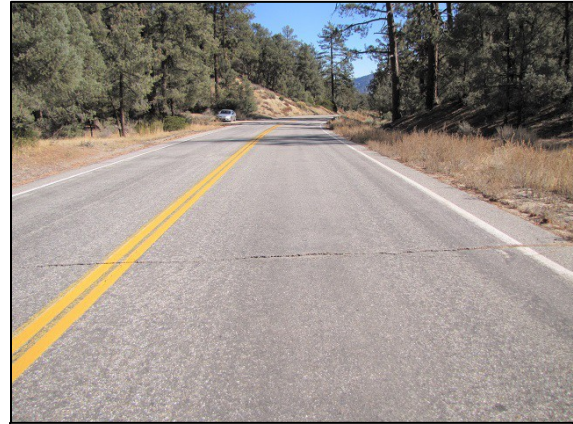
Figure 2. Crash site looking east

The crash occurred on an east/west, two-lane, highway in a rural area of California (**Figure 2**). The roadway was configured with one lane for each direction measuring 3.7 m (12.0 ft) wide and bordered by paved shoulders measuring 0.3 m (1.0 ft) wide. The lanes were separated by solid yellow double stripes and bordered by solid white fog lines. The roadway was not configured with rumble strips. In the area of the crash, the roadway curved right in a radius of 286.7 m (940.6 ft) measured from the fog line on the south edge. At the point of departure, the roadway slope measured -5.0 percent and the superelevation measured -3.0 percent. The roadway was paved in asphalt in good condition. The roadside south of the south edge consisted of a descending dirt embankment measuring 5.5 m (18.0 ft) wide with a negative slope measuring -70 percent lateral to the roadway followed by a ditch and positive slope embankment. The roadside contained dirt, grass, brush, and mature trees.

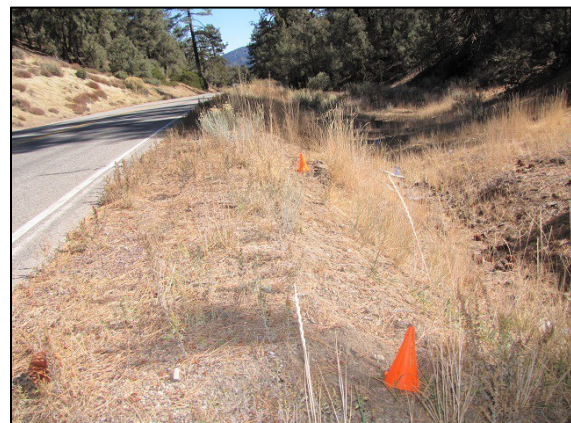
Figure 3. Crash site looking east, tire tracks marked by cones

The Mercedes’ EDR captured four events related to this crash. All four events occurred on the roadside after the vehicle departed the roadway (**Figure 3**). Event 1 was a front plane to ground impact that included undercarriage contact. The EDR captured a frontal, low delta-V non-deployment event for this impact. The lower bumper fascia was displaced and found near the roadway edge. At Event 1 the vehicle was likely in a slight counterclockwise rotation while the driver was attempting to return the vehicle to the roadway. The vehicle traveled down a descending embankment at an angle steep enough for the EDR

to capture an imminent rollover and trigger deployment of the left and right IC air bags and both seat belt pretensioners. Time between EDR Record 4 (frontal) and Record 3 (rollover) was 158 milliseconds (ms). Prior to the vehicle overturning, it rotated counterclockwise and the left aspect of the front bumper struck the ground (Event 2). The EDR captured this impact as a deployment event triggering deployment of both frontal and knee air bags. Damage included fracturing of the front left bumper fascia, crush to the left aspect of the backing bar, displacement and restriction of the left front tire, and shortening of the left wheelbase.

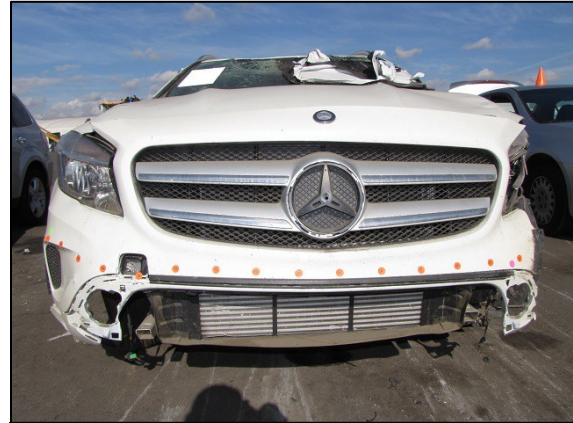
Figure 4. Front end crush measurements, 2017 Mercedes-Benz GLA 250

Event 1 was a minor impact with the ground involving the lower front plane and undercarriage. The damage was overlapped by subsequent damage. The calculated PDOF was positive 17 degrees and the estimated Collision Deformation Classification (CDC) for the Mercedes in Event 1 was 01FDLW1.

Event 2 was a second impact to the front plane with the ground causing more severe damage and overlapping prior damage caused during Event 1. It was captured by the EDR as a frontal deployment event occurring after the rollover event. The investigation determined this impact occurred prior to the vehicle overturning. The impact with the ground caused damage to the front plane beginning at the front left bumper corner and extending 30 cm (11.8 in) to the right. The Field L extended from bumper corner to bumper corner and measured 160 cm (63.0 in). Eighteen measurements were taken at bumper level by the Nikon Total Station and the Faro Blitz program computed crush measurement in six increments as follows: $C_1 = 10$ cm (3.9 in), $C_2 = 0$ cm, $C_3 = 3$ cm (1.2 in), $C_4 = 3$ cm (1.2 in), $C_5 = 0$ cm, $C_6 = 0$ cm. The calculated PDOF for this event was positive 14 degrees and the CDC for the Mercedes in Event 2 was 12FLEE1 (**Figure 4**).

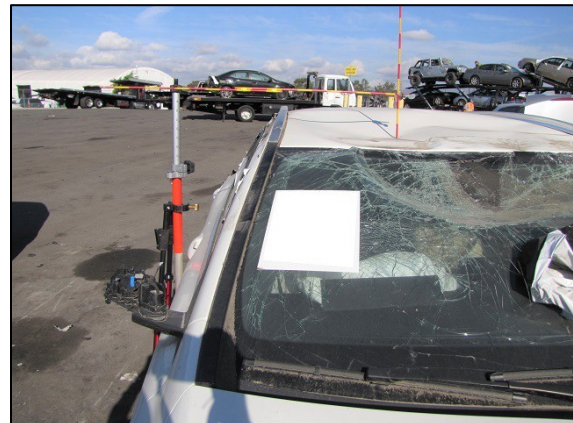
Figure 5. Rollover measurements, 2017 Mercedes-Benz GLA 250

Event 3 was a two quarter-turn, right-side-leading rollover causing direct damage to the right and top planes. The right side-view mirror was fractured and displaced. Direct damage was present on the right roof side rail and D-pillar. Direct damage to the top plane was distributed both laterally and longitudinally, extending laterally from roof side rail to roof side rail and measuring 109 cm (43.0 in), and extended longitudinally from the leading edge of the hood, continuing on the windshield header and ending at the back light header. Maximum vertical crush to the greenhouse measured 9.0 cm (3.5 in) and was located on the middle roof at 25 cm (9.8 in) aft of the windshield

(Figure 5). Maximum lateral crush to the greenhouse measured 7 cm (2.8 in) and was located on the right roof side rail directly above the rear axle. The CDC for the Mercedes in Event 3 was 00TDDO2. The EDR captured a final, frontal deployment event as Record 1 (Most Recent). This event was likely non-horizontal because it occurred following initiation of the rollover. The calculated PDOF for this impact based on EDR data was positive 32 degrees.

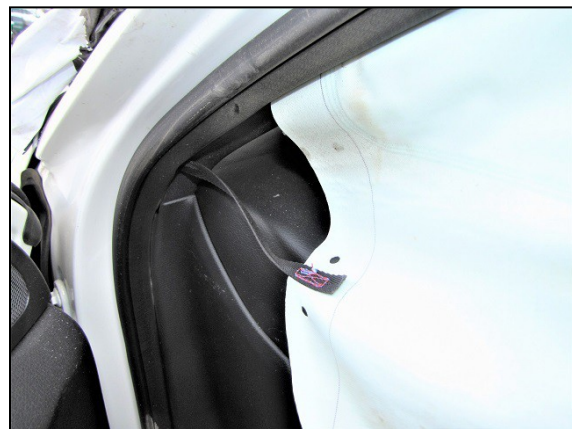
Figure 6. IC air bag tethered at bottom edge of side glass, 2017 Mercedes-Benz GLA 250

The vehicle's IC air bags were configured with features including combination deployment capability in side impact and rollover crashes, large areas of coverage over the side glass both longitudinally and vertically, and tethering near the base of the A-pillars (Figure 6) to assist in keeping the deployed IC air bags in place and occupants in the occupant compartment.

During the rollover event, the side windows were closed and remained intact, and both IC air bags deployed. The front row occupants were restrained and there were no ejections. The driver indicated during the interview he struck the deployed left IC air bag during the rollover.

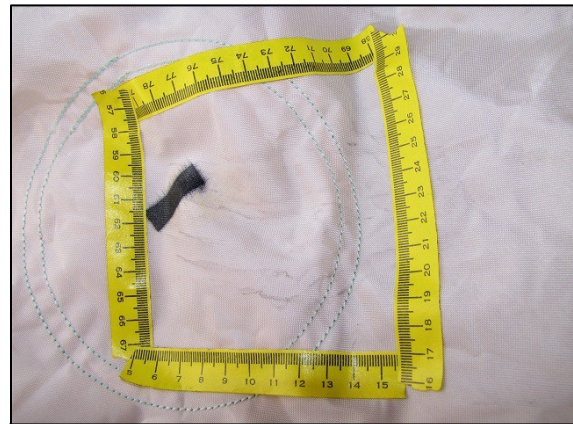
Figure 7. Driver's frontal air bag contact evidence, 2017 Mercedes-Benz GLA 250

The driver's frontal air bag deployed from a module in the steering wheel hub. The air bag appeared to have deployed normally without damage to either the air bag or cover flaps. It measured 53 cm (20.9 in) in diameter and was configured with two internal tethers and one vent port. This air bag exhibited evidence of driver loading in the form of skin oil transfers and

scuff marks measuring 9 x 9 cm (3.5 x 3.5 in) located in the center aspect of the front panel (**Figure 7**).

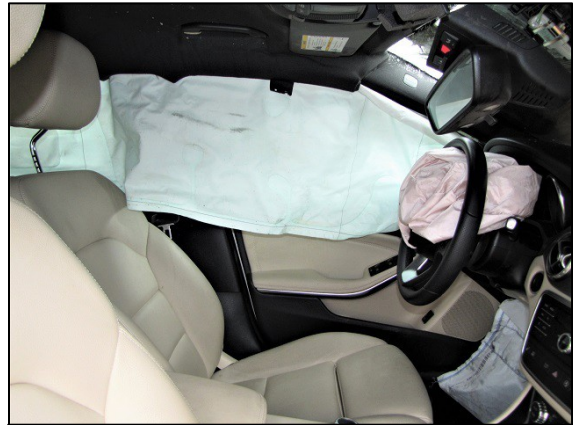
Figure 8. Deployed left IC air bag, 2017 Mercedes-Benz GLA 250

The left IC air bag deployed from the roof side rail above the front and second row seats (**Figure 8**). The air bag measured 40 cm (15.7 in) vertically at the leading edge and 180 cm (70.9 in) in width at the bottom edge. In its post-inflated state the left IC air bag's bottom edge hung 16 cm (6.3 in) below the bottom edge of the side glass in the front row left side door and 10 cm (3.9 in) below the second row left side door. A tether measuring 13 cm (5.1 in) located at the leading edge was attached to the A-pillar 8 cm (3.1 in) above the bottom of the side glass. The air bag covered both left side windows except for a small area near the tether measuring 5 x 5 cm (2.0 x 2.0 in). It appeared to have deployed normally and revealed no damage or driver contact.
