**National Highway  
Traffic Safety  
Administration**

DOT HS 812 752

June 2019

# **Analysis of Real-World Crashes Where Involved Vehicles Were Equipped With Adaptive Equipment**

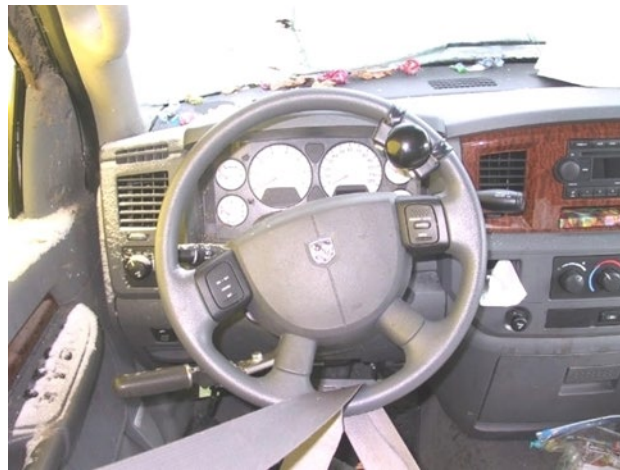
**Figure 2: Case No 2008-13-021 Steering Knob and Hand Controls**

A 2006 Dodge Ram pickup truck (Case No. 2008-13-021) was coded as equipped with a steering knob, hand controls, and a low effort steering system (Figure 2). The vehicle was traveling on a divided icy highway and lost control (Figure 3). It subsequently went off the right side of the road and rolled over. The posted speed limit at the location of the crash was 70 mph. The restrained 60-year-old male driver sustained minor rib contusions during the four-quarter turn rollover. The pre-crash movement was going straight with the critical event traveling too fast for conditions. The driver of the Dodge was coded as attentive or not distracted.

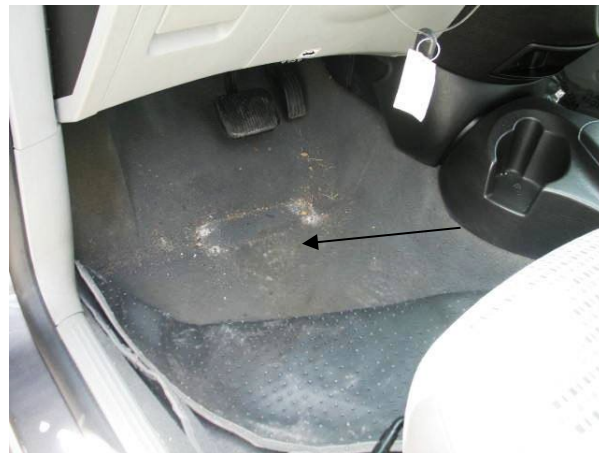
**Figure 10: Case No. 2010-11-165 Relocated Pedals Removed**

There were two cases identified where the vehicles' accelerator pedals were relocated to the left side of the brake pedals (Case Nos. 2010-02-066 and 2010-11-165). In Case No. 2010-11-165, a 2010 Jeep Liberty was traveling south out of a commercial driveway to turn left onto a roadway with a posted speed limit of 45 mph. The subject vehicle, a 2006 Ford Focus, was equipped with the relocated accelerator pedal and was traveling eastbound (Figure 10) and coded going straight on a not physically divided roadway with two-way left turn lane (Figure 11). The front of the Ford contacted the left side of the Jeep in the roadway. The attempted avoidance maneuver by the 63-year-old male driver of the Ford was braking. The driver of the Ford was coded as attentive or not distracted. However, the driver of the Jeep was coded as looked but did not see.

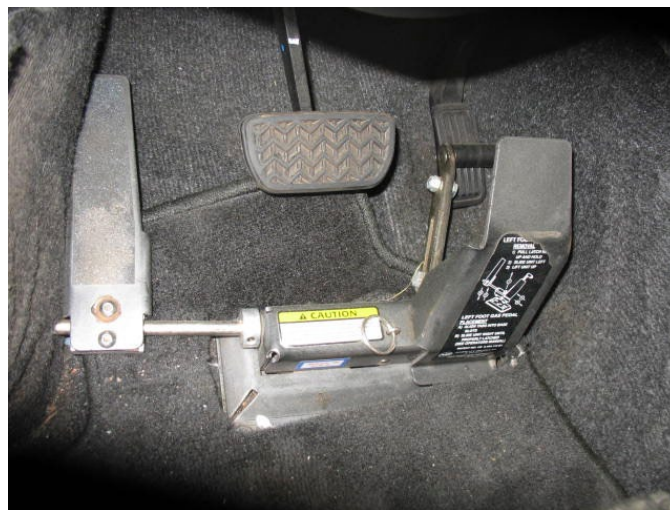
**Figure 12: Case No. 2010-02-066 Relocated Pedals**

Case No. 2010-02-066 involved a 2008 Toyota Yaris, which was equipped with a relocated accelerator pedal (Figure 12). A deer jumped off an embankment on the left side of the road onto the roadway, which had a posted speed limit of 55 mph. The attentive driver of the Yaris was coded as going straight; however, the driver tried to avoid the deer by steering right. The driver struck the deer and then went off the right side of the road. This case will be discussed further in the non-operational adaptive equipment section below because it was also equipped with a driver’s side seat belt extender.

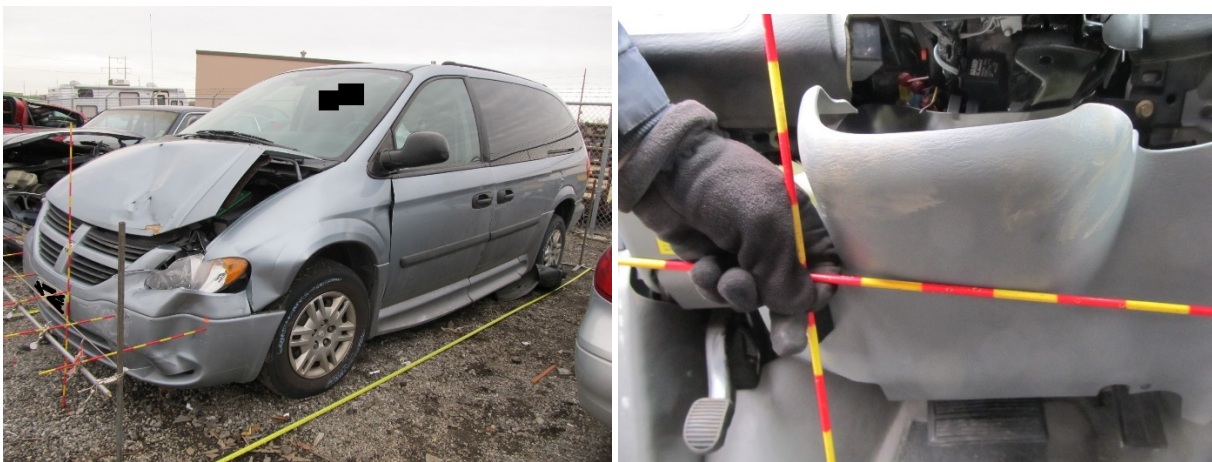
**Figure 15: Case No. 2011-74-166 Damage and Knee Bolster Air Bag**

The 54-year-old female drive was properly restrained in the vehicle's seat belt system. In this 23 km/h delta-v frontal crash, the driver sustained an AIS-2 tibia fracture sourced to the knee bolster air bag door under the instrument panel (Figure 15).

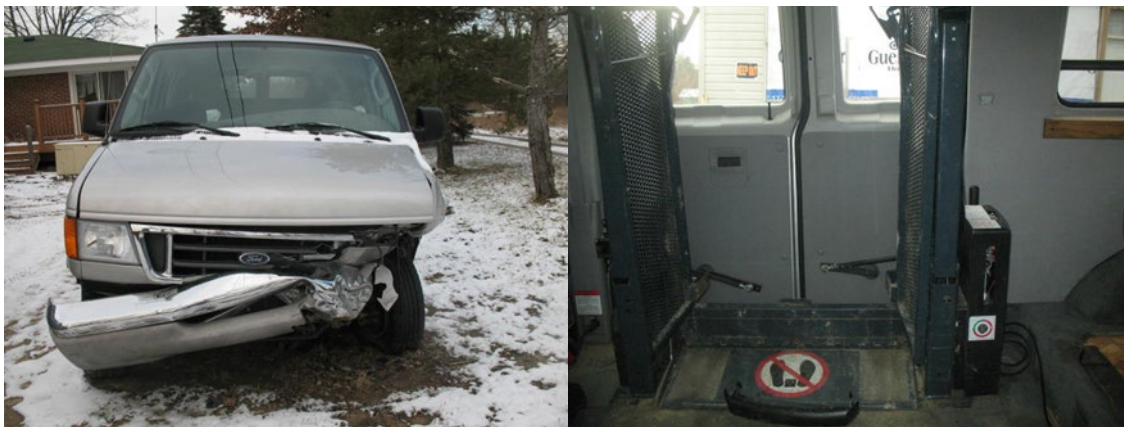
**Figure 17: Case No. 2007-11-197 Front End Damage and Wheelchair Lift**

A 2004 Pontiac Vibe was traveling northbound. A 1994 Chevrolet Lumina was traveling southbound with the 2003 Ford E Series van traveling behind the Chevrolet. The front of the Pontiac contacted the left side of the Chevrolet causing the Pontiac to rotate counterclockwise, where the right side of Pontiac contacted the front of Ford. The Chevrolet then drove off the right side (west) of the roadway and came to rest facing south, while the Ford drove off the right (west) side of the roadway and came to rest facing southwest.

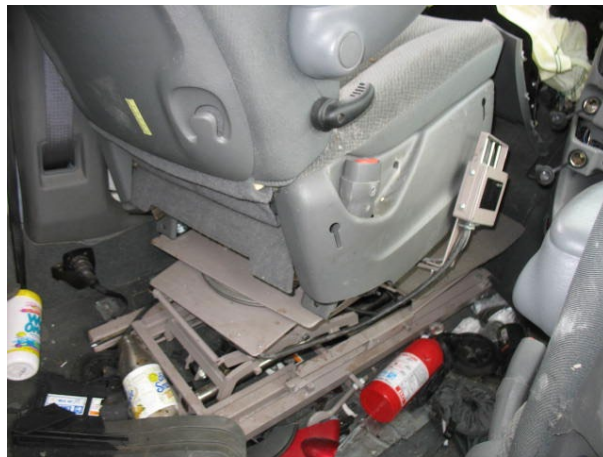
**Figure 21: Case No. 2008-02-148 Driver's Seat Base Adaption to Account for Lowered Floor**

Generally, these vehicles also have the floor lowered, and the seat base for the driver and front passenger are also modified to account for the lowered floor (Figure 21).

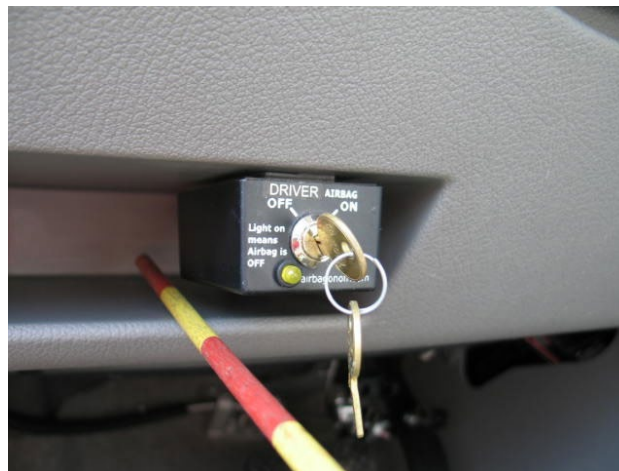
**Figure 24: Case No. 2009-11-094 Air Bag On-Off Switch**

There was one crash (Case No. 2009-11-094) previously discussed in the context of operational adaptive equipment where a 2009 Saturn Vue was equipped with an air bag on-off switch in addition to pedal extenders for a small statured (109 cm tall) 24-year-old female. The driver was in a minor impact, and the air bags did not deploy because they were suppressed by the air bag switch (Figure 24). The driver, who was the sole occupant, did not sustain any reported injuries. The delta-v was not calculated for the crash.

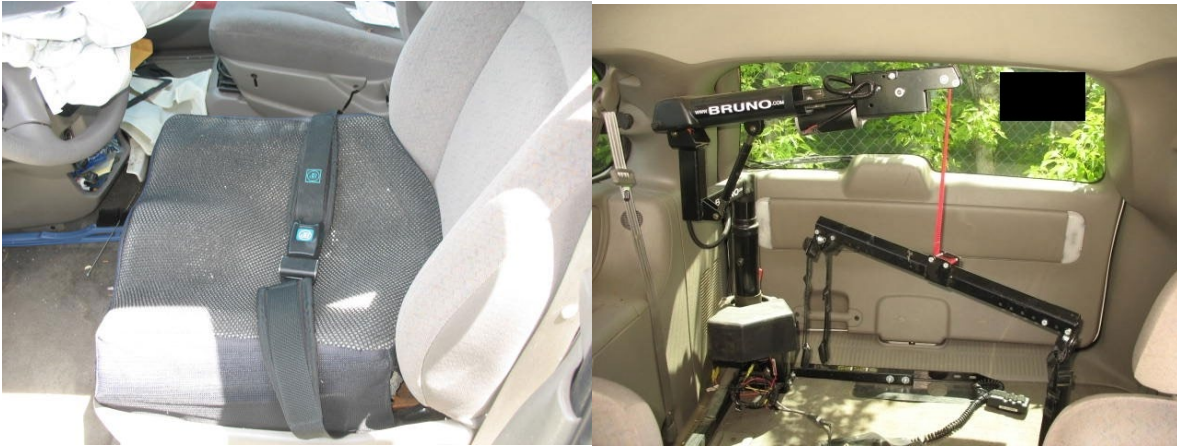
**Figure 25: Case No. 2010-75-103 Modified Driver's Seat Cushion and Rear Mounted Wheelchair Lift**

In the frontal 12 km/h crash, a 38-year-old properly restrained male driver sustained an AIS-2 ulna fracture. It appears the factory driver's seat belt was worn by the driver. However, it should be noted: the additional lap belt and aftermarket seat cushion bottom did not appear to contribute to the AIS-2 right ulna fracture coded in the case.

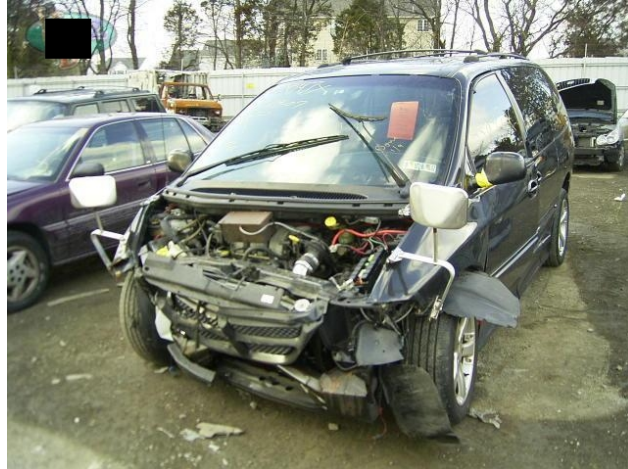
**Figure 26: Case No. 2007-05-002 Subject Vehicle Damage**

The total delta-v for the Dodge was 19 km/h (Figure 26). The 24-year-old male driver was seated in a wheelchair and reported to have been only wearing a shoulder belt at the time of the crash, and was likely improperly restrained.

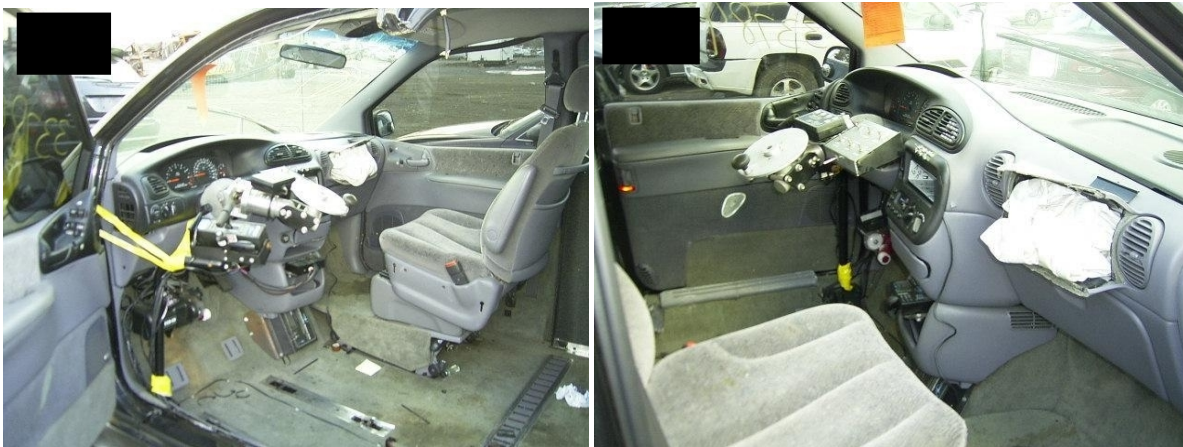
**Figure 27: Case No. 2007-05-002 Adaptive Equipment**

As shown in Figure 27, the original equipment steering wheel along with the driver's side frontal air bag was removed. During the event, the passenger side air bag deployed.

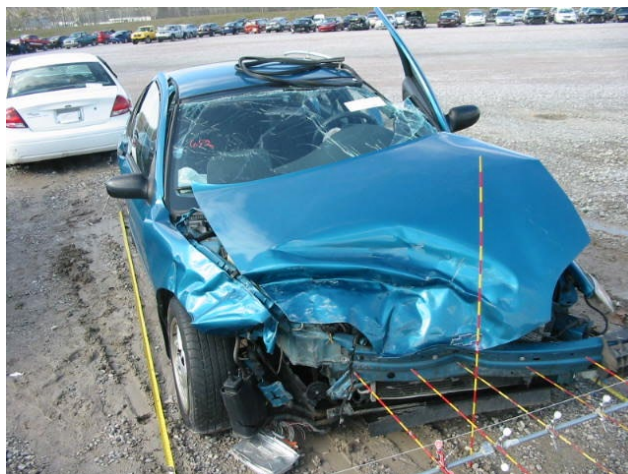
**Figure 28: Case No. 2008-45-002 Subject Vehicle Damage**

The total delta-v for the Chevrolet was 25 km/h (Figure 28). The 54-year-old female driver was restrained at the time of the crash and the frontal air bag deployed.

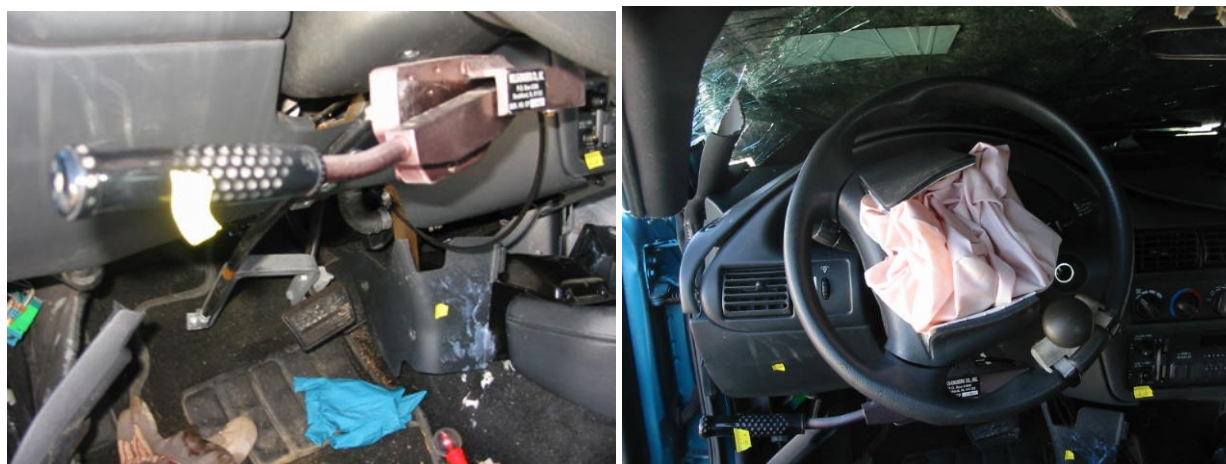
**Figure 29: Case No. 2008-45-002 Hand Controls and Steering Knob**

The driver of the Chevrolet sustained various injuries sourced to the adaptive equipment installed on the vehicle (Figure 29). The driver sustained AIS-1 left hand injuries sourced to the hand controls and a minor AIS-1 chest contusion sourced to the steering knob. The serious left AIS-3 fibular fracture was coded as “Other adaptive device” but likely involved contact with the support rods, which are attached to the hand control lever as shown in Figure 29.

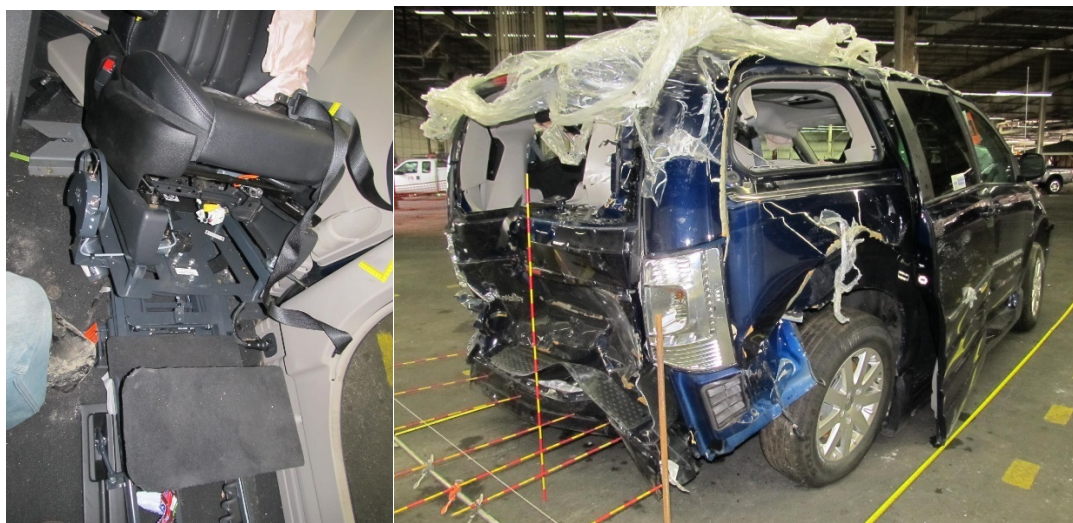
**Figure 30: Case No. 20014-81-033 Post-Crash Damage to Seat Base and Vehicle**

The Chrysler was an altered vehicle with a lowered floor. The posted speed limit at the location of the crash was 60 mph. For the Chrysler, the delta-v of the crash was estimated to be 34 km/h. During the impact, the driver's side seat deformed rearward (Figure 30). This was a relatively severe impact resulting in the driver of the Chrysler sustaining a minor neck strain.

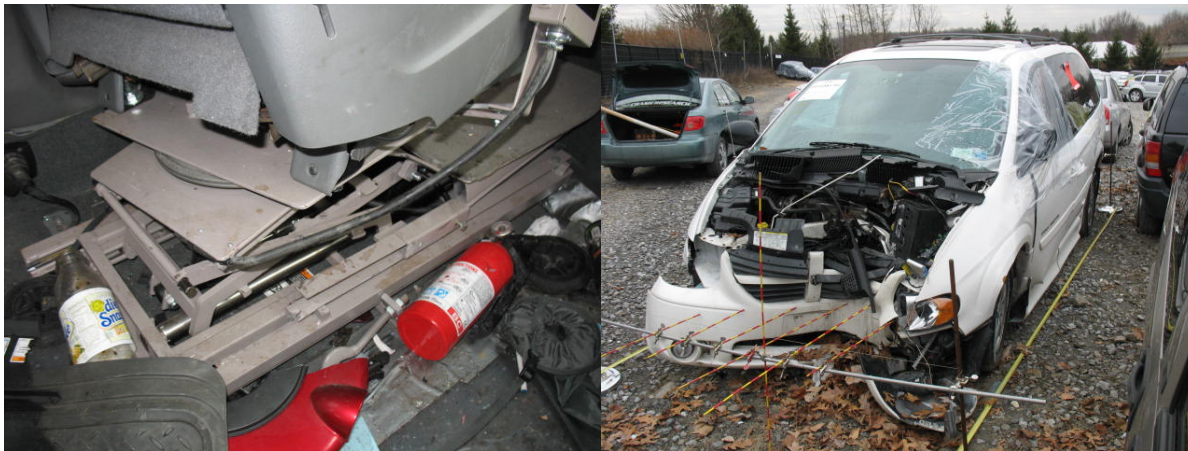
**Figure 31: Case No. 2008-02-148 Post Crash Damage to Seat Base and Vehicle**

side of the road. The front of the Dodge struck a 10 by 10 cm wood post (Figure 31). The delta-v for the crash was estimated to be 47 km/h. The properly restrained driver sustained an AIS-3 Cerebrum subarachnoid hemorrhage sourced to contact with the A-pillar. Even with the driver's side air bag deployed, it is possible the deformation of the seat may have increased the occupant's excursion and allowed for the contact with the A-pillar resulting in the serious head injuries.

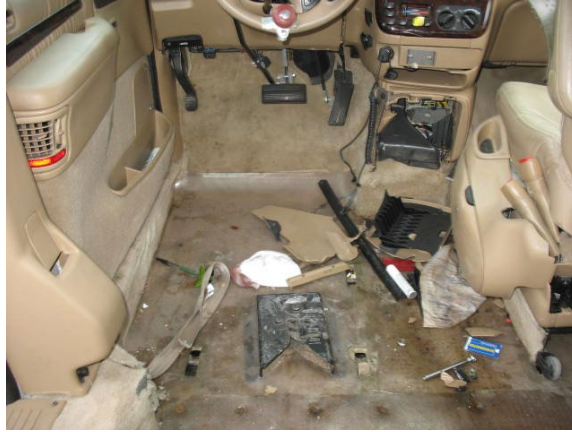
**Figure 32: Case No. 2008-75-27 Driver's Seat Position**

excursion and contact with the steering wheel from the lack of upper body restraint. It is not known if the lap portion was available or why it may not have been used. The subject vehicle was more than 10 years old at the time of the crash.

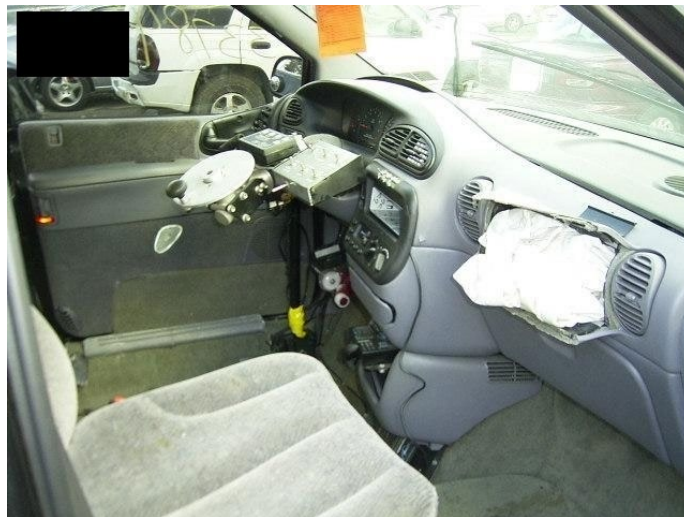
**Figure 33: Case No. 2007-05-002 Modified Steering Wheel With Air Bag Removed**

As previously discussed, Case No. 2007-05-0002 was included because the 24-year-old driver was coded as wearing only the shoulder portion of the restraint system and may have been improperly restrained during the crash, which is indicative because of the AIS-2 kidney laceration sourced to the replacement steering system (Figure 33). In addition, if the occupant's lower body was not properly restrained, this may have led to excess excursion and loading of the tibia resulting in the AIS-3 injury. A lap buckle assembly is not shown in the photo, and it is unknown if the lap belt was removed, not equipped, or encumbered the ingress and egress of the driver and not used.

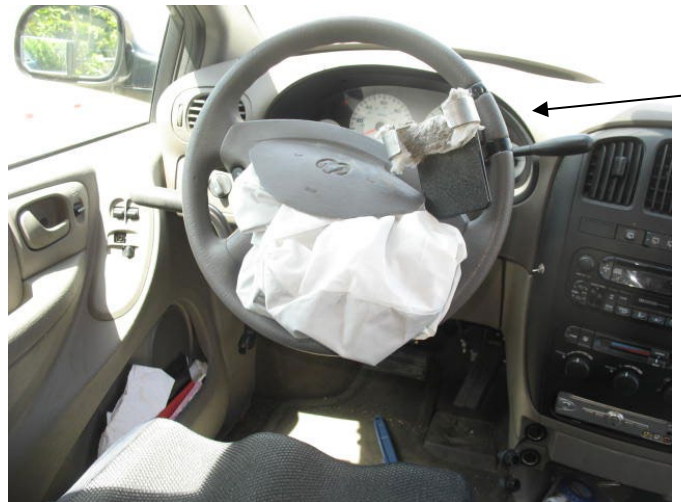
**Figure 34: Case No. 2010-75-103 Driver's Seat Position**

Last, Case No. 2010-75-103, which has also previously been discussed, a 38-year-old properly restrained male driver sustained an AIS-2 ulna fracture in a 12 km/h severity frontal crash.

According to the case, the source of the ulna fracture was not coded. It appeared the driver may have been using the steering assist device shown in Figure 34 at the time of the crash. During the crash event, the driver's forearm may have loaded the steering wheel, resulting in the fracture.

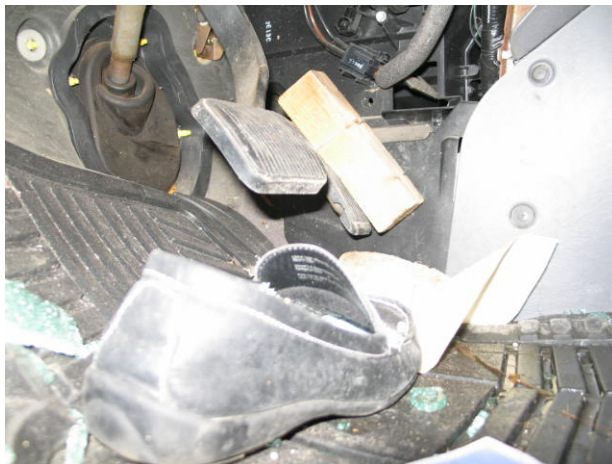
**Figure 39: Case No. 2011-13-038 Wooden Block**

The 2002 Ford Escape was modified with the addition of a wooden block on top of the accelerator pedal<sup>36</sup> as shown in Figure 39. The female driver was 147 cm tall.

<sup>36</sup> It is understood that a wooden block is a rudimentary means to raise the accelerator pedal. But its functional intent is consistent with a professionally installed commercial available raised pedal system. For that reason, this case was included with the other cases where the pedals were raised.

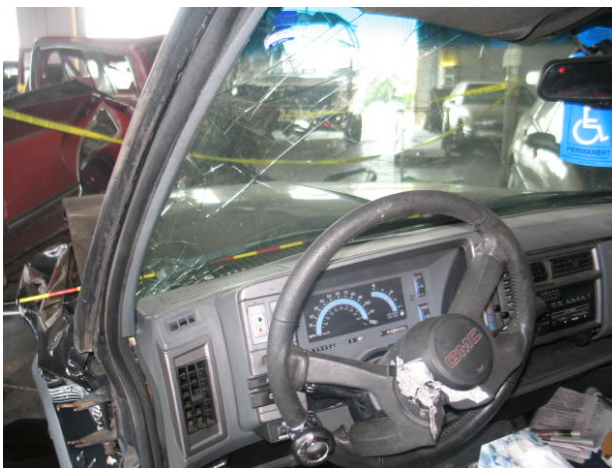
**Figure 40: Case No. 2008-45-142 Steering Knob**

The GMC was not equipped with a frontal driver's side air bag in the 32 km/h delta-v impact. The unrestrained driver sustained fatal chest injuries attributed to impact with the steering wheel. The driver's attentiveness was coded as unknown.
