# **Special Crash Investigations On-Site Ambulance Crash Investigation**

**Vehicle: 2004 Ford**

**E-350 Type III Ambulance**

**Crash Date: April 2016**

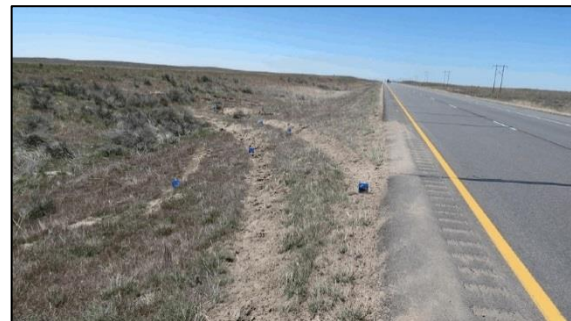
The Ford had traveled approximately 43 km (27 miles) west of the departure hospital prior to the crash. The driver indicated to police that strong winds had forced the Ford into the first lane from the right. When the driver steered left to return the vehicle to its original travel lane, she lost traction and control on the wet roads. The Ford departed the roadway to the left edge and entered the grassy center median (**Figure 3**).

**Figure 3.** Left roadside departure looking west.

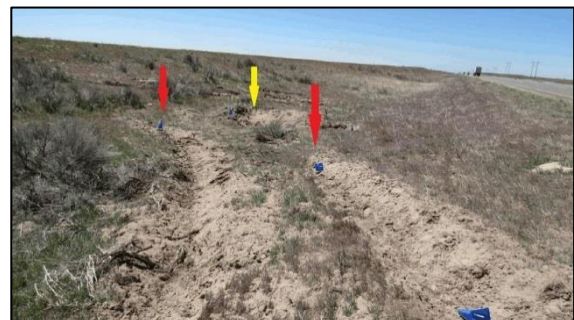
The Ford began a counterclockwise rotation while traveling down the descending median. The right side tires engaged the ground with sufficient opposing lateral force to cause a right side leading trip rollover. The trip point was documented in the median at approximately 25.0 m (82.0 ft) southwest of the area of departure. Initially, the Ford rolled one quarter turn and the right side roof rail of the ambulance body struck the ground (**Figure 4**). The distance from trip point to the roof rail impact was 3.0 m (9.8 ft). The vehicle continued to roll four more quarter-turns along its longitudinal axis while traveling approximately 9.1 m (30.0 ft). The total rollover distance measured 12.1 m (39.8 ft). It came to rest on its right side in the center of the median facing generally south (**Figure 5**).

**Figure 4.** Trip point (red arrows) and right side impact (yellow arrow), looking west.

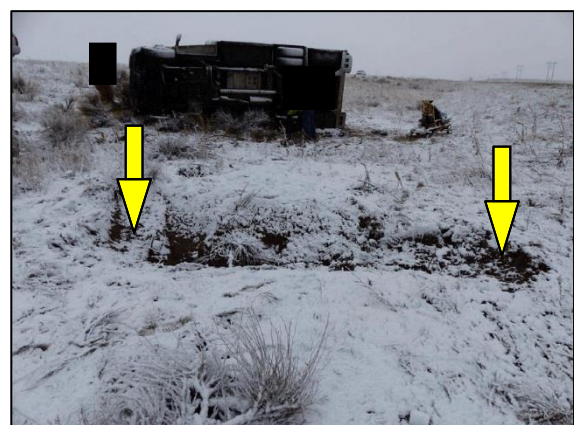
**Figure 5.** Right roof rail impact (yellow arrow) and final rest (police photo), looking west.

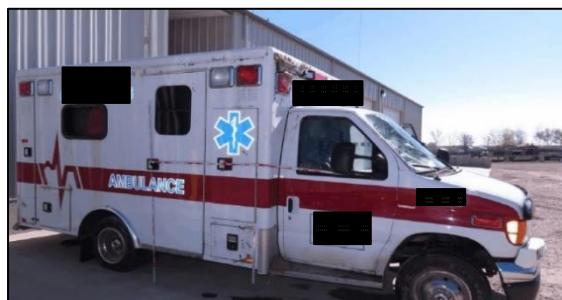
The Ford sustained minor damage to the right plane during the five quarter-turn rollover (Event 1). The direct damage began at the rear aspect of the patient compartment and extended 535.0 cm (210.6 in) forward (**Figure 7**). The vertical damage extended from the sill to the roof side rail. The right mirror, windshield, right light bar, and antenna were damaged. There was no measurable crush. The Truck Deformation Classification (TDC) was 00RDAO2.

**Figure 7.** Right plane damage, 2004 Ford E-350 ambulance.

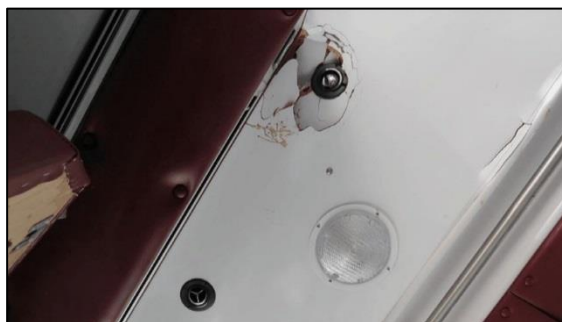
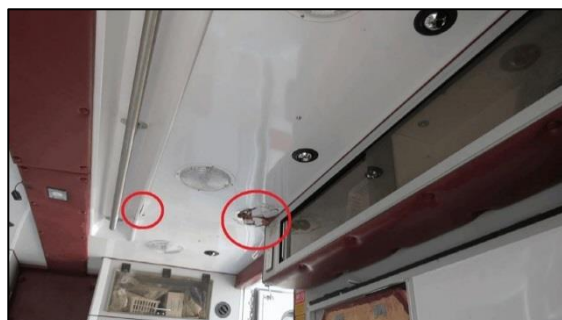
**Figure 8.** Patient compartment damage, 2004 Ford E-350 ambulance.

There was contact damage to the right roof area at one of the interior lights (**Figures 8 and 9**). The fiberboard was fractured and there was blood along the fracture. There was fracture damage along the left roof area and blood located along the right wall. There was tearing damage to the right padded surface near the roof hand rail.

**Figure 9.** Patient compartment damage, 2004 Ford E-350 ambulance.

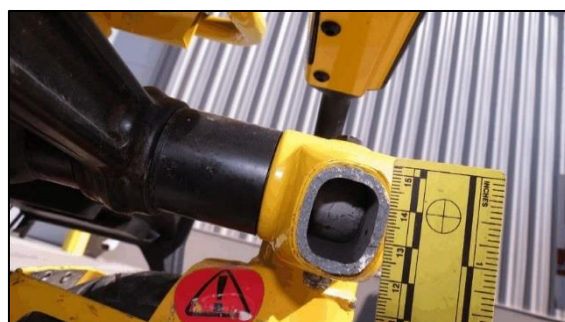
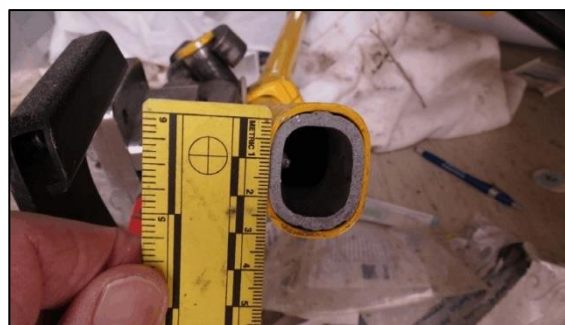
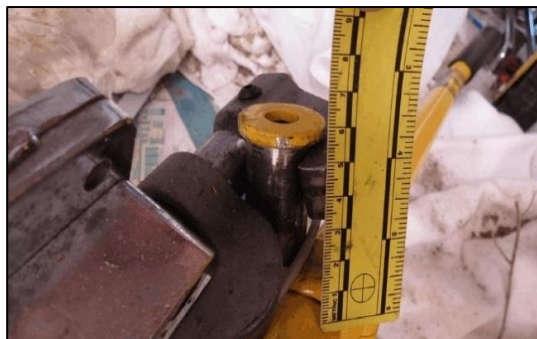
During the crash, the lower left attachment arm of the patient cot fractured at both ends and the cot separated from the floor fastener. The cot and patient were displaced from their anchored position and, during the rollover, moved freely in the patient compartment. This topic is discussed further in the Patient Cot and Occupant Kinematics sections of this report.

**Figure 11.** Lower frame rail damage at rear.

**Figure 12.** Lower frame rail damage at rail.

mechanism clamped around a pin protruding from the cot's lower frame rail. During this crash, the lower frame rail fractured at both ends (**Figures 11–13**) and the cot and patient were displaced to the right and toward the roof (probably during the first one- quarter roll). The lower frame rail/pin remained clamped to the cot fastener system (**Figure 14**).

**Figure 13.** Lower frame rail/pin.

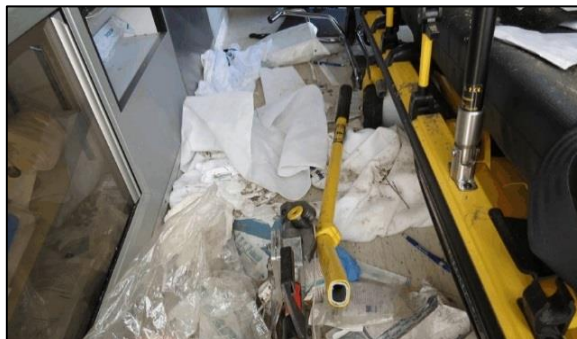
**Figure 14.** Lower frame rail damage.

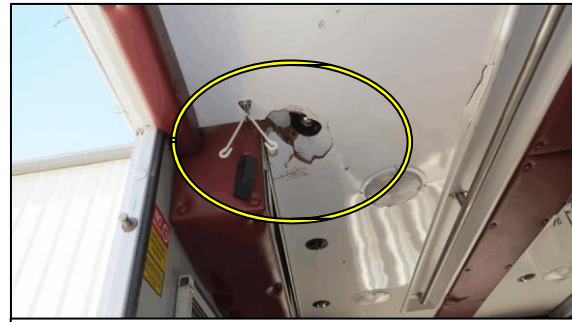
The 57-year-old female patient was immobilized on the cot and restrained by the available lap belts. Her head and feet were elevated and the upper and lower belt restraints were loosened. Following the crash, the cot had been placed back into the rear compartment of the ambulance and it was in the partially reclined position. As the vehicle began a counterclockwise rotation, the patient was directed to the right as the vehicle decelerated. She was held in place by the lap belts. As the vehicle tripped and then struck the ground with its right side, the ambulance cot lower frame rail fractured, and the cot and its occupant were displaced to the right and top. The cot and patient likely struck the right roof (**Figure 15**). Injuries to her head and face included subgaleal hematomas, laceration to the scalp and nose, and contusions and abrasions to the face and right ear. The patient sustained abrasions to her right breast and torso caused by loading of the belt restraints. She sustained a hemorrhage of the right kidney and contusions to her upper extremities caused by contact with the side panels of the rear compartment.

**Figure 15.** Contact evidence, probable injury source for patient, 2004 Ford E-350.
