U.S. Department  
of Transportation

**National Highway  
Traffic Safety  
Administration**

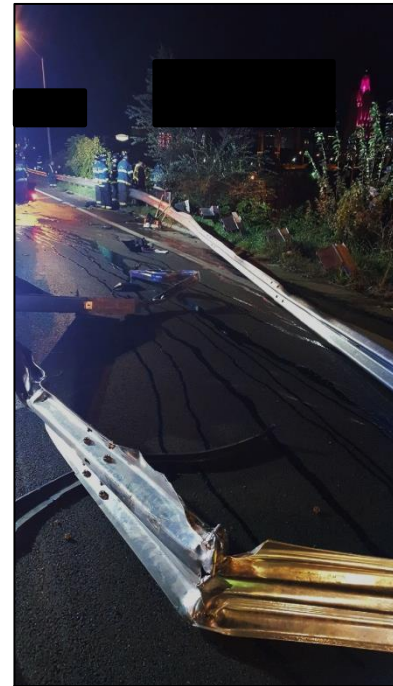
**Figure 1.** Northeast-facing on-scene image of the crash site. Image supplied by MODOT.

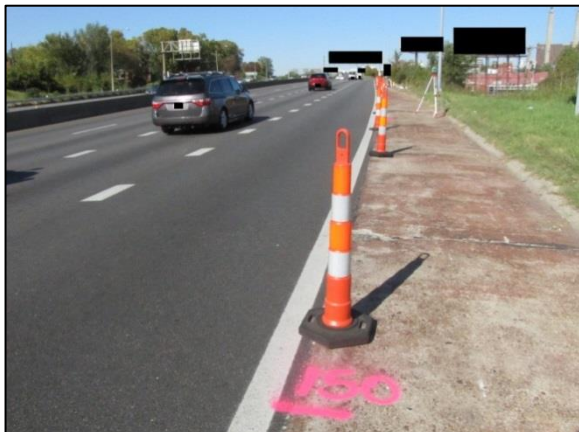
**Figure 2.** Overall view of Ford's northbound approach to the crash site at 150 m prior to impact with the end terminal.

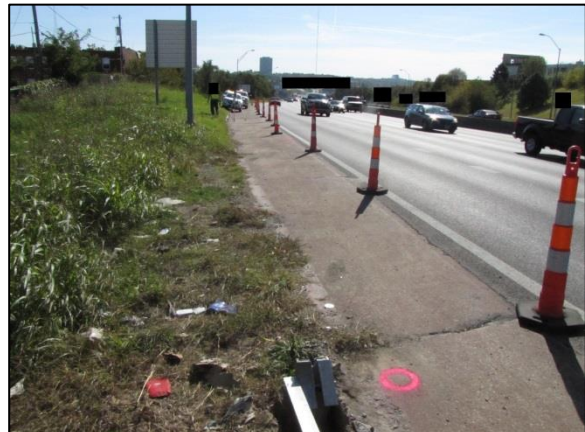
**Figure 3.** South-facing look back view for the point of impact depicting the roadway curvature.

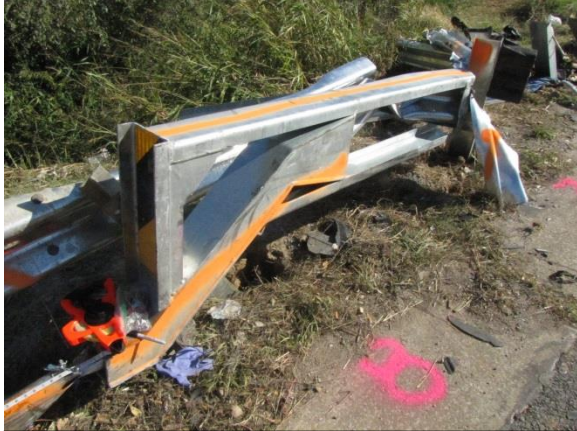
**Figure 5.** East-facing image depicting the end terminal and deformed W-beam. Note: end terminal was moved to this location by fire fighters.

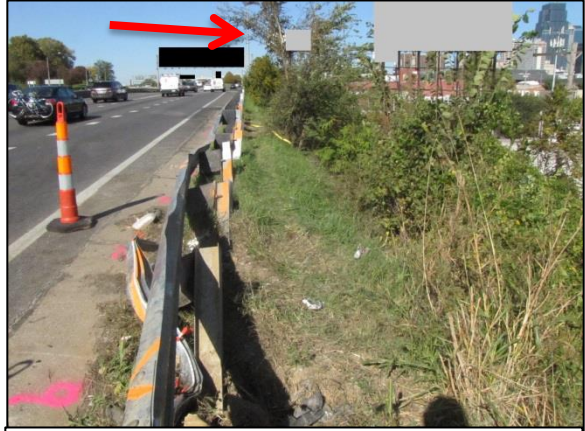
**Figure 6.** North-facing view depicting the vehicle's path along the field side of the guardrail. The red arrow referenced the small diameter tree contacted by the Ford.

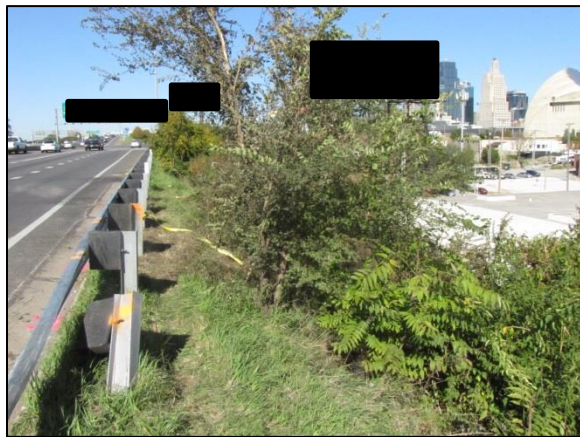
**Figure 7.** North-facing view depicting the vehicle's path along the field side of the guardrail and the tree contact.

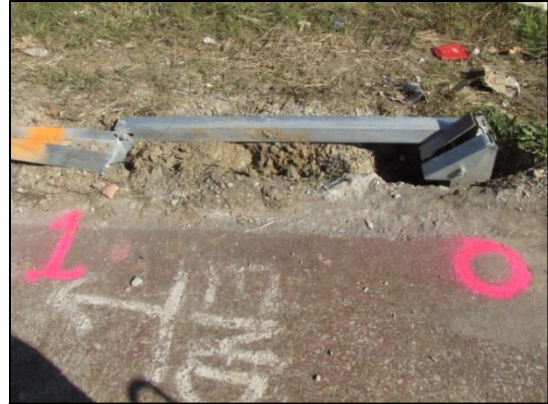
**Figure 9.** East-facing image depicting Post 0, Post 1, and the ground strut.

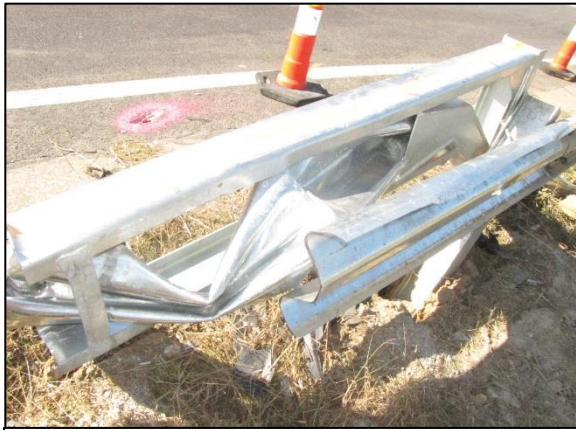
**Figure 10.** Northwest-facing view of the end terminal and deformed W-beam.

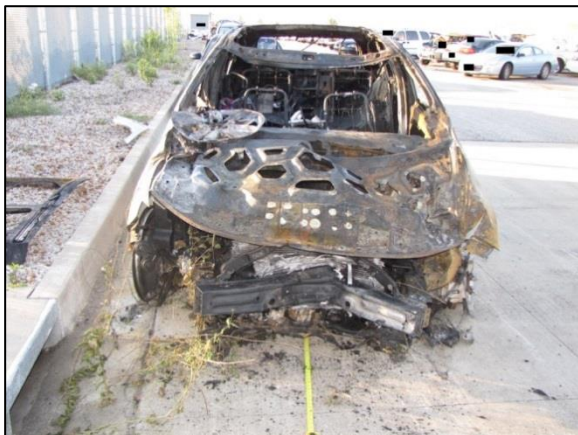
**Figure 13.** Front view of the Ford depicting the deformation.

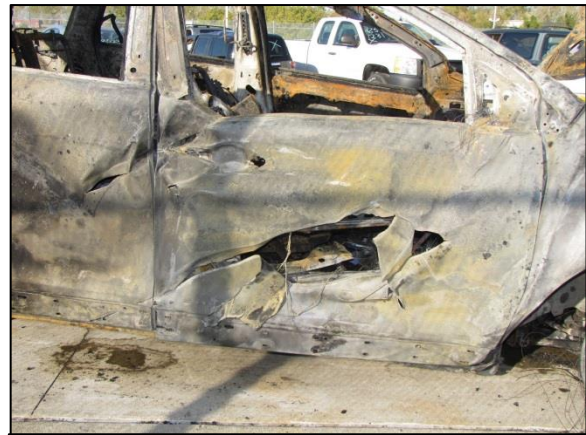
**Figure 14.** Right view of the Ford depicting the door deformation.
