DOT HS 812 835

# **Special Crash Investigations On-Site ET-Plus Guardrail End Terminal Investigation Vehicle: 1997 Chevrolet Blazer Location: Missouri Crash Date: February 2016**

**Special Crash Investigations**  
**On-Site ET-Plus Guardrail End Terminal Investigation**  
**Case Number: IN16005**  
**Vehicle: 1997 Chevrolet Blazer**  
**Location: Missouri**  
**Crash Date: February 2016**

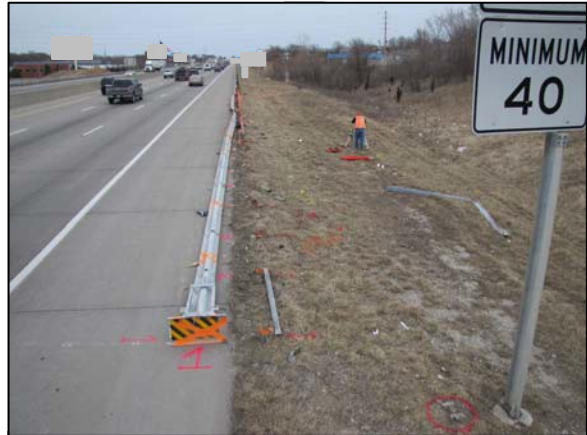
**Figure 1.** View east to the damaged guardrail.

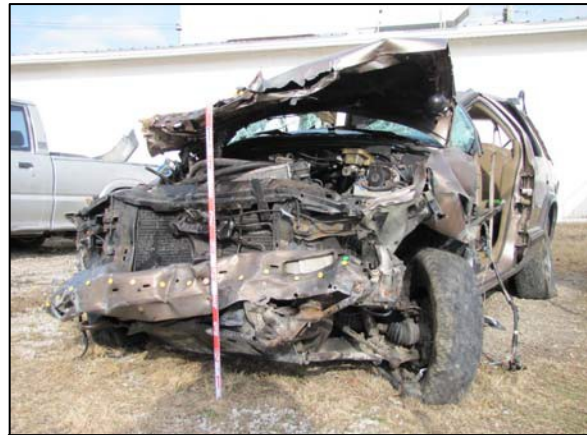
**Figure 2.** The damaged 1997 Chevrolet Blazer.

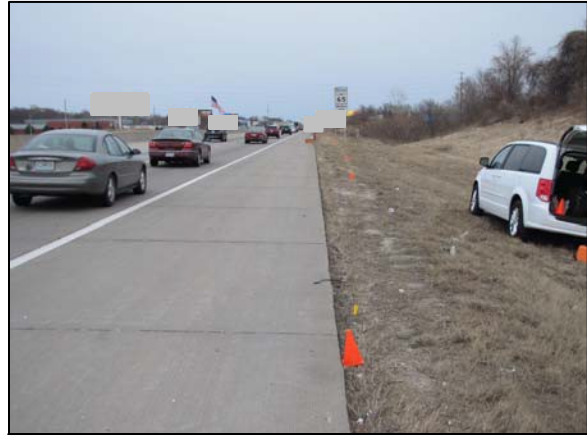
**Figure 3.** Approach to impact, view east.

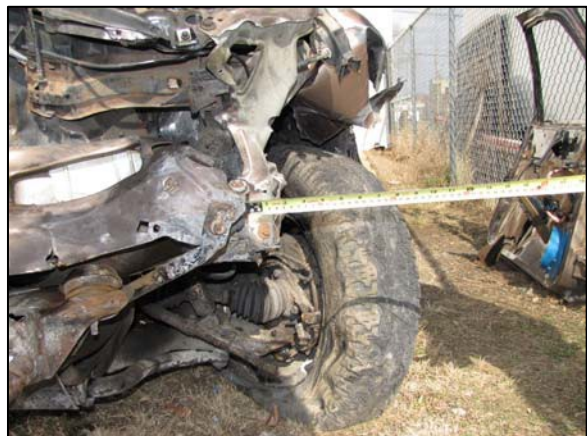
**Figure 4.** Area of end terminal impact.

The Chevrolet's right plane sideswiped the left post of the speed limit sign (Event 1), displacing the post from the sign. The front left corner (**Figure 4**) of the vehicle then immediately struck the end terminal (**Figure 5**, Event 2). The contact occurred to the right face of the end terminal and was 18 cm (7.1 in) wide. The impact with the end terminal was minor as indicated by the extrusion of only 28 cm (11.0 in) of guardrail from the end terminal. Rubber transfer on the face and right edge of the end terminal indicated that the left front wheel of the vehicle also made contact as the vehicle traveled past the end terminal and into the back side of the guardrail. The vehicle remained in contact with the back side of the guardrail as it traveled approximately 38 m (125 ft) while rotating counterclockwise an estimated 70 degrees and damaging 20 guardrail posts. The vehicle then rolled over, right side leading, damaging three additional guardrail posts. The vehicle rolled over a total of six quarter turns across a distance of approximately 24 m (79 ft), coming to final rest on its top plane on the field side of the guardrail heading northwest (**Figure 6**). The left front door came open due to driver contact during the rollover (See Exterior Damage, Event 3 on page 6) and the unbelted driver was ejected. He came to final rest on the right eastbound through lane located 20.3 m (66.5 ft) east of the vehicle's final rest position according to the police measurements. The left front door separated from the vehicle during the rollover and was located on the field side of the guardrail 3.0 to 6.0 m (10.0 to 20.0 ft) east of the final rest position of the vehicle, according to the SCI interview with the tow truck driver. The rollover initiation type was classified as "Trip Over," since there was a divot in the ground that corresponded to the approximate location of the right front wheel at the beginning of the path of several other ground divots and the debris field from the rollover.

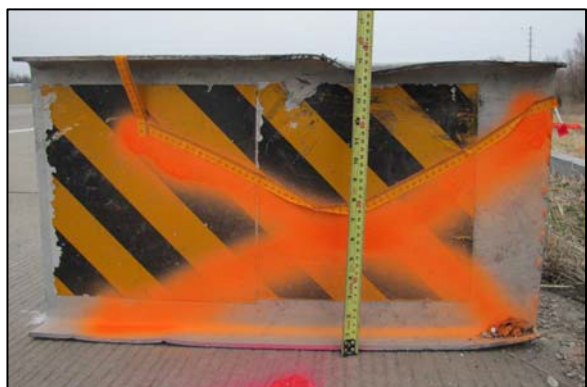
**Figure 5.** The damaged end terminal.

The Chevrolet's front plane impact to the ET-Plus was minor (**Figures 5 and 7**), engaging only an 18 cm (7.1 in) wide area of the face of the ET-Plus that extruded 28 cm (11.0 in) of guardrail (**Figures 7 and 8**) toward the field side. Rubber transfer was present on the ET-Plus, indicating that the left front tire also contacted the ET-Plus. Post 1 to 23 were directly struck by the vehicle as it traveled down the back side of the guardrail and rolled over. Posts 1 to 7 were constructed of wood and all were fractured and separated from the guardrail and ground (**Figure 9**). Post 8 and 9 were constructed of steel and were bent downstream nearly to the ground and separated from the guardrail (**Figure 10**). The wooden block-outs for posts 2 to 9 were fractured into numerous pieces and scattered around the crash scene. The bolts for posts 2 to 12, 14 to 20, 22 and 23 had pulled through the bolt holes. The plastic block-outs for steel posts 10 to 20, 22, and 23 were damaged but still attached to the post. Each post was also bent downstream. The block-out for post 21 was separated from the post, but was still attached to the guardrail. The anchor cable was separated from the guardrail and was found at post 11. The width of the ET-Plus feeder channel was 10 cm (4.0 in). The guide chute height was 38 cm (15.0 in). The connection of the feeder channel to the head was not damaged and there were no kinks in the damaged guardrail.

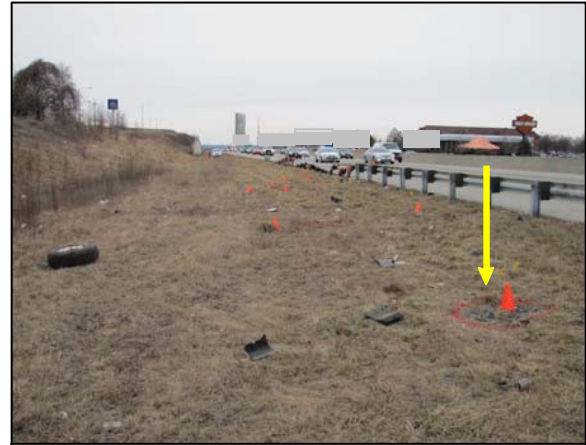
**Figure 6.** View northwest through area of final rest (arrow) and back along path of rollover.

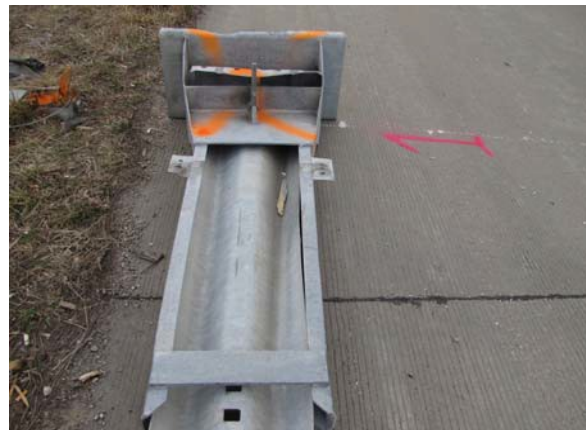
**Figure 7.** The field side of the end terminal.

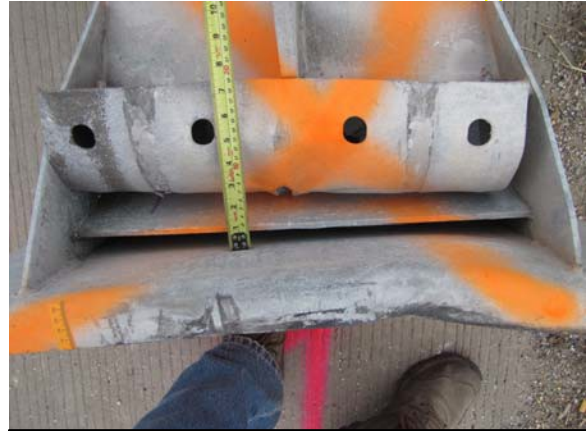
**Figure 8.** Extruded guardrail on field side of end terminal.

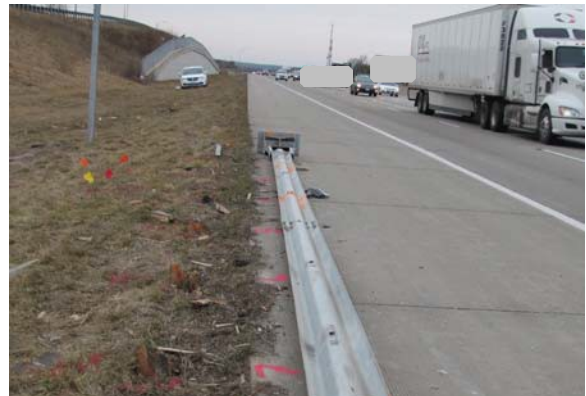
**Figure 9.** Fractured posts 1 - 7, view west.

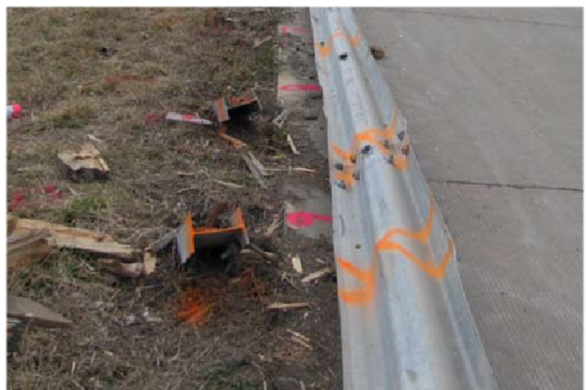
**Figure 10.** Bent posts 8 and 9, view west.

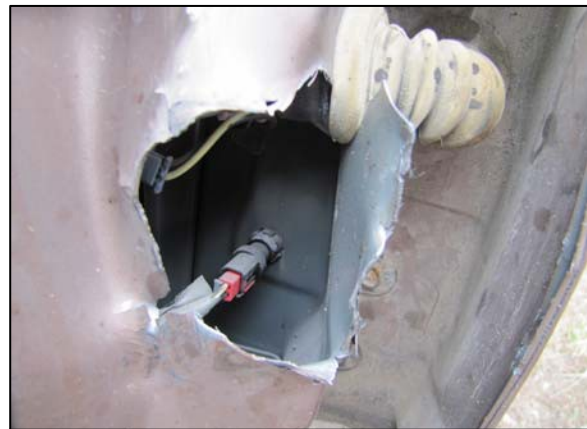
**Figure 11.** Chevrolet's torn door frame sheet metal where left front door striker was mounted.

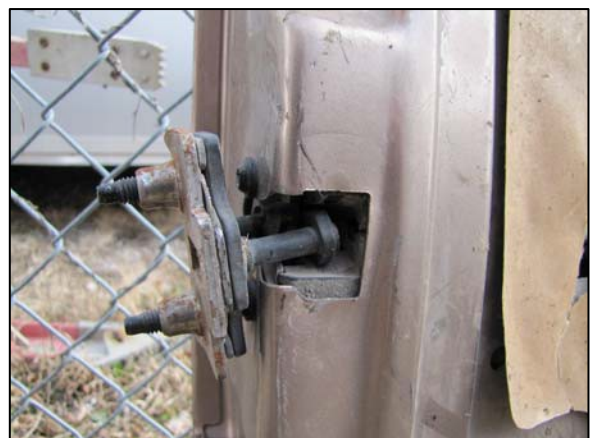
**Figure 12.** Striker remained in left front door latch.

the driver was ejected from the vehicle. The door then separated from the vehicle as it continued to rollover. The door's upper hinge was fractured and the pin separated from the hinge. The lower hinge and hinge pin were deformed and the hinge separated. There was insufficient damage to the door and window frame to indicate that the door came open as a result of ground or guardrail contact during the rollover.

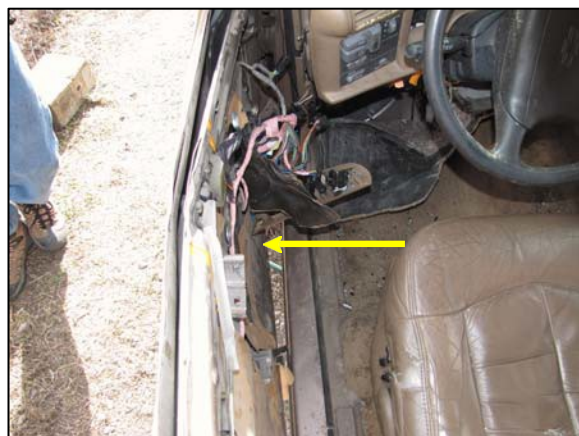
**Figure 13.** Chevrolet's deformed left front door from occupant contact.

Evidence of occupant contact consisted of a cracked lower left instrument panel, probably from contact by the driver's left knee, and the left front door was deformed from contact by the driver's left flank. While the steering wheel was not deformed, the steering column was displaced slightly upward suggesting contact by the driver's chest and possibly abdomen and thighs during the frontal impact. The right front door was jammed shut. The left front door separated from the vehicle during the crash as discussed in the Exterior Damage section of this report on page 6. The left rear and right rear doors and the rear hatch remained closed and operational. All of the non-fixed glazing was closed at the time of the crash. The windshield was cracked and holed from impact forces. The left front, left rear, third left rear, backlight, third right rear, right rear, and right front glazing was disintegrated from impact forces. The second left and right rear glazing was undamaged.
