DOT HS 812 837

Special Crash Investigations On-Site Alleged Air Bag Non-Deployment Crash Investigation Vehicle: 2011 Hyundai Sonata Location: Pennsylvania Date: January 2018

**SPECIAL CRASH INVESTIGATIONS
ON-SITE ALLEGED AIR BAG NON-DEPLOYMENT
CRASH INVESTIGATION
CASE NUMBER: CR18002
OFFICE OF DEFECTS INVESTIGATION
VEHICLE: 2011 HYUNDAI SONATA
LOCATION: PENNSYLVANIA
CRASH DATE: JANUARY 2018**

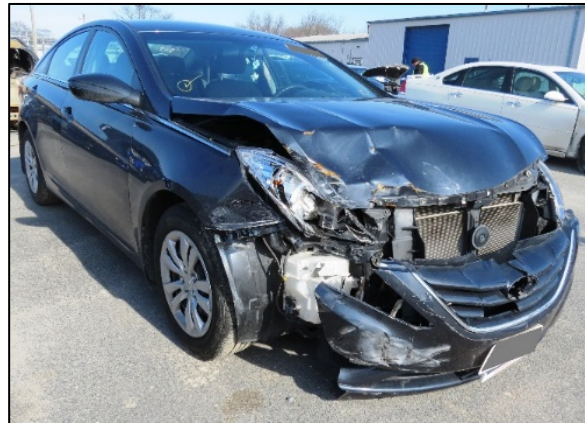
Figure 1. Front right oblique view of the Hyundai at the time of the SCI vehicle inspection.

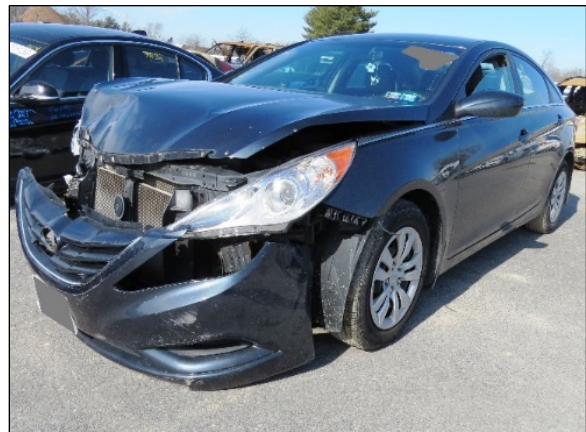
Figure 5. Front left oblique view of the 2011 Hyundai Sonata at the time of the SCI vehicle inspection.

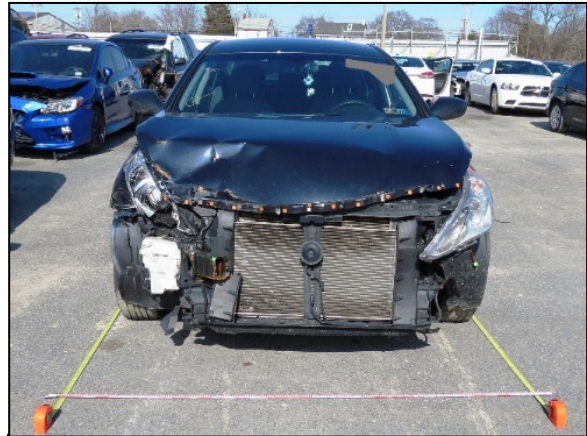
Damage to the exterior of the Hyundai was located on the front plane, associative to the respective primary and secondary frontal impacts with the left plane and left rear corner of the Chevrolet. Deformation and damage associated with the Event #1 impact was distributed across the entire width of the front plane. The bumper fascia and underlying bumper beam were separated from the vehicle, with minor longitudinal and slight lateral deformation to the front plane components (**Figure 6**). The hood's leading edge was deformed rearward, while both frame rail extensions (bumper beam mounts) were deformed at a sharp angle toward the left. Direct contact spanned the Hyundai's entire 150 cm (59.0 in) undeformed end width (**Figure 7**).

From a front plane perspective, the width of the direct and induced damage (Field-L) for the crush profile measured 121 cm (47.6 in). Due to the complete separation of the front bumper beam, in order to calculate a representative crush profile, the SCI investigator obtained a crush profile to the leading edge of the hood. This produced the following resultant measurements: C1 = 5 cm (2.0 in), C2 = 3 cm (1.2 in), C3 = 3 cm (1.2 in), C4 = 6 cm (2.4 in), C5 = 4 cm (1.6 in), and C6 = 15 cm (5.9 in). Maximum crush was located at the front right corner. Based on the visible damage, the CDC assigned to the Hyundai for the Event 1 impact with the left plane of the Chevrolet was 02FDEW1.

Figure 6. View of the front plane damage profile to the 2011 Hyundai Sonata.

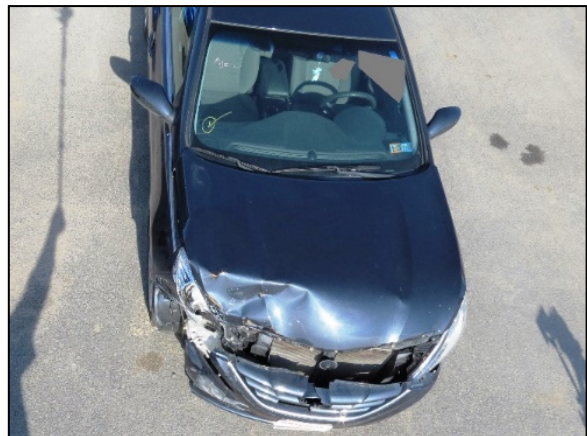
Figure 7. Damage pattern to the front plane of the Hyundai from an overhead perspective.

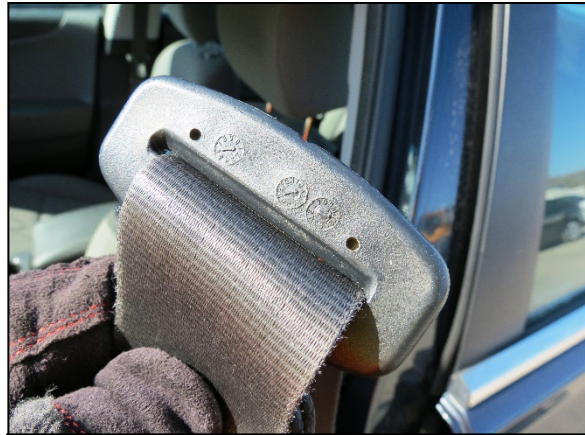
At the time of the SCI inspection, the driver's D-ring was adjusted fully upward. The webbing was stowed in a retracted position, but spooled freely from the retractor. Evidence of historical wear was discernable to both the latch plate and webbing of the driver's seat belt system. No visible loading evidence could be detected along the length of the exposed webbing. However, a subtle area of loading abrasions was discernable in the belt path on the latch plate (**Figure 8**). It was apparent to the SCI investigator that the driver was restrained by the driver's seat belt system at the time of the crash.

Figure 8. Latch plate of the Hyundai driver's seat belt system with minor loading abrasion evidence.

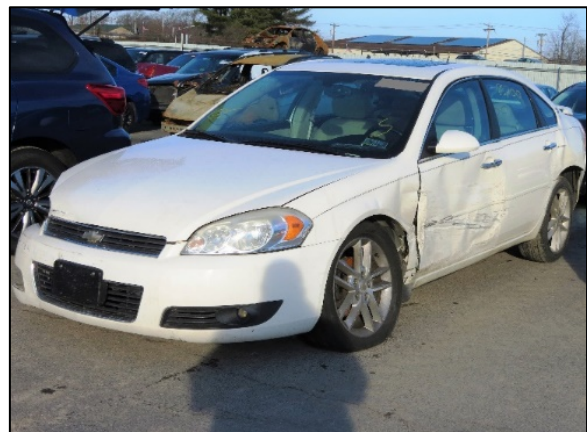
Figure 9. Front left oblique view of the 2009 Chevrolet Impala at the time of the SCI vehicle inspection.

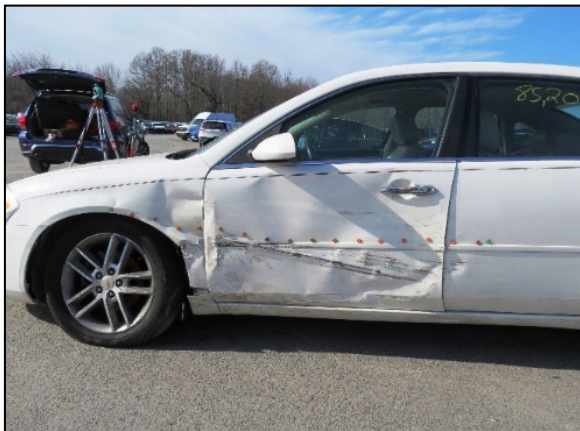
Damage to the exterior of the Chevrolet was located on the left and front planes, associative to the multiple events of the crash. Deformation from the Event #1 impact was distributed across the front half of the left plane, specifically beginning in the area of the left front axle position and extending rearward to the forward aspect of the left rear door. Within the damage pattern was minor lateral deformation to the left front fender and left front door. The left front axle position was also canted inward, a result of the fracture of the suspension arms and damage to the wheel from the impact. Direct contact began 4 cm (1.6 in) rearward of the left front axle position and extended 171 cm (67.3 in) rearward. This dimensionally matched the direct and induced damage width (Field-L) used to document the residual crush profile (**Figure 10**) of the Event 1 impact damage from the Hyundai. The resultant measurements included: C1 = 3 cm (1.2 in), C2 = 4 cm (1.6 in), C3 = 2 cm (0.8 in), C4 = 3 cm (1.2 in), C5 = 2 cm (0.8 in), and C6 = 3 cm (1.2 in). Maximum crush measured 4 cm (1.6 in) and was located at the rear aspect of the left front fender below the left A-pillar. Based on the visible damage, the CDC assigned to the Chevrolet for the Event 1 impact by the front plane of the Hyundai was 11LYEW1.

Figure 10. View of the Event #1 damage pattern to the 2009 Chevrolet Impala.

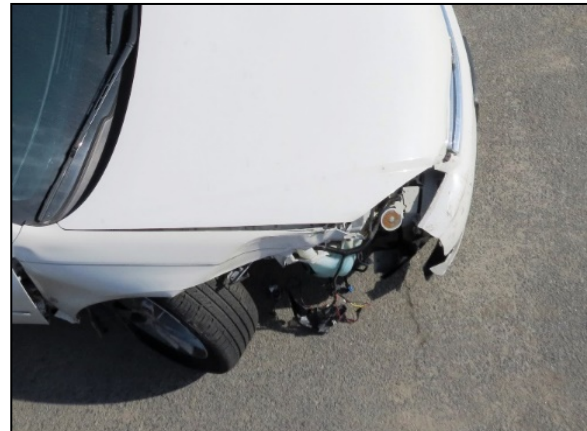
Figure 11. Utility pole damage pattern to the Chevrolet from an overhead perspective.

The second impact with the utility pole occurred at the right front corner aspect of the Chevrolet. Damage included longitudinal displacement of frontal components, outboard of the right frame rail. The right front tire/wheel was deflated and displaced rearward, shortening the vehicle's right wheelbase by 13 cm (5.1 in). No crush profile could be obtained due to the location of the damage outside of the vehicle's front plane structure (**Figure 11**). The CDC assigned to the Chevrolet for the Event 2 utility pole impact was 12FREE3. The corner impact configuration was beyond the scope of the WinSMASH program.

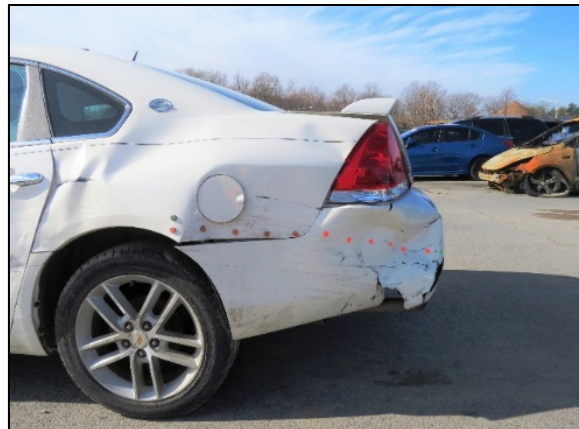
The third impact event, consisting of secondary contact from the Hyundai's front plane, was located at the rear aspect of the Chevrolet's left plane. Direct contact began 22 cm (8.7 in) rearward of the left rear axle position and extended 92 cm (36.2 in) rearward to the left rear bumper corner. Within the damage pattern was minor lateral deformation to the left rear quarter panel and the wrap-around of the rear bumper fascia (**Figure 12**). The resultant residual crush was as follows: C1 = 16 cm (6.3 in), C2 = 16 cm (6.3 in), C3 = 8 cm (3.1 in), C4 = 5 cm (2.0 in), C5 = 2 cm (0.8 in), and C6 = 0 cm (0 in). Maximum crush was located at the left rear bumper corner. Based on the visible damage, the CDC assigned to the Chevrolet for the Event 3 impact by the front plane of the Hyundai was 08LBW2.

Figure 12. View of the Event #3 damage pattern to the 2009 Chevrolet Impala.
