DOT HS 812 856

Special Crash Investigations Child Restraint System Crash Investigation Vehicle: 2010 Dodge Avenger Location: Missouri Crash Date: August 2018

Special Crash Investigations
Child Restraint System Crash Investigation
Case Number: DS18022
Vehicle: 2010 Dodge Avenger
Location: Missouri
Crash Date: August 2018

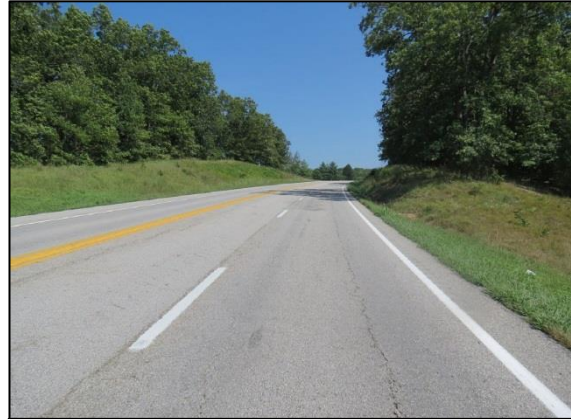
Figure 2. Northbound approach.

The crash site was a curved three-lane state highway that was generally oriented in a north/south direction. The asphalt roadway was configured with one southbound lane and two northbound lanes. The radius of curvature was 2,899 ft (883 m). The northbound and southbound lanes were separated by triple solid yellow painted stripes. The northbound lanes were separated by a dashed white painted line and bordered on the right by a solid white painted line and an asphalt shoulder (**Figure 2**). There was a shallow ditch east of the roadway. There was a positive 5 percent grade approaching the area of impact. The southbound lane was bordered on the right by a solid white painted stripe and an asphalt shoulder (**Figure 3**). There were a negative 4 percent grade and a negative 7 percent superelevation approaching the area of impact. The speed limit was 105 km/h (65 mph) in both directions.

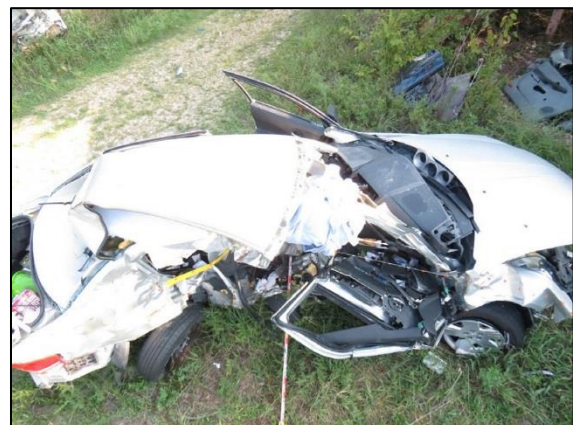
Figure 4. 2010 Dodge Avenger, right side Damage.

The Dodge sustained severe right side damage from the impact with the front plane of the Ford (**Figure 4**). The direct damage began 79 cm (31.1 in) aft of the rear axle and extended 315 cm (124.0 in) forward. The Field L extended from bumper corner to bumper corner and measured 365 cm (143.7 in). Forty measurements were taken at the mid-door level by the Nikon Total Station and the Faro Blitz program computed crush

measurement in six increments as follows: $C_1 = 0$ cm, $C_2 = 34$ cm (13.3 in), $C_3 = 59$ cm (23.2 in), $C_4 = 55$ cm (21.6 in), $C_5 = 16$ cm (6.2 in), and $C_6 = 14$ cm (5.5 in). The crush at the sill level was measured manually as follows: $C_1 = 0$ cm, $C_2 = 30$ cm (11.8 in), $C_3 = 73$ cm (28.7 in), $C_4 = 64$ cm (25.1 in), $C_5 = 31$ cm (12.2 in), and $C_6 = 0$ cm. The average crush profile was as follows: $C_1 = 0$ cm, $C_2 = 34$ cm (13.3 in), $C_3 = 66$ cm (25.9 in), $C_4 = 55$ cm (21.6 in), $C_5 = 24$ cm (9.4 in), and $C_6 = 7$ cm (2.7 in). The maximum crush measured 78 cm (30.7 in) and was located 110 cm (43.3 in) forward of the rear axle. The sill height was 24 cm (9.4 in) and the height of the maximum crush was 45 cm (17.7 in). The door sill differential (DSD) was 28 cm (11.0 in). The Collision Deformation Classification (CDC) was 04RDAW4.

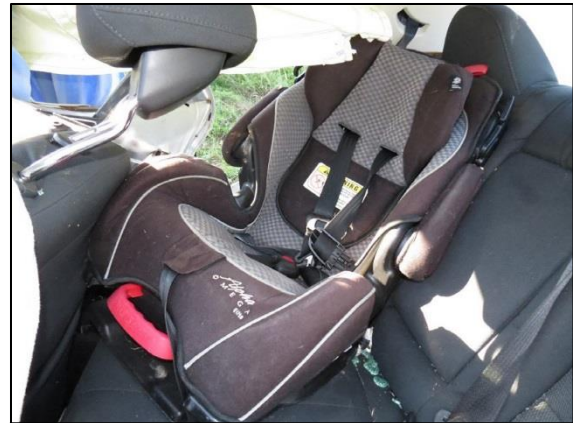
Figure 5. Alpha Omega Elite CRS.

The 3-year-old male was seated in a Safety 1st Alpha Omega Elite CRS (**Figure 5**) identified by the model number CC159-CRML with a manufacture date of 5/22/2015. The convertible CRS was designed to be used in one of three modes: rear-facing, forward-facing, or a belt positioning booster. This CRS was being used in the forward-facing orientation. The CRS was intended to be used for children weighing between 10.1-18 kg (22-40 lbs) and whose age is greater than 1 year. The child met the age and size requirements. The seat was configured with an adjustable 5-point internal harness, 3-position recline, and LATCH. The CRS was intended to be installed using either LATCH or the vehicle's seat belt. In this case, the seat was installed using the vehicle lap and shoulder seat belt (**Figure 6**). The tether was not used. It is unknown if the seat belt locking mode was engaged. The CRS was held tightly in place at the time of the inspection by intruding vehicle components. The seat belt buckle could not be accessed during the inspection. The CRS was removed from the vehicle by the SCI investigator by cutting the seat belt. The internal harness was adjusted to the top slot. The seat sustained damage due to the impact/intrusion. There were 21 cm (8.2 in) long longitudinal and 10 cm (3.9 in) lateral fractures along the right side (**Figure 7**). There was a series of cuts along the right seat pad measuring 16 cm (6.2 in).

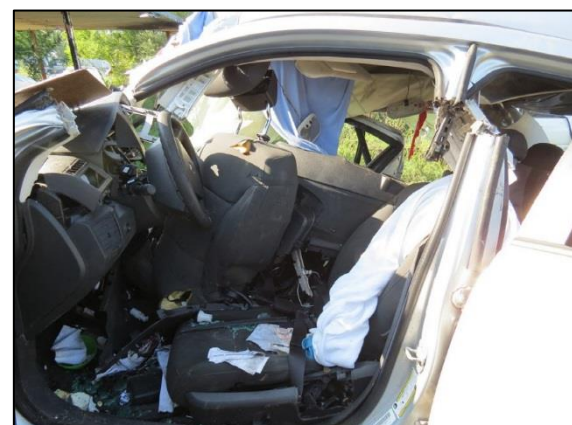
Figure 8. Right intrusion, 2010 Dodge Avenger.

The Dodge sustained severe interior damage from intrusion. There was lateral intrusion to the right side from the right front door, right sill, right roof side rail, right B-pillar and right rear door. The right front seat was displaced to the left into center and left seat positions (**Figure 8**).

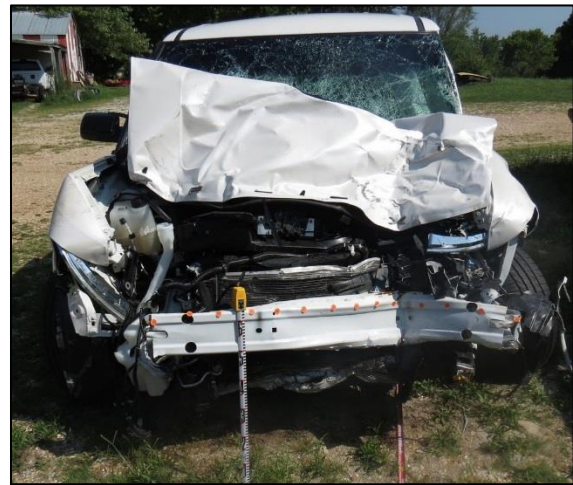
Figure 9. Frontal damage, 2017 Ford Flex.

The Ford sustained moderate front plane damage from the impact to the right plane of the Dodge (**Figure 9**). The direct damage began 22 cm (8.6 in) right of the left front bumper corner and extended 115 cm (45.2 in) to the right. The Field L extended from bumper corner to bumper corner. Twelve measurements were taken at the bumper level by the Nikon Total Station and the Faro Blitz program computed crush measurement in six increments as follows: $C_1 = 35$ cm (13.7 in), $C_2 = 53$ cm (20.8 in), $C_3 = 55$ cm (21.6 in), $C_4 = 41$ cm (16.1 in), $C_5 = 29$ cm (11.4 in), and $C_6 = 14$ cm (5.5 in). The CDC was 12FDEW3.

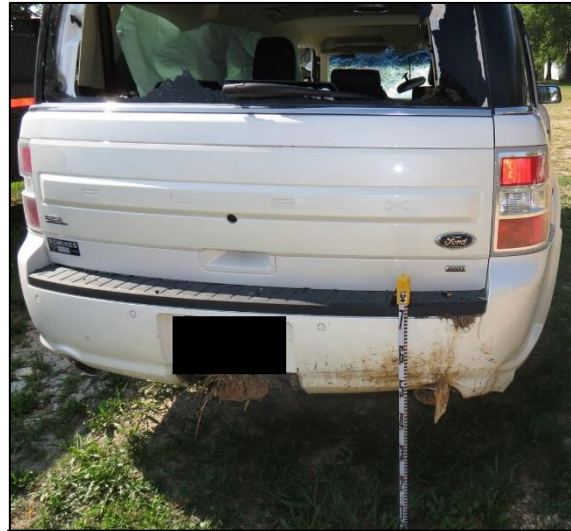
Figure 10. Rear damage, 2017 Ford Flex.

The Ford sustained minor damage to the right rear bumper back plane from contact to the side of the ditch (**Figure 10**). The direct damage began at the right rear bumper corner and extended 85 cm (33.4 in) to the left. The CDC was 03BZLS1.
