DOT HS 812 866

Special Crash Investigations Alleged Air Bag Fatality Crash Investigation Vehicle: 2009 Lexus ES350 Location: Texas Crash Date: August 2018

Special Crash Investigations
Alleged Air Bag Fatality Crash Investigation
Case Number: DS18029
Vehicle: 2009 Lexus ES350
Location: Texas
Crash Date: August 2018

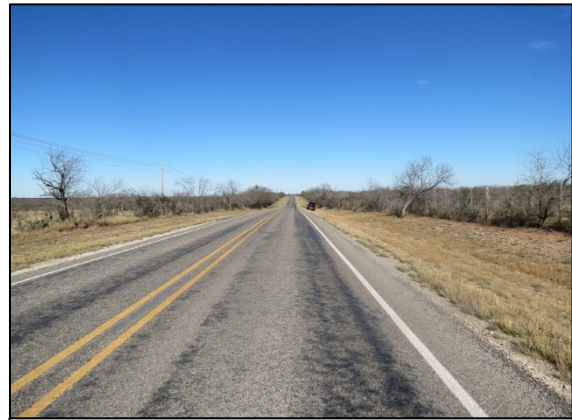
The crash site was a two-lane undivided east/west roadway in rural Texas (**Figure 2**). There were no reported defects to the roadway and visibility was unobstructed. The posted speed limit was 89 km/h (55 mph). The asphalt roadway was straight with a negative grade of 2 percent. Pavement markings on the road include solid white fog lines on both roadway edges, and a continuous double yellow centerline. The roadway was bordered on the left by an asphalt shoulder, a grass/dirt ditch, and a barbed wire fence. A 70 cm (27.5 in) diameter tree was located 8.7 m (28.5 ft) to the north of the roadway edge. The weather at the nearest reporting station was 26 degrees C (79 degrees F), 40 percent humidity, fair skies, and the winds were out of the southeast at 19 km/h (12 mph). A crash diagram is attached at the end of this technical report.

Figure 2. Eastbound approach.

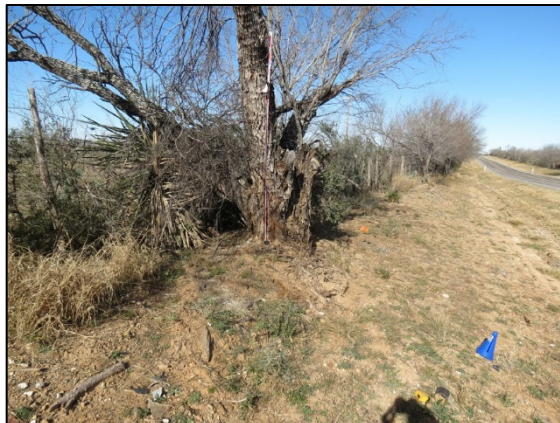
As the vehicle continued forward, the front plane struck the tree (**Figure 3**). The vehicle speed was 64 km/h (39.8 mph). The WinSMASH program calculated a barrier equivalent speed (BES) of 57 km/h (35 mph). The longitudinal and lateral components were -57 km/h (-35 mph) and 0

Figure 3. Tree impact, looking north.

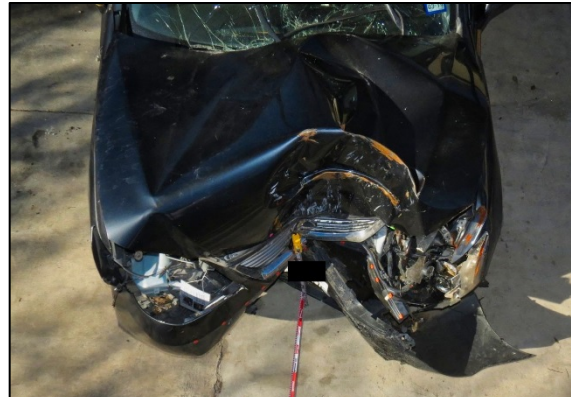
The Lexus sustained severe front plane damage from the impact with the tree (**Figure 4**). The direct damage began 22 cm (8.6 in) right of the left bumper corner and extended 46 cm (18.1 in) to the right. Thirteen measurements were taken at the bumper level by the Nikon Total Station

and the Faro Blitz program computed crush measurement in six increments as follows: $C_1 = 20$ cm (7.8 in), $C_2 = 53$ cm (20.8 in), $C_3 = 63$ cm (24.8 in), $C_4 = 57$ cm (22.4 in), $C_5 = 38$ cm (14.9 in), and $C_6 = 13$ cm (5.1 in). The maximum crush was located 70 cm (27.5 in) to the right of the left bumper corner. The collision deformation classification (CDC) was 12FYEW3.

Figure 4. Frontal damage, 2009 Lexus ES350.

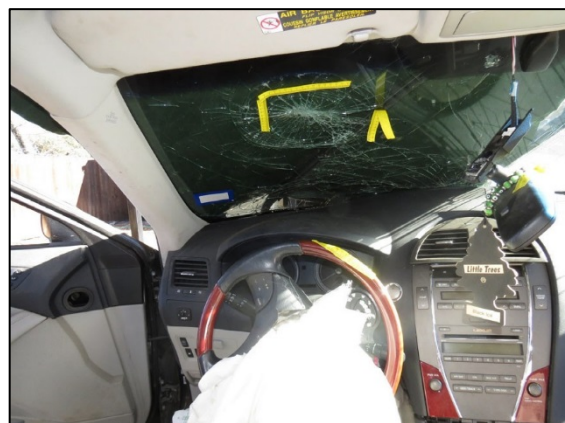
The interior of the Lexus was inspected for crash-related damage and occupant contact. There was no identifiable intrusion into the occupant compartment. Occupant contacts were observed on the windshield, driver's knee air bag, steering wheel, driver's mirror, right instrument panel, and center console. The windshield contact fractured the windshield and was likely caused by the driver's hand (**Figure 5**). The steering wheel was compressed forward due to loading. The top of the rim was located 2 cm (0.8 in) from the top instrument panel and the bottom of the rim was located 27 cm (10.6 in) from the bottom instrument panel. The driver's mirror was scuffed and displaced from the windshield. The center console was displaced, possibly by the driver's hip. A small scuff was observed on the lower right instrument panel. The contact evidence found on the knee air bag is described in the Supplemental Restraint Systems section of this report.

Figure 5. Windshield contact, 2009 Lexus ES350.

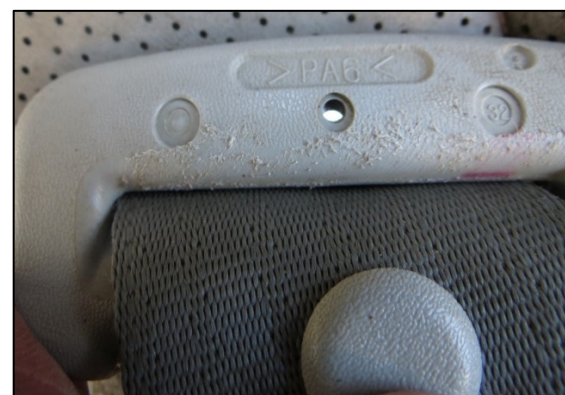
Figure 6. Right passenger seat belt latch loading, 2009 Lexus ES350.

The front right passenger’s seat belt was found in the spooled-out position. The retractor was locked in position, resultant from actuation of the retractor pretensioner (**Figure 6**). There were scuffs measuring 5 cm (1.9 in) located 33 cm (12.9 in) from stop button and measuring 8 cm (3.1 in) located 12 cm (4.7 in) from stop button. There was loading evidence in the latch plate (**Figure 7**). There was also loading and scuffing located along the right seat guide area. This seat belt was used improperly by the child occupant.

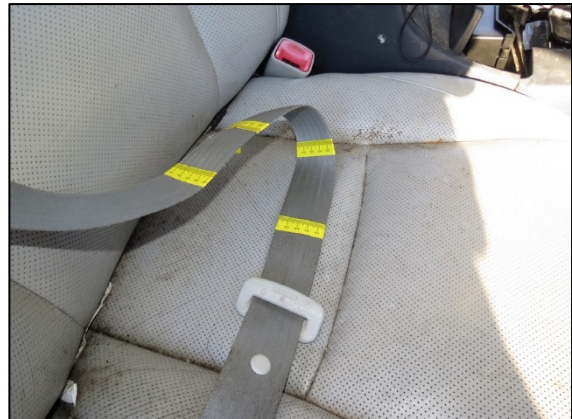
Figure 7. Right passenger lap and shoulder seat belt loading, 2009 Lexus ES350.

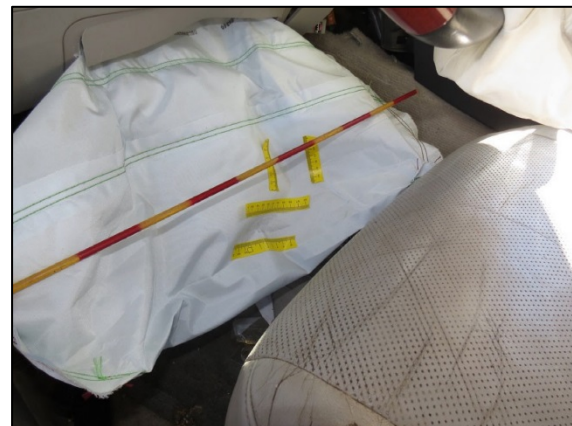
The driver’s knee air bag was located in the lower instrument panel. The air bag had a deflated rectangular shape that measured 29 x 52 cm (11.4 x 20.4 in). There were two contacts identified (**Figure 8**). The first scuff measured 2 x 8 cm (0.8 x 3.1 in) and was located 26 cm (10.2 in) from the left edge and 5 cm (1.9 in) from the bottom. The second scuff measured 4 x 4 cm (1.5 x 1.5 in) and located 34 cm (13.3 in) from the left edge and 9 cm (2.5 in) from the bottom.

Figure 8. Driver knee air bag, 2009 Lexus ES350.
