DOT HS 812 876

# **Special Crash Investigations On-Site Guardrail End Treatment Crash Investigation Vehicle: 2001 Toyota Corolla Location: Pennsylvania Crash Date: March 2018**

**Special Crash Investigations  
Office of Defects Investigation  
On-Site Guardrail End Treatment Crash Investigation  
Case Number: CR18006  
Vehicle: 2001 Toyota Corolla  
Location: Pennsylvania  
Crash Date: March 2018**

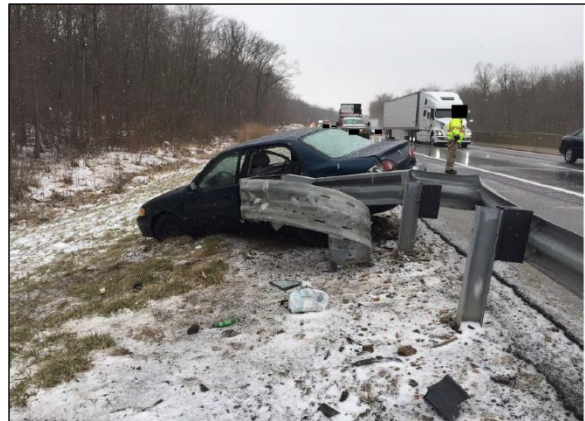
**Figure 1.** West-facing lookback view depicting the crash site and the Toyota at its final rest position. Image supplied by the PTC.

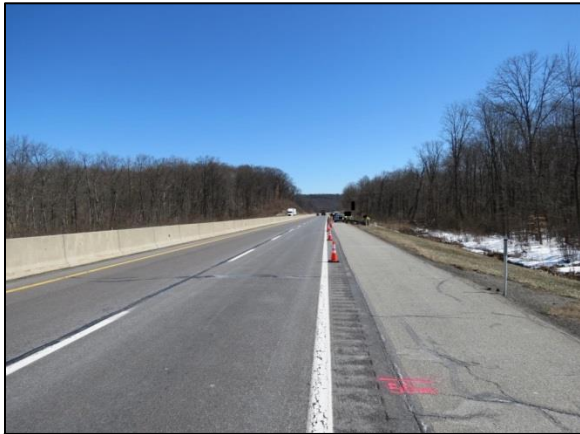
**Figure 2.** Eastbound trajectory view of the crash site at 50 m pre-impact with the guardrail.

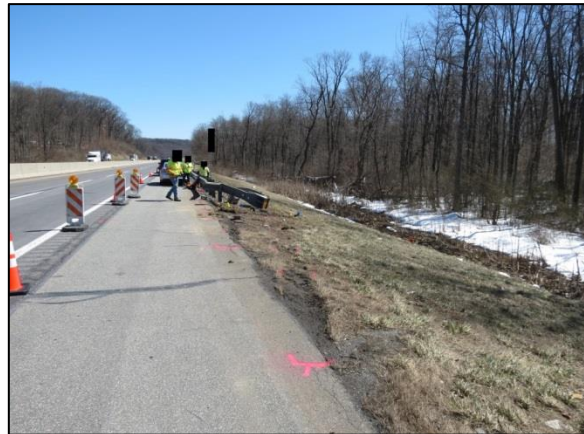
**Figure 3.** Eastbound view of the shoulder, roadside and struck SKT guardrail end treatment.

The end treatment and guardrail were installed on the right roadside and protected traffic from an increasing sloped roadside that transitioned to a drainage ditch. The grass roadside had an average slope of -19 percent at the point of impact. **Figure 3** is an east-facing trajectory view approximately 20 m (66 ft) from the point of impact (guardrail post 1). A crash diagram is included at the end of this report.

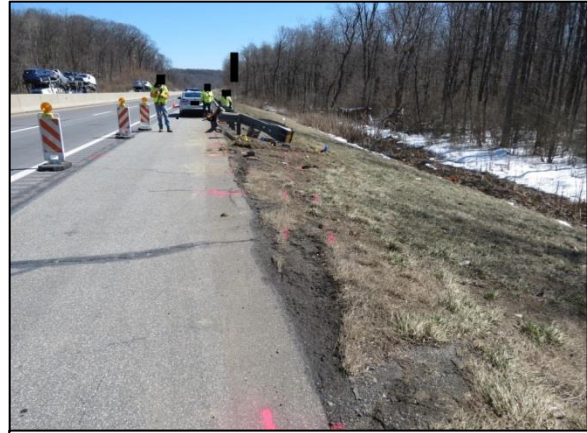
The 65-year-old male driver was driving east in the right lane of the divided roadway. He told police he was operating the vehicle at approximately 105 km/h (65 mph). He exited a shallow left curve located approximately 0.8 km (0.5 miles) west of the guardrail end treatment and entered a straight section of the interstate. While traveling on this straight segment, the driver lost control of the Toyota in wet/snow conditions, and the vehicle initiated a clockwise yaw. The Toyota departed the right (south) road edge onto the paved shoulder, traversed the asphalt shoulder in a left side leading attitude, and entered the grass roadside. During the SCI scene inspection, two tire marks were identified that evidenced the vehicle's trajectory (**Figure 4**). Reconstruction of the vehicle dynamics determined that the front tires created these two marks. The left front tire mark was 13.4 m (44.0 ft) in length and the right front mark measured 4.0 m (13.1 ft).

**Figure 4.** Easterly view of the left side tire yaw marks on the grass roadside.

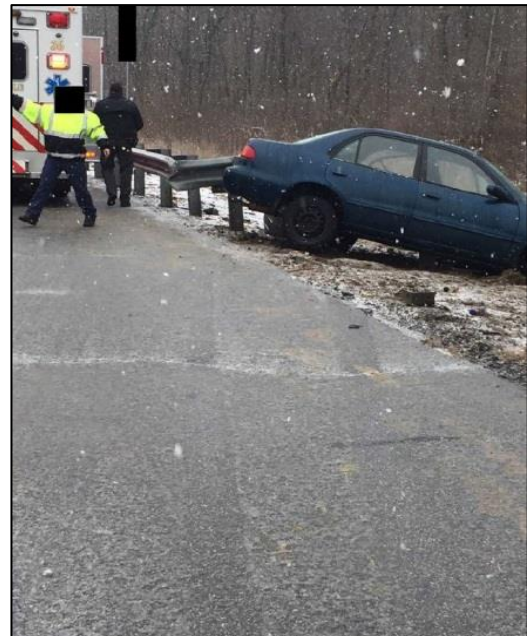
An on-scene image provided by the PTC depicted the rear tire yaw marks on the icy shoulder (**Figure 5**). These marks ended at the edge of the shoulder at the point of impact with the guardrail end treatment. The diverging orientation of the rear marks indicated that the Toyota had rotated beyond 90 degrees as it approached the impact with Post 1. Due to the passage of time between the dates of the crash and inspection and the change in surface conditions, the rear tire marks on the shoulder were not visible during the SCI inspection.

**Figure 5.** Easterly view of the on-scene tire yaw marks on the icy asphalt shoulder. Image provided by the PTC.

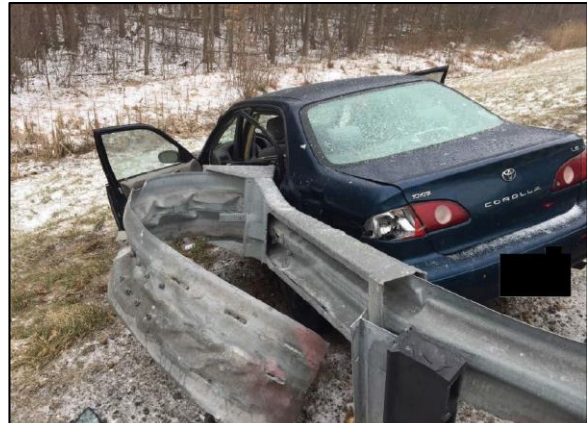
the Toyota came to rest facing southwest, adjacent to the deformed guardrail and end terminal 6.4 m (21.0 ft) from the Post 1 impact location. **Figures 6** and **7** are final rest views of the Toyota (images provided by the PTC).

**Figure 6.** Southwesterly view of the final rest position of the Toyota engaged against the terminal end. Image provided by the PTC.

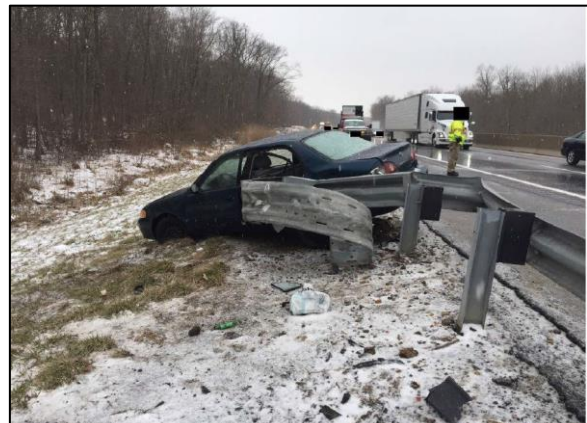
**Figure 7.** Westerly view of the final rest position of the Toyota. Image provided by the PTC.

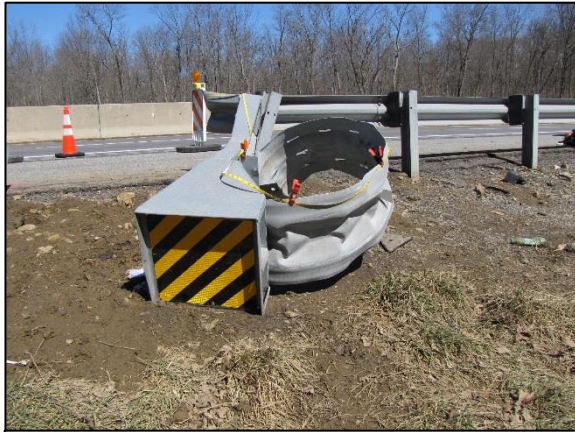
below. Posts 1 to 4 of the installation were damaged during the crash, along with 9.1 m (30.0 ft) of W-beam. The deformed guardrail was inspected and documented through measurements and photographs. The FHWA Guardrail Form documenting the crash and installation is included at the end of this report as **Appendix A**.

**Figure 8.** Image depicting the impacted end terminal and the extruded W-beam.

Posts 3 to 5 of the installation were 15 x 10 cm (5.9 x 3.9 in) I-beams and prior to the crash supported the W-beam with composite block-outs and carriage bolts. The posts did not appear to have weakening holes. During the crash, the heads of these bolts at Posts 3 and 4 pulled through the W-beam by deformation of the slot in the rail. Post 3 bent approximately 80 degrees toward the road as a result of contact with the left rear axle of the Toyota. At final rest, the left rear tire was resting on the post. Post 4 was bent approximately 20 degrees to the east. After the carriage bolt separated at Post 4, the W-beam bent through the slot approximately 90 degrees to the south and along with the Toyota contacted Post 4 as the vehicle came to rest. There was slight bending of Post 5 and 6 (less than 10 degrees). The repair of the guardrail necessitated replacement of the W-beam to the splice at Post 7.

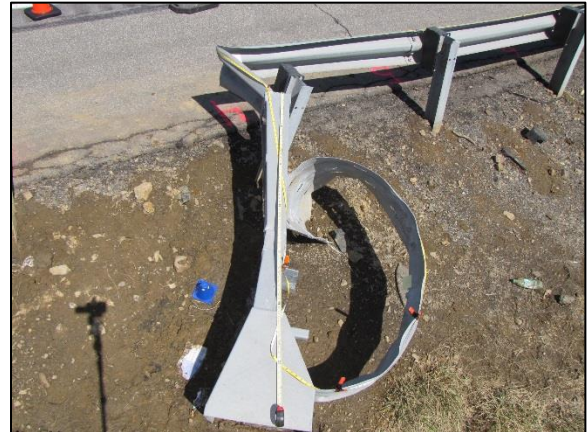
The guardrail was a tangent system installed adjacent to the paved shoulder. The height of the W-beam measured 70 cm (27.5 in) in an undamaged section of the beam at Post 7. The Toyota struck the face of the end terminal (**Figure 8**) at Post 1. The impact face measured 51 x 51 cm (20.0 x 20.0 in). The force of the impact displaced the end terminal to the east and extruded 3.2 m (10.5 ft) of the W-beam. The extruded W-beam curled to the field side, away from the road. The force of the impact displaced the end terminal between Posts 3 and 4 (**Figure 9**). The end terminal chute was bent approximately 10 degrees at its midpoint; refer to the overhead image

**Figure 9.** Overhead view of the location of the displaced end terminal.

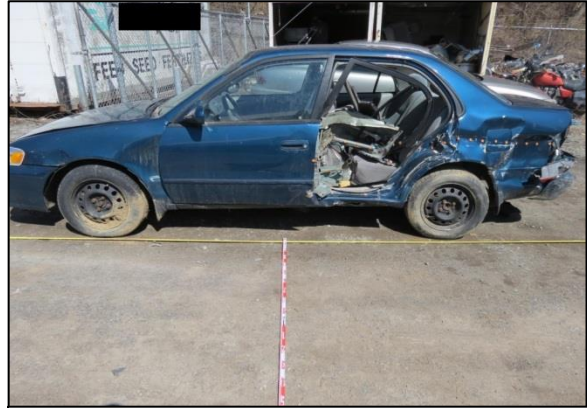
**Figure 10.** Left plane damage to the Toyota.

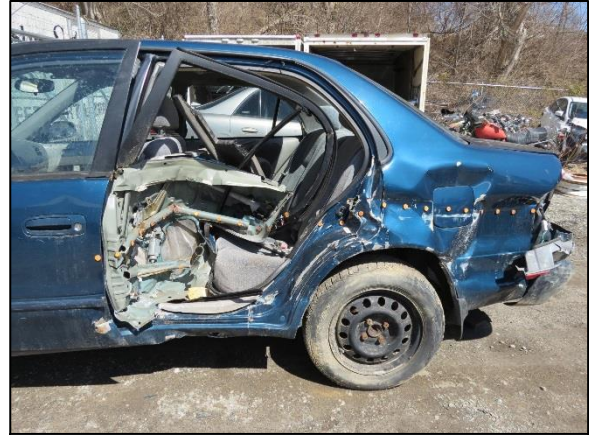
The Toyota sustained left plane damage consistent with the Event 1 impact with the guardrail system. The initial contact occurred on the left rear door immediately aft of the left B-pillar from engagement with the end terminal. The square profile of the end terminal was observed on the sheet metal of the separated door panel. The lateral impact force crushed the door inward into the second row occupant space. The C-pillar-mounted striker post pulled through the sheet metal mounting point causing an integrity loss at the door location. As the Toyota continued on its errant southeast trajectory, the guardrail system deformed by bending due to the off-axis loading. The left rear quarter panel contacted the

**Figure 11.** Left side view of the Toyota depicting the damage pattern.

chute aspect of the end terminal resulting in a continuous damage pattern that extended from the vehicle's left B-pillar to the back left corner. The total length of direct and induced damage was 187 cm (73.6 in) along the left plane. Maximum crush was 30 cm (11.8 in) located on the side impact protection beam of the left rear door. The door penetrated into the occupant compartment due to the striker separation from the C-pillar. The exterior door panel separated from the door frame. A crush profile (**Figure 11**) documented along the damage plane by the total station was as follows: C1 = 7 cm (2.8 in), C2 = 5 cm (2.1 in), C3 = 7 cm (2.8 in), C4 = 20 cm (7.9 in), C5 = 30 cm (11.8 in), and C6 = 6 cm (2.4 in). The left front door was jammed shut by the impact and forced open at the scene to assist the driver. The door would not close or re-latch due to body deformation. Both right side doors remained operational post-crash. The left wheelbase was reduced 1 cm (0.8 in); the right wheelbase was unchanged. The Collision Deformation Classification (CDC) attributed to this damage pattern was 08LZEW3. The barrier equivalent speed calculated by the damage algorithm of the WinSMASH program was 22 km/h (14 mph).

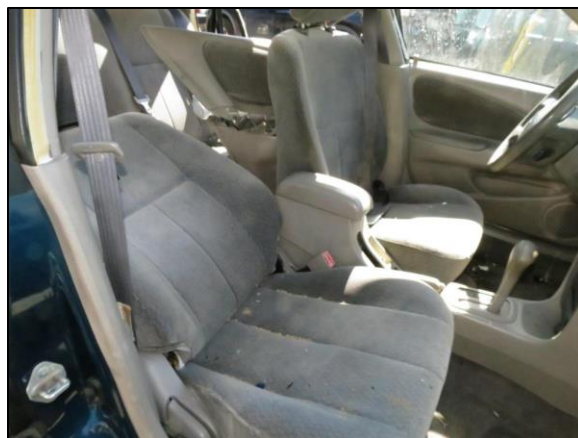
Occupant contact damage was limited to rearward displacement of the right front seat back. The seat back was deformed to a reclined angle of 60 degrees aft of vertical and was jammed. The seatback rotation resulted in 30 cm (12 in) of intrusion into the second row left and center positions (**Figure 12**). The front row right occupant engaged the center console without physical

**Figure 12.** Overall interior view of the Toyota and the rearward deflection of the front row right seat back.
