DOT HS 812 897

# **Special Crash Investigations On-Site Side Inflatable Curtain Occupant Protection Crash Investigation**

**Vehicle: 2014 Volkswagen  
Jetta**

**Crash Date: May 2015**

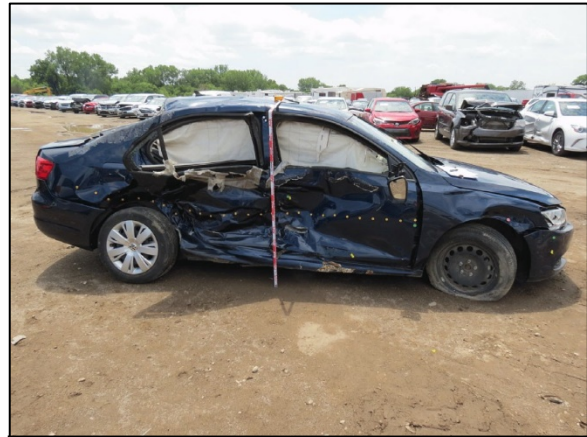
**Figure 1:** The damaged 2014 Volkswagen Jetta

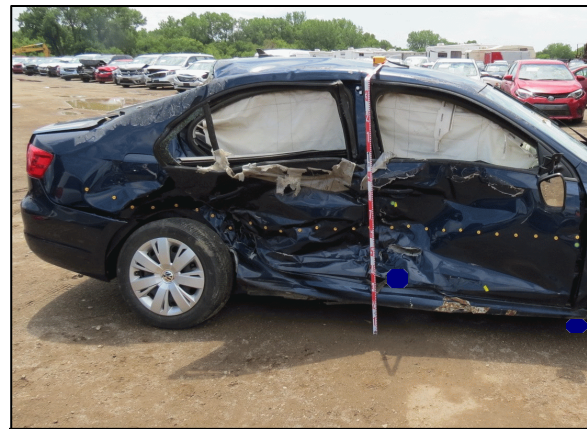
The front plane of the Chevrolet struck the right plane of the Volkswagen (**Figure 4**, Event 1). The force direction on the Volkswagen was in the 2 o'clock sector and the impact actuated both front seat belt pretensioners and deployment of both frontal, IC, and front passenger's seat-mounted side impact air bags. The "missing vehicle" algorithm of the WinSMASH program calculated the total delta V for the Volkswagen as 20 km/h (12 mph). The longitudinal and lateral velocity changes were -10 km/h (-6 mph) and -17 km/h (11 mph), respectively. WinSMASH calculated the total delta V for the Chevrolet as 11 km/h (7 mph). The longitudinal and lateral velocity changes were -10 km/h (-6 mph) and 6 km/h (4 mph), respectively. The results were considered borderline for each vehicle since the Chevrolet was not inspected.

**Figure 4:** Damage to the Volkswagen's right plane from impact by the front plane of the Chevrolet

*Exterior Damage Event 1:* The Volkswagen sustained direct and induced damage to both right side doors, B- and C-pillars, right rear window frame, quarter panel, and the roof side rail. The direct damage began 172 cm (67.7 in) forward of the right rear axle and extended 172 cm (103.1 in) rearward. The Field L was 262 cm (103.1 in) in length beginning 220 cm (86.6 in) forward of the right rear axle. The crush measurements were taken at the mid-door level and the maximum residual crush was 27 cm (10.6 in) occurring 35 cm (13.8 in) forward of the right rear axle. The crush values were:  $C_1 = 0$  cm,  $C_2 = 12$  cm (4.7 in),  $C_3 = 21$  cm (8.3 in),  $C_4 = 12$  cm (4.7 in),  $C_5 = 22$  cm (8.7 in),  $C_6 = 0$  cm. The sill height was 25 cm (9.8 in) and the height of the maximum crush was 60 cm (23.6 in). The door sill differential (DSD) was 18 cm (7.1 in).

*Damage Classification Event 1:* The Collision Deformation Classification (CDC) was 02RZEW3 (60 degrees).

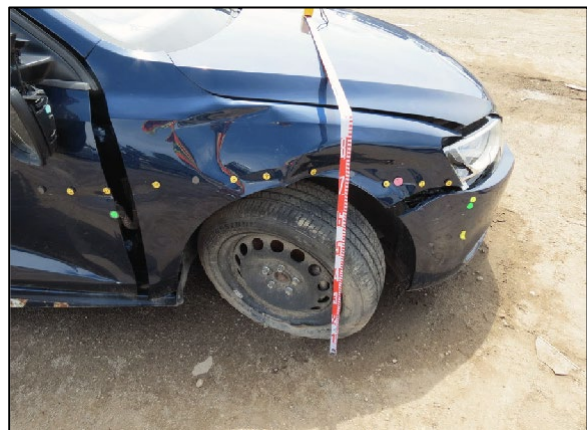
The impact caused the Volkswagen to rotate clockwise an estimated 100 degrees and the vehicle's right fender (**Figure 5**) struck the right fender of the Chevrolet (Event 2). The force direction on the Volkswagen was in the 3 o'clock sector and the "missing vehicle" algorithm of WinSMASH calculated the total delta V as 7 km/h (4 mph). The longitudinal and lateral velocity changes were 0 km/h and -7 km/h (-4 mph), respectively. WinSMASH calculated the total delta V for the Chevrolet as 4 km/h (3 mph). The longitudinal and lateral velocity changes were -4 km/h (-3 mph) and 0 km/h, respectively. The results were considered borderline for each vehicle.

**Figure 5:** Damage to the Volkswagen's right fender from impact with the Chevrolet's right fender

*Exterior Damage Crash Event 2:* The vehicle sustained direct and induced damage to the front portion of the right front door, right fender, and right side of the front bumper fascia during the side- slap impact with the right fender of the Chevrolet. The direct damage began 320 cm (126.0 in) forward of the right rear axle and extended 110 cm (43.3 in) rearward. The Field L was also 110 cm (43.3 in) long beginning at the same location as the direct damage. The crush measurements were taken at the mid-door level and the maximum residual crush was 8 cm (3.1 in) occurring 89 cm rear of the right-rear axle. The crush values were:  $C_1 = 0$  cm,  $C_2 = 0$  cm,  $C_3 = 4$  cm (1.6 in),  $C_4 = 6$  cm (2.4 in),  $C_5 = 8$  cm (3.1 in),  $C_6 = 0$  cm.

*Damage Classification Crash Event 2:* The CDC was 03RYEW2 (90 degrees).

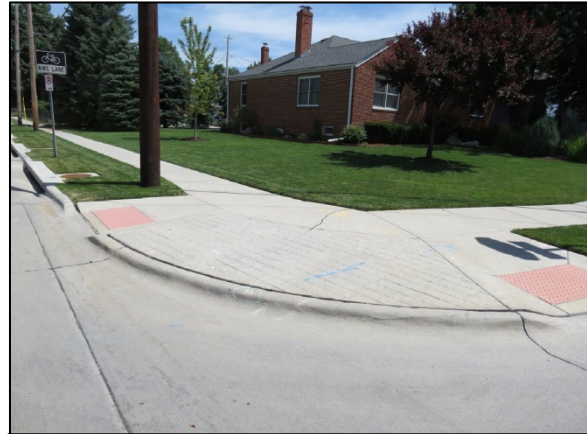
estimated 12 m (39 ft) and the front plane struck a 36 cm (14.2 in) diameter wooden utility pole (Event 4). The vehicle then came to final rest against the pole heading northeast (**Figure 6**) with the rear portion of the vehicle remaining in the roadway. The Volkswagen continued northeast following the curb impact through a residential yard for approximately 18 m (59 ft) and the left front corner struck a bush (Event 5) as the vehicle came to final rest heading northeast next to a private residence.

**Figure 6:** Volkswagen’s northeast approach to curb impact and final rest near house; final rest of the Chevrolet against the utility pole in the foreground

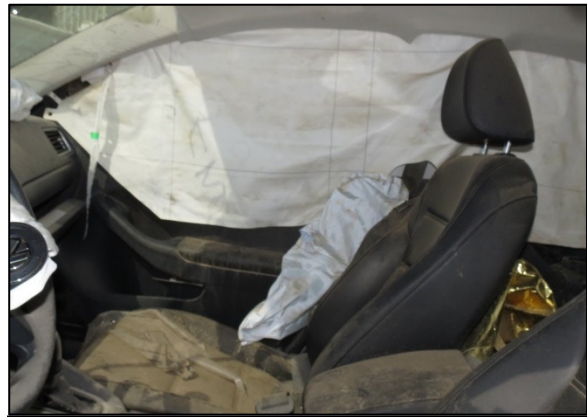
The front right seat-mounted side impact air bag was located in the outboard side of the seat back and deployed through a tear seam. The deflated air bag (**Figure 7**) was 50 cm (19.7 in) high and 15 cm (5.9 in) wide and had a single vent port. There was no discernable evidence of occupant contact and no damage to the air bag.

**Figure 7:** The Volkswagen's deflated front right seat-mounted side impact and right IC air bag

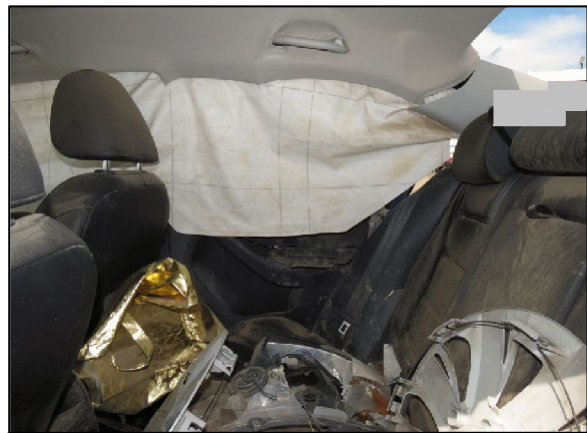
The IC air bags were located along the roof side rail inside the headliner and extended from the A-pillar to the C-pillar. The deflated left IC was 179 cm (70.5 in) wide and 45 cm (17.7 in) high and extended 21 cm (8.7 in) below the beltline. There was no gap between the front of the IC and the left A-pillar. Inspection of the IC revealed no discernable evidence of occupant contact and there was no crash-related damage to the IC. Emergency responders cut the top of the air bag from the C- pillar to the B-pillar. The deflated right IC (**Figure 8**) was 185 cm (72.8 in) long and 50 cm (19.7 in) high and extended 22 cm (8.7 in) below the beltline. There was no gap between

**Figure 8:** The Volkswagen's deflated right IC air bag in the second row

the front of the IC and right A-pillar. The air bag was very soiled from exposure to the elements at the salvage facility and there was no discernable evidence of occupant contact. The IC sustained no damage during the crash.
