DOT HS 812 939

# **Special Crash Investigations: On-Site Guardrail End Terminal Investigation; Vehicle: 2000 Toyota Tacoma; Location: Missouri; Crash Date: October 2017**

**Special Crash Investigations**  
**On-Site Guardrail End Terminal Investigation**  
**Case Number: IN17030**  
**Vehicle: 2000 Toyota Tacoma**  
**Location: Missouri**  
**Crash Date: October 2017**

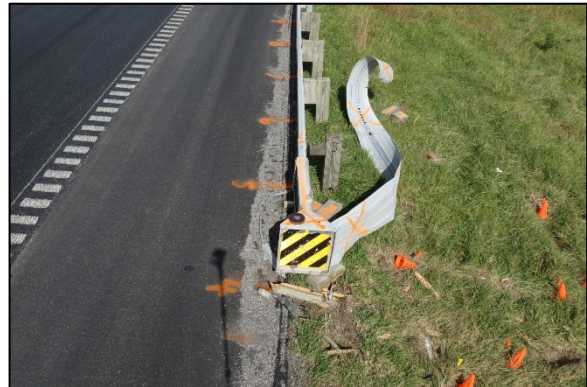
This report documents the on-site investigation of a pickup truck impact to an ET2000 guardrail end terminal (**Figure 1**) that is of interest to the Federal Highway Administration (FHWA). This crash was identified by an engineer with the Missouri Department of Transportation (MoDOT), who submitted images of the damaged end terminal and vehicle to the FHWA. The FHWA determined that the end terminal and crash type were of interest for further research. This crash investigation was then initiated by the National Highway Traffic Safety Administration in October 2017 and assigned to the Special Crash Investigation team at the Indiana University Transportation Research Center. This crash involved a 2000 Toyota Tacoma pickup truck (**Figure 2**), an unknown vehicle and an impact to a guardrail end terminal. The crash occurred in Missouri in October 2017 during daylight and was investigated by a local police agency. The guardrail, the crash scene, and the vehicle were inspected in October 2017.

**Figure 1.** The damaged end terminal and guardrail.

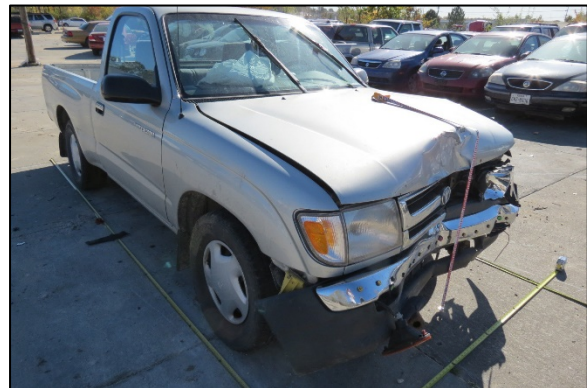
**Figure 2.** The damaged 2000 Toyota Tacoma.

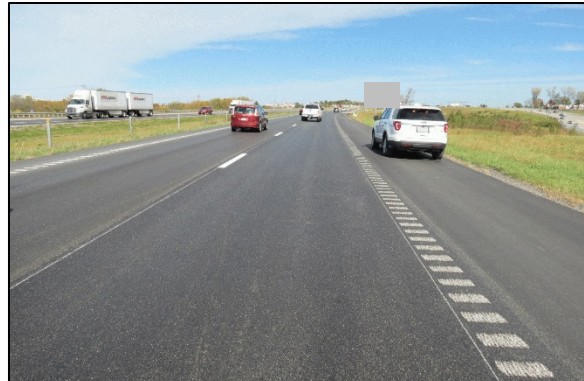
The Toyota was traveling north in the right northbound lane (**Figure 3**). The police crash report stated that the vehicle departed the right side of the roadway for an unknown reason. However, the SCI inspection of the Toyota revealed sideswipe damage to the left plane, indicating that a hit-and-run vehicle probably struck the left plane of the Toyota, resulting in the vehicle's departing the right side of the roadway. The police-reported measurements of the crash scene indicated that the Toyota departed the roadway 50.3 m (165.0 ft) prior to the ET2000. Tire marks found on the roadside during the SCI crash scene inspection indicated that the angle of the vehicle's approach

**Figure 3.** Northbound approach of the Toyota.

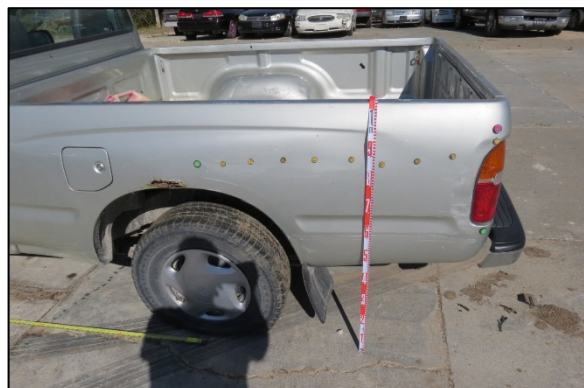
**Figure 4.** Sideswipe damage to the left side of the Toyota's truck bed.

The Toyota sustained sideswipe-type damage to the left side of the truck bed during the impact with a hit-and-run vehicle (Event 1). The direct damage began 7 cm (2.8 in) rear of the left rear axle and extended 93 cm (36.6 in) rearward. The Field L was also 93 cm (36.6 in). Crush measurements were taken at the mid-door level and the maximum residual crush was 1 cm (0.4 in) occurring 100 cm (39.4 in) rear of the right rear axle. The crush values were  $C_1 = 1$  cm (0.4 in),  $C_2 = 0$  cm,  $C_3 = 0$  cm,  $C_4 = 0$  cm,  $C_5 = 0$  cm, and  $C_6 = 0$  cm.

The Collision Deformation Classification (CDC) was 06LBMS1 (180 degrees). The severity of the damage was minor.

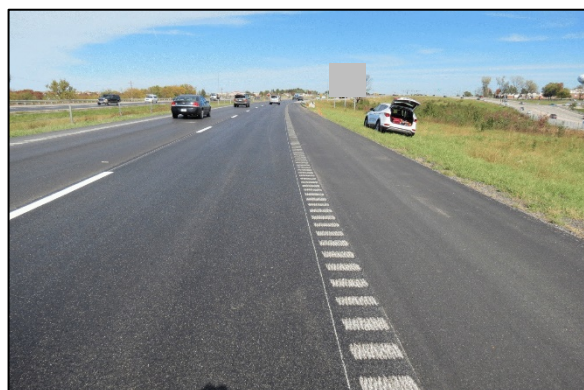
**Figure 5.** North-facing view of the area of the Toyota's roadway departure.

The left plane of the Toyota (**Figure 4**) was sideswiped by an unknown vehicle (Event 1). The impact resulted in the Toyota departing the right side of the roadway (**Figure 5**) where the front plane (**Figure 6**) struck the end terminal (**Figure 7**, event 2). The impact extruded 5.9 m (19.3 ft) of guardrail to the field side, fractured four wood posts, and damaged 15.2 m (50.0 ft) of guardrail. The force direction on the vehicle was in the 12 o'clock sector and the impact resulted in deployment of both frontal air bags. The impact speed is not known and WinSMASH could not be used to calculate delta V since an impact with a yielding object is out of scope for the program. However, WinSMASH was used to calculate a barrier equivalent speed (BES) of 34 km/h (21 mph) based on the crush to the front plane. The vehicle came to final rest on the field side of the guardrail heading southeast after traveling 9.2 m (30.2 ft) from the impact and rotating counterclockwise 245 degrees.

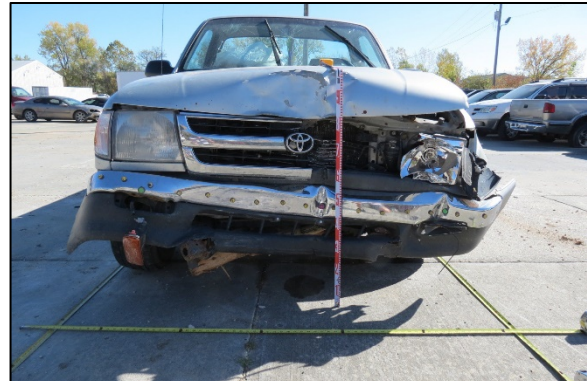
**Figure 6.** Damage to the front plane of the Toyota from the impact with the end terminal.

The front plane sustained direct and induced damage during the impact with the end terminal and guardrail. The direct damage began 17 cm (6.7 in) right of the left bumper corner and extended 117 cm (46.1 in) to the right across the front plane. The Field L was 148 cm (58.3 in). The edges of the end terminal were stamped into the bumper and the direct damage length from the end terminal was 50 cm (19.6 in) beginning at the same location. Crush measurements were

The CDC was 12FDEW2 (0 degree). The severity of the damage was moderate.

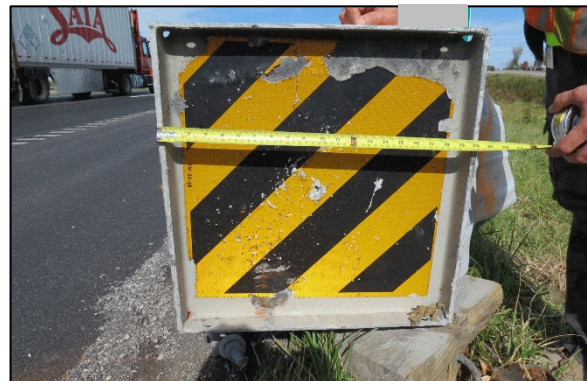
The front-plane impact of the Toyota to the end terminal extruded 5.9 m (19.3 ft) of guardrail to the field side. The direct damage involved the full height and width [52 cm (20.5 in) and 51 cm (20.1 in)] of the face of the end terminal. Posts 1 to 8 were constructed of wood and had wood offset blocks with the exception of post 1. The remaining posts were constructed of steel and had steel offset blocks. Posts 1 to 4 were fractured and displaced. Post 5 was slightly damaged and the bolt was pulled through the guardrail. The wooden offset block for post 6 was slightly displaced and the guardrail remained bolted to the post. The remaining posts were undamaged. The crash damaged 15.2 m (50.0 ft) of guardrail. The feeder channel width at the impact head was 13 cm (5.0) wide. The guide chute exit height was 38 cm (15.0 in). The connection of the feeder channel to the head was undamaged and no welds were broken. The anchor cable was disconnected and was found near post 5. There were no kinks in the guardrail. The FHWA guardrail form is attached to the end of this report as **Appendix A**.

**Figure 7.** The damaged end terminal.

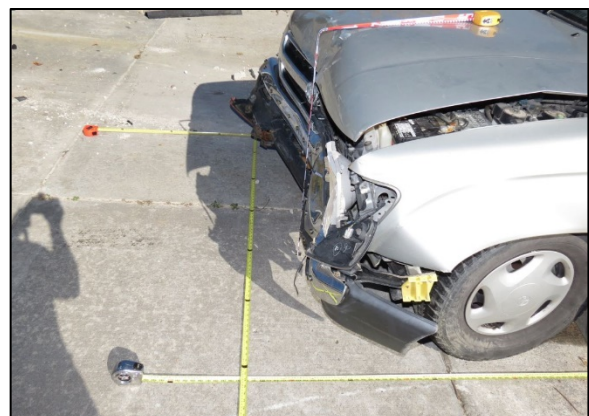
**Figure 8.** Left lateral view depicting the crush of the Toyota.

taken at the bumper level. The residual crush profile (**Figure 8**) was C1 = 3 cm (1.3 in), C2 = 15 cm (5.9 in), C3 = 27 cm (10.6 in), C4 = 25 cm (9.8 in), C5 = 9 cm (3.5 in), and C6 = 0. The maximum residual crush was 27 cm (10.6 in) occurring 10 cm (3.9 in) left of the vehicle's centerline. A portion of a fractured wood post remained engaged to the undercarriage below the level of the bumper.

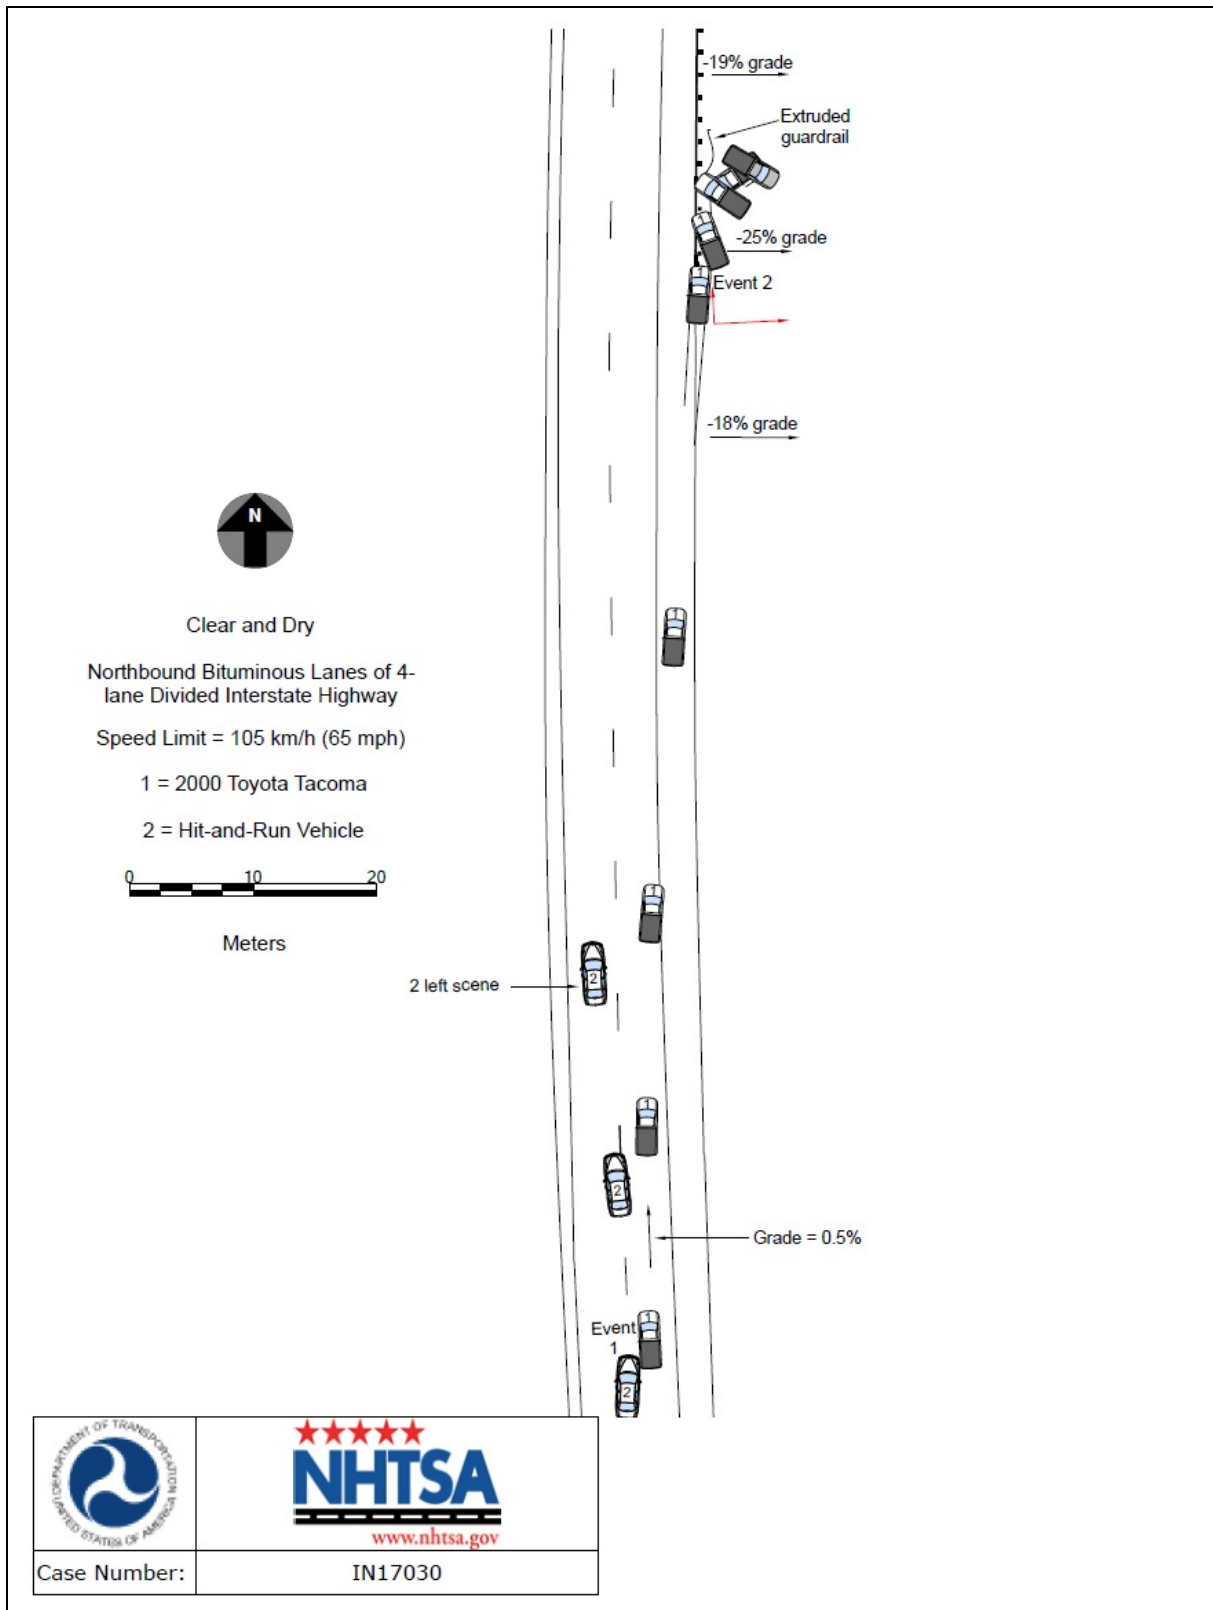
# CRASH DIAGRAM

This crash occurred during daylight on the east side of the northbound lanes of a curved, four-lane, divided State highway. The weather conditions at the time of the crash were clear visibility, north-northeast winds at 24 km/h (15 mph), a temperature of 11.1 °C (52 °F), and a dew point of 5.0 °C (41 °F), according to local weather reports. The highway traversed in a north/south direction and had two bituminous through lanes in each direction that were divided by a grass median with a guardrail median barrier. The northbound roadway was bordered by a 1.0 m (3.3 ft) wide bituminous median shoulder and a 2.9 m (9.5 ft) wide bituminous right shoulder. The right northbound lane was 3.9 m (12.8 ft) wide and the left northbound lane was 4.1 m (13.4 ft) wide. The northbound roadway was curved to the right and had a calculated radius of curvature of 1,412 m (4,631.4 ft). The travel lanes were bordered by rumble strips and the two travel lanes were separated by broken white pavement markings. A blocked-out W-beam guardrail equipped with an ET2000 end terminal was located on the right side of the road adjacent to the shoulder. The speed limit was 105 km/h (65 mph). A crash diagram is included at the end of this report on page 9.
