DOT HS 812 941

**Special Crash Investigations:  
On-Site Guardrail End Terminal  
Investigation;  
Vehicle: 2005 Nissan Maxima;  
Location: Missouri;  
Crash Date: August 2017**

**Special Crash Investigation  
On-Site Guardrail End Terminal Investigation  
Case Number: IN17026  
Vehicle: 2005 Nissan Maxima  
Location: Missouri  
Crash Date: August 2017**

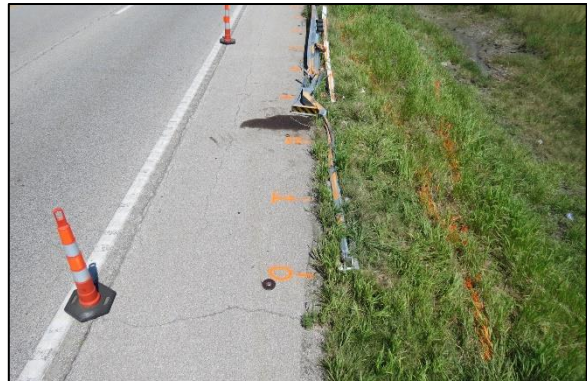
This report documents the investigation of the crash of a passenger vehicle to a Soft Stop guardrail end terminal (**Figure 1**) that is of interest to the Federal Highway Administration (FHWA). This crash was identified by an engineer with the Missouri Department of Transportation (MoDOT), who submitted photographs of the damaged end terminal to the FHWA. The FHWA determined that the guardrail end terminal and crash type were of interest. This crash investigation was then initiated by the National Highway Traffic Safety Administration in August 2017 and assigned to the Special Crash Investigation (SCI) team at the Indiana University Transportation Research Center. This single-vehicle crash involved a 2005 Nissan Maxima (**Figure 2**). The crash occurred in Missouri in August 2017 during the afternoon hours and was investigated by a local police agency. The guardrail, crash scene, and vehicle were inspected in August 2017.

**Figure 1.** Overhead view of the damaged end terminal and guardrail, view north.

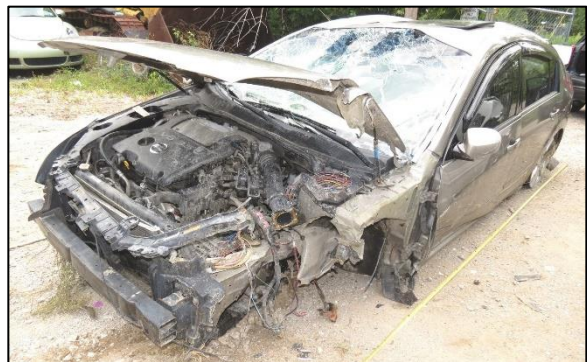
**Figure 2.** The damaged 2005 Nissan Maxima.

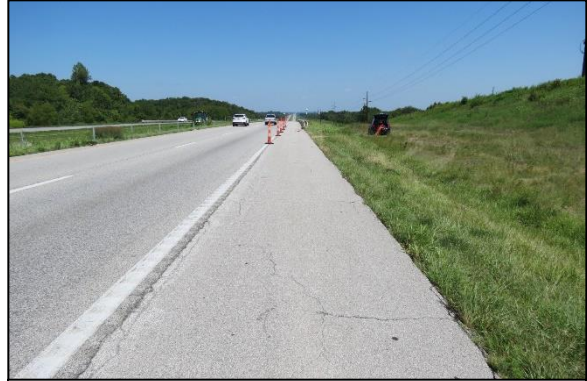
The Nissan was traveling in the right northbound lane at a driver-estimated speed of 105 to 113 km/h (65 to 70 mph). The vehicle drifted slightly into the left lane, then back to the right lane and departed the travel lane onto the east shoulder. The Nissan traversed the shoulder and the right side tires entered the grass roadside (**Figure 3**). The path of the vehicle's right side tires was found during the SCI crash scene inspection in the grass adjacent to the right shoulder. The rotating tire marks began 28.9 m (94.8 ft) prior to the Soft Stop end terminal. Projecting the path of the tire mark back along the approach of the vehicle indicated that the vehicle departed the roadway approximately 84 m (276 ft) prior to the end terminal. The witnesses reported seeing no brake lights on the vehicle prior to the impact. The driver admitted to police that he was under the influence of inhalants (unspecified type).

**Figure 3.** Northbound approach of the Nissan to the end terminal.

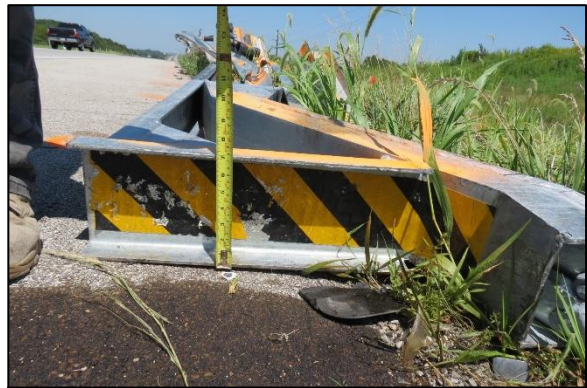
**Figure 4.** The damaged end terminal, view north.

The front plane of the Nissan struck the guardrail terminal (**Figure 4**, Event 1). The impact occurred at the left corner of the vehicle's front plane outboard of the bumper beam and left frame rail. Vehicle components involved in the crash were the left fender, hood, inner fender support, left front tire and wheel, suspension, and the drive axle. The left front wheel, strut, and axle assembly were fractured and displaced from the vehicle as result (**Figure 5**). The crash displaced six posts and extruded 3.8 m (12.5 ft) of guardrail from the end terminal. The force direction on the vehicle was in the 12 o'clock sector and the impact resulted in deployment of the driver's frontal air bag. The WinSMASH program could not be used to calculate delta V since an impact with a yielding object is out of scope for the program. A barrier equivalent speed could not be calculated because there was no crush to the bumper beam and the crash involved front, side, and undercarriage components. The severity of the damage was moderate based on the extent of damage to the vehicle.

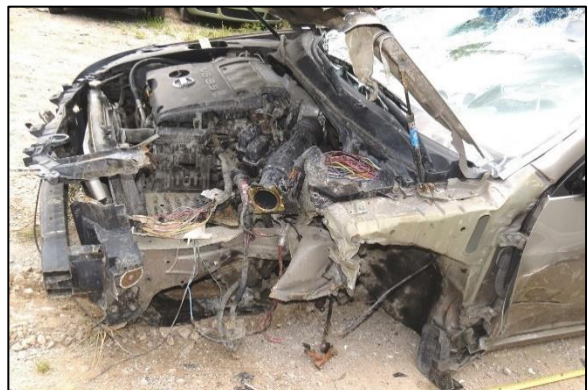
**Figure 5.** Damage to the Nissan from the impact with the end terminal.

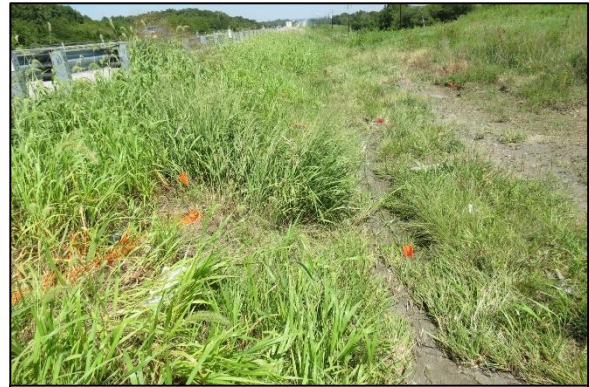
**Figure 6.** The area where the Nissan tripped and rolled over, view north.

The vehicle rotated approximately 60 degrees CCW onto the negative slope of the roadside and tripped into a right-side-leading rollover (Event 4/**Figure 6**). The Nissan rolled four quarter turns across a distance of approximately 20 m (66 ft), coming to final rest on its wheels facing northwest. The front right-seat-mounted side impact and right IC air bags deployed during the rollover.

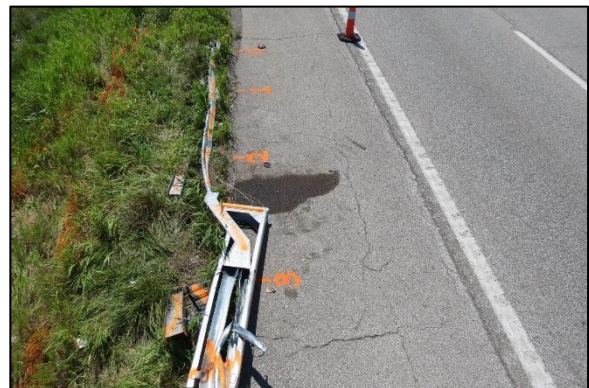
**Figure 7.** Extruded guardrail from the end terminal, view south.

The Nissan's front plane impact to the end terminal extruded 3.8 m (12.5 ft) of guardrail (**Figure 7**) and damaged six posts (**Figures 7 and 8**). The full height and width, 72.0 x 18.0 cm (28.3 x 7.1 in), of the face of the Soft Stop was directly damaged. The guardrail remained attached to the anchor at post zero and was displaced from posts 1 to 6. Posts 1 and 2 fractured and separated at the pre-drilled holes and were displaced downstream to the ground. Post 2 typically is equipped with a composite offset block; however, one was not located at the crash scene. Post 3 was bent downstream approximately 70 degrees from vertical and the bolt pulled through the guardrail. The post was slightly twisted toward the traffic side and the composite offset block was damaged and separated from the post. Post 4 was bent downstream approximately 45 degrees from vertical and the bolt pulled through the guardrail. The post was twisted toward the traffic side and the composite offset block remained attached to the post. Post 5 was bent downstream approximately 25 degrees from vertical and the bolt pulled through the guardrail. The post was twisted toward the traffic side. The composite offset block remained attached to the post and was undamaged. Post 6 was bent downstream approximately 30 degrees from vertical and the bolt pulled through the guardrail. The composite offset block was damaged and separated from the post. The guardrail was not kinked but an approximate 109 cm (42.9 in) long middle section of the guardrail was sliced when it contacted the cross-brace at the entrance to the feeder channel (**Figure 9**). The guide chute exit height was 13.8 cm (5.5 in). The connection to the feeder channel was not damaged. The height of the guardrail was 78.7 cm (31.0 in). The total length of damaged guardrail was 15.2 m (50.0 ft). The FHWA guardrail form is attached at the end of this report as **Appendix A**.

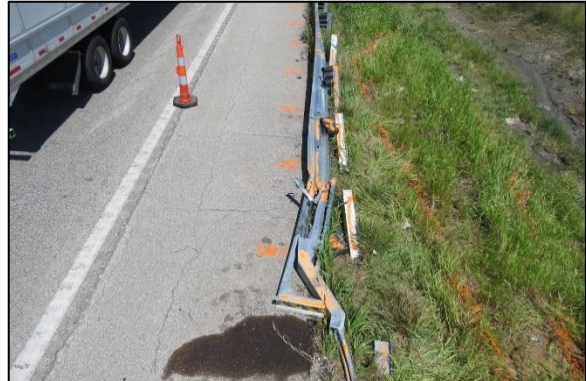
**Figure 8.** Damaged posts and guardrail, view north.

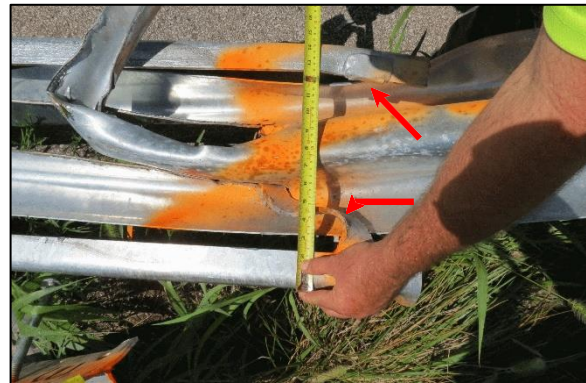
**Figure 9.** Sliced section of the guardrail and fractured cross-brace (arrows) at the entrance to the feeder channel.

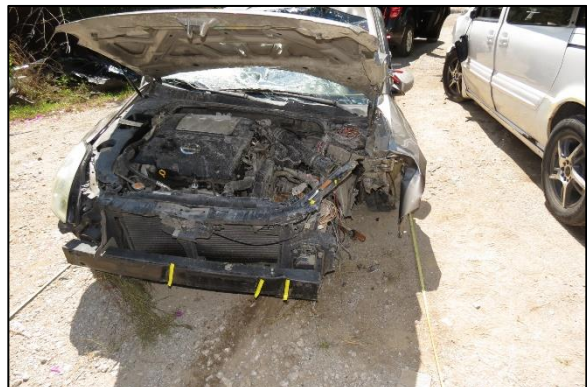
***Exterior Damage Event 1:*** The Nissan (**Figure 10**) sustained direct and induced damage to the front plane during the impact with the end terminal. The initial engagement with the end terminal occurred at the left corner of the front plane resulting in a direct damage width of 20 cm (7.9 in) on the bumper fascia. The impact was located outboard of the bumper beam and the engagement with the end terminal involved the left front fender, hood, and left front tire and wheel resulting in fracture and displacement of the wheel, strut, and axle assembly from the vehicle. During the crash, a loose component of the guardrail system (possible offset block) struck and fractured the right aspect of the Nissan's windshield. The Collision Deformation Classification (CDC) was 12FLEE6 (0 degrees). The severity of the damage was moderate based on the fracture and displacement of the left-front wheel, strut, and axle assembly from the vehicle.

***Exterior Damage Event 2 and 3:*** The front plane struck two posts as the guardrail was deformed.

The post impacts dented the bumper beam directly forward of the left frame rail and immediately right of the Nissan's centerline resulting in a total length of direct contact of 75 cm (29.5 in). Although crush measurements were taken on the bumper beam, there was no residual crush. The CDC for the post impacts were 12FLEN1 and 12FCEN1.

**Figure 10.** Front view of the Nissan depicting the damage of Events 1 to 3.

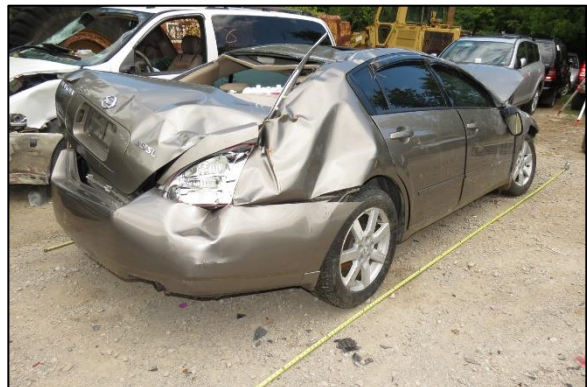
**Figure 11.** Right-rear oblique view depicting the Event 4 rollover damage.

*Exterior Damage Event 4:* The right, top, and left planes sustained direct and induced damage during the four-quarter turn rollover (**Figure 11**). The roof and right trunk area of the vehicle sustained the primary crush during the rollover. The maximum vertical crush was 10 cm (3.9 in) occurring to the roof immediately forward of the right C-pillar. The maximum lateral crush was 3 cm (1.2 in) occurring to the right roof-side rail in the mid-right front door area. The CDC was 00TDDO3. The severity of the damage was moderate.

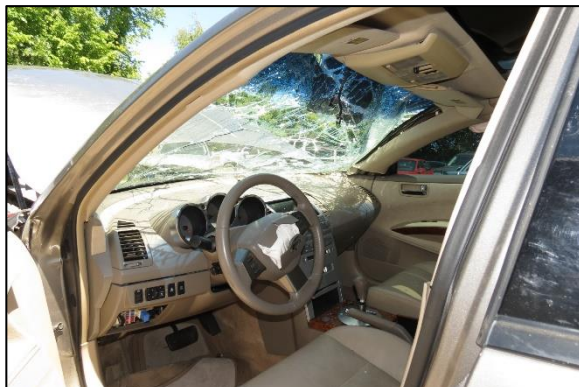
The interior of the Nissan (**Figures 12 and 13**) sustained minor damage from intrusion of the roof. The most severe roof intrusion was approximately 10 cm (3.9 in) occurring in the second row right seating position. The right front and right rear doors were jammed shut. The left front and left rear doors remained closed and operational. The right aspect of the windshield was cracked from exterior impact forces and contact from an unknown object (possible offset block). The right A-pillar trim was scuffed on the forward aspect, but this was not considered an occupant contact. The backlight was disintegrated from impact forces. The remaining glazing, inclusive of the sunroof, was undamaged.

**Figure 12.** Left interior view of the Nissan.

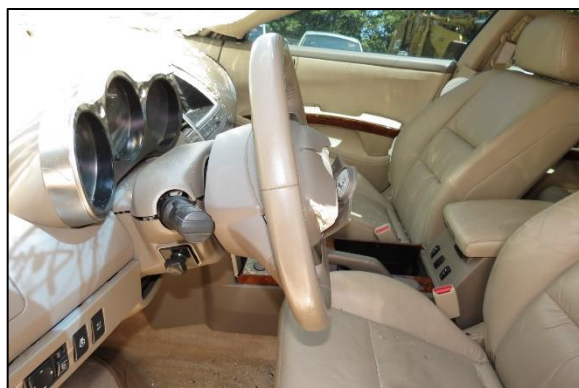
**Figure 13.** Left lateral view of the steering wheel rim.
