DOT HS 812 955

**Special Crash Investigations:  
Child Restraint System Crash  
Investigation;  
Vehicle: 2006 Honda CR-V;  
Location: Oregon;  
Crash Date: December 2017**

**Special Crash Investigations  
Child Restraint System Crash Investigation  
Case Number: DS18001  
Vehicle: 2006 Honda CR-V  
Location: Oregon  
Crash Date: December 2017**

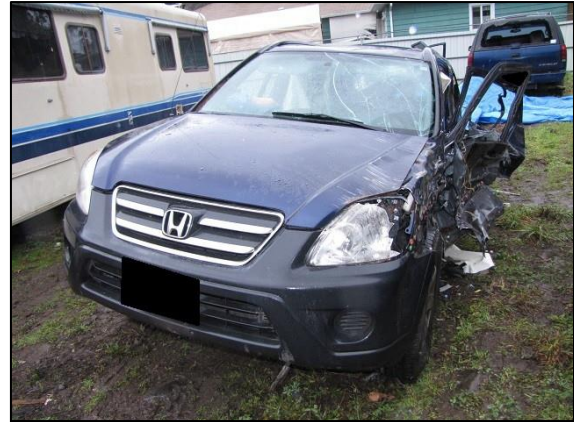
**Figure 1.** The 2006 Honda CR-V.

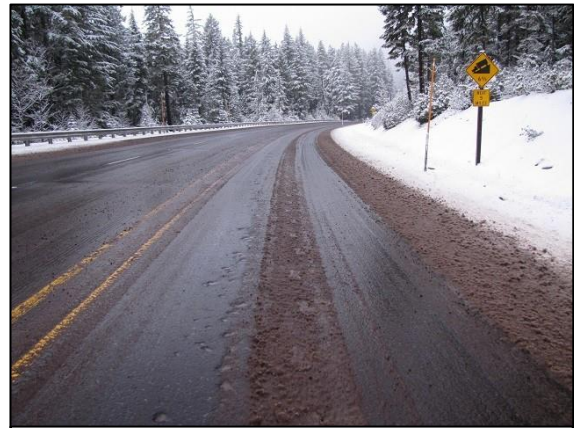
The crash occurred on an east/west, three-lane State highway in rural Oregon (**Figure 2**). The roadway was paved with asphalt in fair condition. The roadway was configured with one westbound and two eastbound lanes each measuring 3.7 m (12.0 ft) in width. The westbound lane was bordered by a double solid yellow painted stripe on the left, and a solid white painted fog line on the right. The eastbound lanes were separated by a dashed white painted stripe and bordered by a double solid yellow painted stripe on the left, and a solid white painted fog line on the right. On the south side a metal and wood guardrail followed the curvature of the roadway. Traveling westbound, the roadway curved right in a radius measuring 402.5 m (1,320.5 ft) at the north fog line. At the area of impact, the roadway slope measured -0.9 percent traveling west and the superelevation measured -5.5 percent.

**Figure 2.** The crash site looking west.

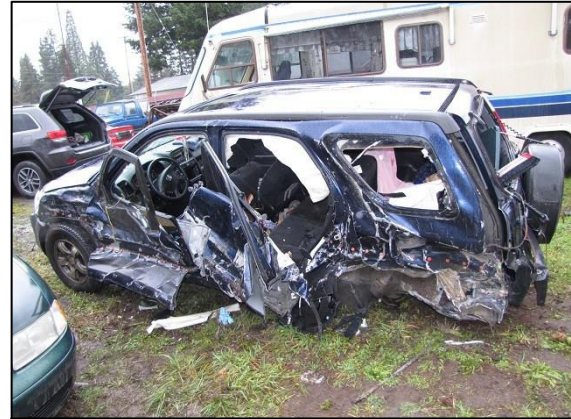
The crash included one vehicle-to-vehicle impact causing direct damage to the left plane. Direct damage began at the front left bumper corner extending 385 cm (151.6 in) rearward and ending at the left rear bumper corner. The Field L was distributed over the same distance. Thirty-three measurements were taken at mid-door level (**Figure 3**) by the Nikon Total Station and the Faro Blitz program computed six crush measurements as follows:  $C_1 = 4$  cm (1.6 in),  $C_2 = 16$  cm (6.3 in),  $C_3 = 2$  cm (0.8 in),  $C_4 = 10$  cm (3.9 in),  $C_5 = 0$  cm, and  $C_6 = 0$  cm. The estimated Principal Direction of Force (PDOF) was 350 degrees, and the Collision Deformation Classification (CDC) for the Honda in Event 1 was 12LDAW2.

**Figure 3.** Left plane damage, the 2006 Honda CR-V.

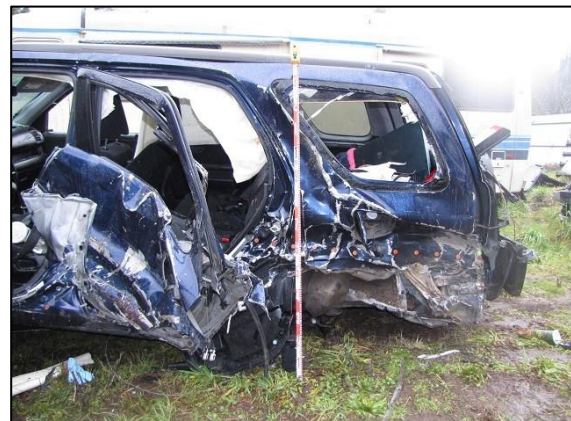
This crash involved two vehicles having mismatched heights. The Dodge had a front bumper height of 63 cm (24.8 in) and beltline height of 130 cm (51.1 in). The Honda had a bumper height of 49 cm (19.3 in) and a beltline height of 90 cm (35.4 in). Direct damage to the front plane of the Dodge extended vertically from the bumper to the forward aspect of the hood. Corresponding damage to the Honda's left plane extended vertically from the sill to above the beltline and induced damage extended vertically to the upper left C-pillar (**Figure 4**).

**Figure 4.** Vertical damage measurement, the 2006 Honda CR-V.

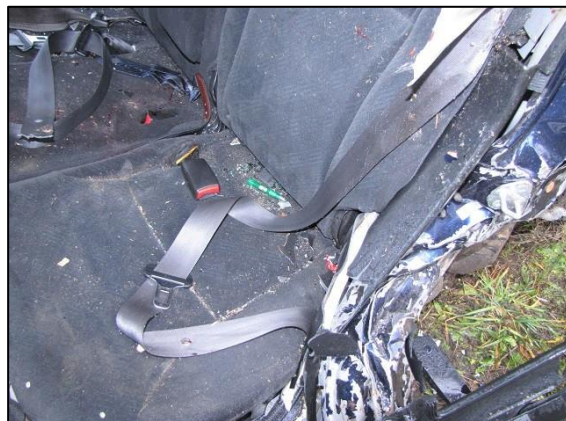
**Figure 5.** Seat belt, second-row left seat position, the 2006 Honda CR-V.

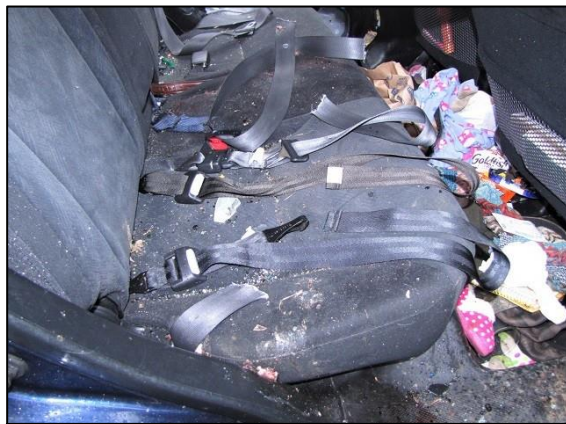
**Figure 6.** Seat belt and LATCH, second-row right seat position, the 2006 Honda CR-V.

responders during post-crash activities. A cut section of belt remained threaded through the latch plate that was still inserted into the buckle. This seat position was configured with LATCH. The lower anchor connector from a CRS was inserted in the left LATCH lower anchor and a tether strap was inserted in the right anchor (**Figure 6**). CRS and LATCH usage are discussed in greater detail in the CRS discussion of this report.

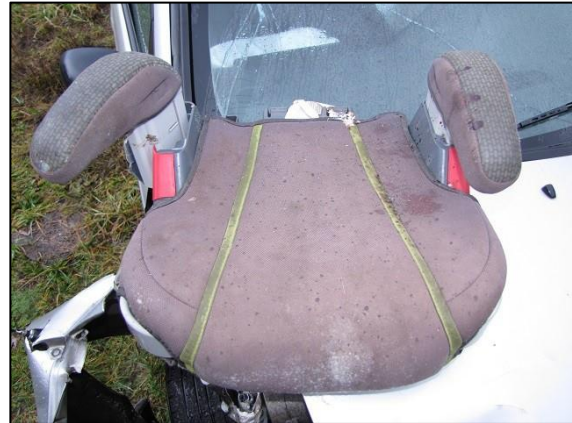
Graco TurboBooster Backless Booster Seat (BSS): The 7-year-old male occupant was restrained in a Graco TurboBooster BSS (**Figure 7**) used in combination with the vehicle's lap and shoulder seat belt. The BSS was placed forward-facing on the seat cushion in the second row left seat position. The model

The occupant using the BSS booster seat met the age, weight, and height requirements. The vehicle's second-row seat position was configured with an adjustable head restraint that was in place and set in the lowest position at the time of the inspection. The seat cushion revealed body fluid deposits. The seating area of the shell was not damaged. The shell was fractured where the right armrest was inserted into it and the right armrest was deformed outward at a 45-degree angle. This damage was likely caused at impact of the other vehicle when the occupant was displaced to the right loading the armrest.

**Figure 7.** Graco TurboBooster CRS, the 2006 Honda CR-V.

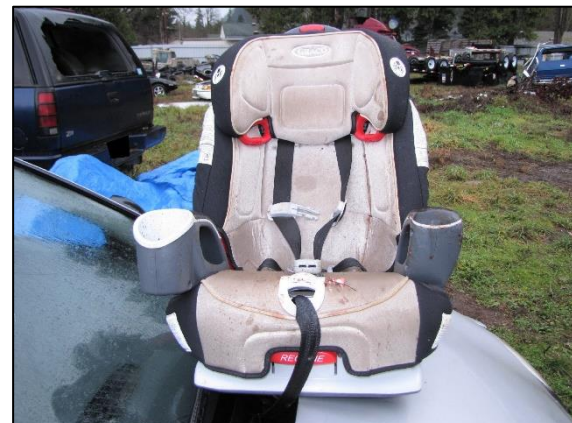
The Graco (**Figure 8**) was configured with a removable back support, removable padded seat cushion, headrest height adjustment, 5-point harness system, recline adjustment, armrests, cup holder, shoulder belt guide, vehicle belt guide and LATCH. The CRS user manual states all the following parameters should be met when using it with the back support and harness system.

**Figure 8.** Graco Nautilus CRS, the 2006 Honda CR-V.

This CRS appeared to have been installed using the LATCH system and possibly in combination with the vehicle's lap and shoulder seat belt. At the time of the inspection, the lower left anchor strap was attached to the left LATCH anchor and the upper tether strap was attached to the right LATCH anchor. The seat belt for this seat position was buckled and the webbing was cut in two places. The CRS user manual states that either LATCH anchors or a lap and shoulder seat belt can be used for installation. The upper tether anchors in the Honda are located on the roof header in the cargo area behind the second row. Given the placement of the LATCH components and the buckled status of the seat belt, it was determined that the CRS was installed using both systems.

The headrest was adjusted to the lowest position. The harness system was intact and appeared to be unremarkable. The seat cushion, shell, and other components revealed body fluid deposits. The shell was not damaged. The LATCH straps had been cut from the CRS by responders during post-crash activities. The harness system remained in place and appeared unremarkable. A NHTSA recall for Graco safety seats included this CRS. An online news article stated the voluntary recall affects harness buckles used on all Graco toddler convertible car seats and harnessed booster seats manufactured from 2009 to July 2013. At issue was the red release button in the center of the harness, which NHTSA said can become difficult to unlatch, or can become stuck. That can make it difficult or impossible to remove the child quickly in an emergency. Graco explained that it found that food and dried liquids can make some harness buckles progressively more difficult to open over time or become stuck in the latched position. It is unknown whether this harness buckle had been replaced in response to the recall.

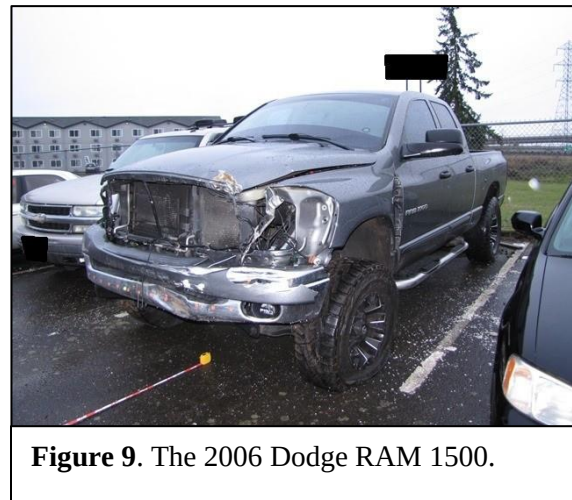
The crash included one vehicle-to-vehicle impact causing direct damage to the front plane (**Figure 9**). Direct damage began at the front left bumper corner extending 110 cm (43.3 in) to the right. The front grille and both headlamp assemblies were displaced during the crash. Direct damage extended vertically from the bumper to the leading edge of the hood and measured 67 cm (26.4 in). The Field L was distributed from bumper corner to bumper corner and measured 180 cm (70.9 in). Twenty-one measurements were taken at bumper level by the Nikon Total Station and the Faro Blitz program computed crush measurement in six increments as follows:  $C_1 = 6$  cm (2.4 in),  $C_2 = 2$  cm (0.8 in),  $C_3 = 7$  cm (2.8 in),  $C_4 = 1$  cm (0.4 in),  $C_5 = 1$  cm (0.4 in), and  $C_6 = 0$  cm. The estimated PDOF was 50 degrees and the CDC for the Dodge in Event 1 was 02FYEW1.

**Figure 9.** The 2006 Dodge RAM 1500.

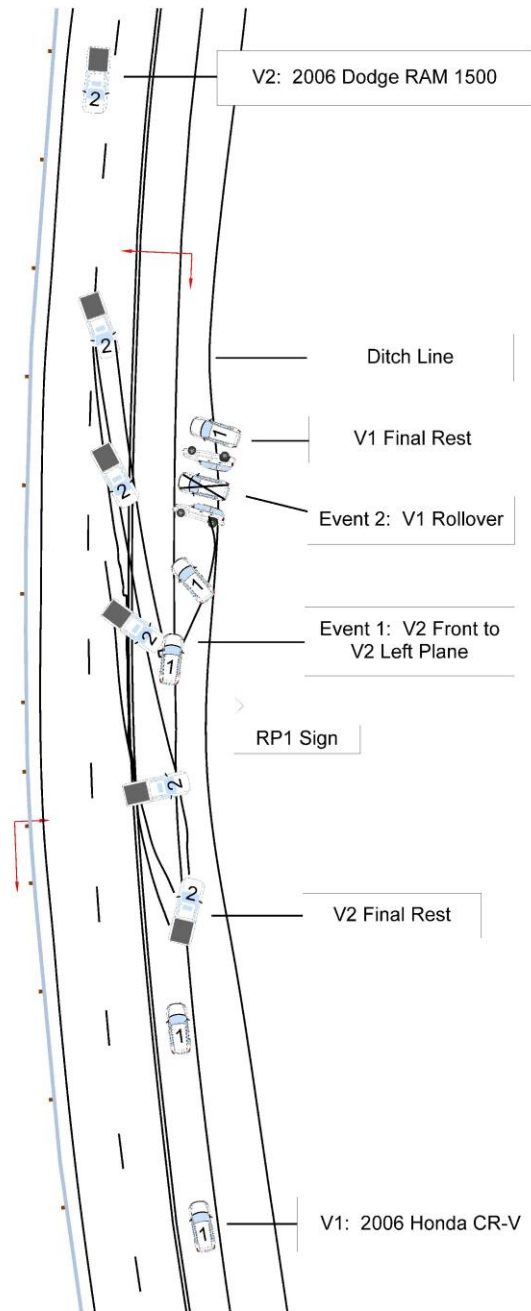
## CRASH DIAGRAM

Child Restraint System  
 Crash Investigation  
 December 2017  
 Oregon  
 State Highway  
 Conditions: Dark, Clear & Wet  
 V1: 2006 Honda CR-V  
 V2: 2006 Dodge RAM 1500  
 Speed Limit: 89 km/h (55 mph)  
 (Police measurements were used to depict scene)
