U.S. Department
of Transportation

**National Highway
Traffic Safety
Administration**

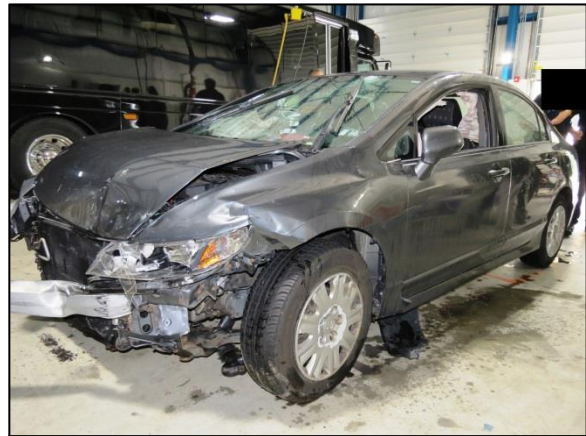
Figure 1. Front-left oblique view of the 2009 Honda Civic at the time of the SCI vehicle inspection.

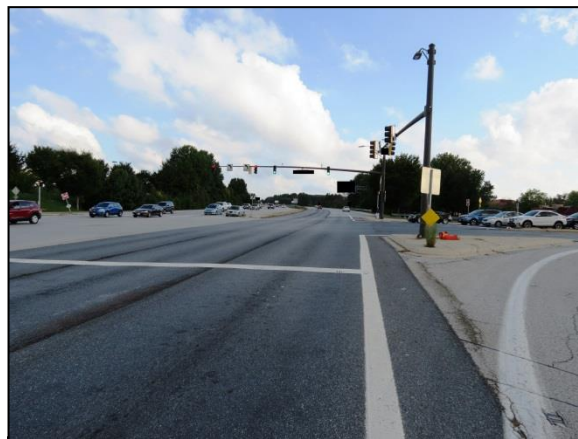
Figure 2. East-facing trajectory view of the roadway in the vicinity of the crash.

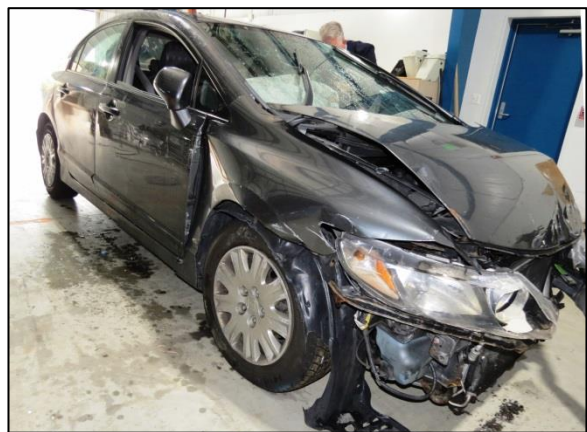
Figure 4. Front-right oblique view of the 2009 Honda Civic at the time of the SCI vehicle inspection.

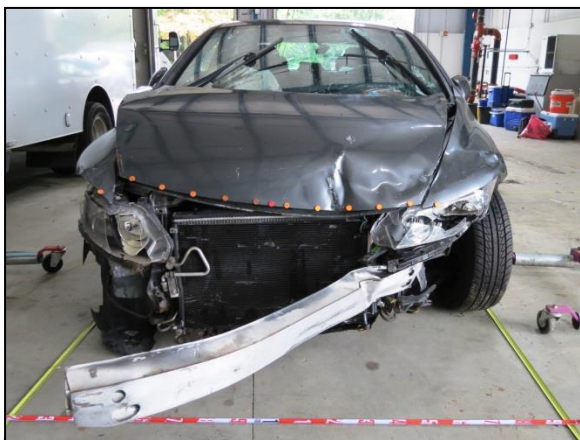
Figure 5. Frontal damage pattern to the 2009 Honda Civic sedan.

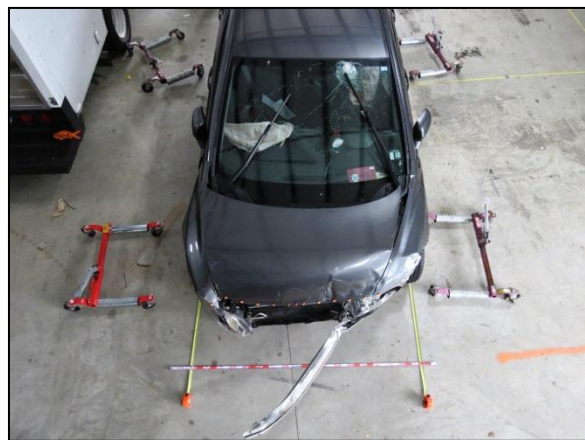
Figure 6. Overhead view of the frontal damage profile to the 2009 Honda Civic.

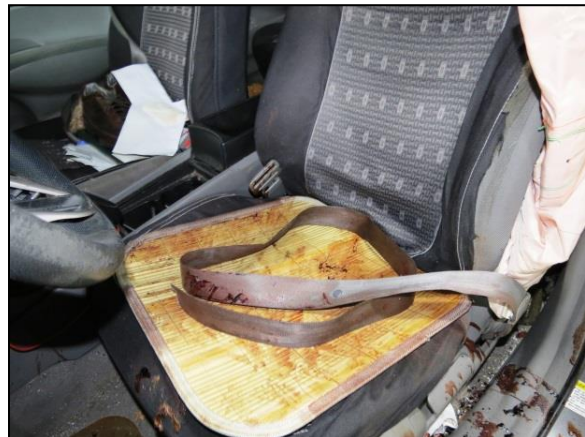
Figure 7. Driver's 3-point lap and shoulder seat belt system in the 2009 Honda Civic.

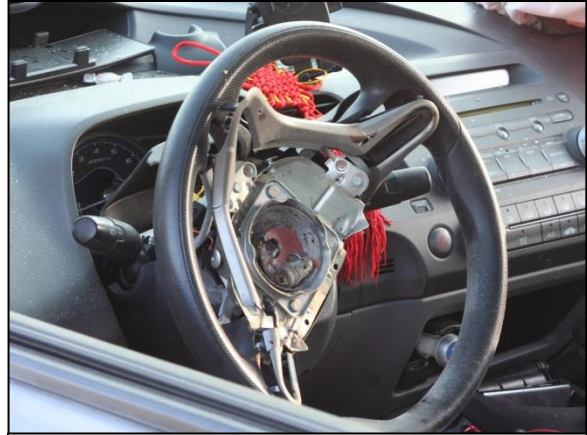
Figure 9. View of the Honda's steering wheel hub, missing components of the driver's frontal air bag module (on-scene law enforcement image).

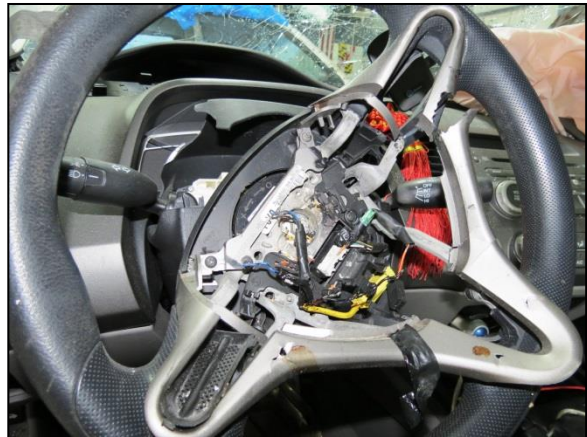
Figure 10. View of the Honda's steering wheel hub at the time of SCI inspection, evidentiary of prior removal of remaining air bag module components.

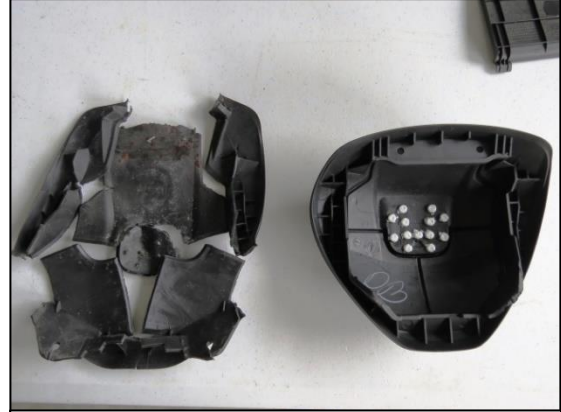
Figure 12. Characteristics of the involved cover flap/fascia (left) did not match those of a genuine component (right).

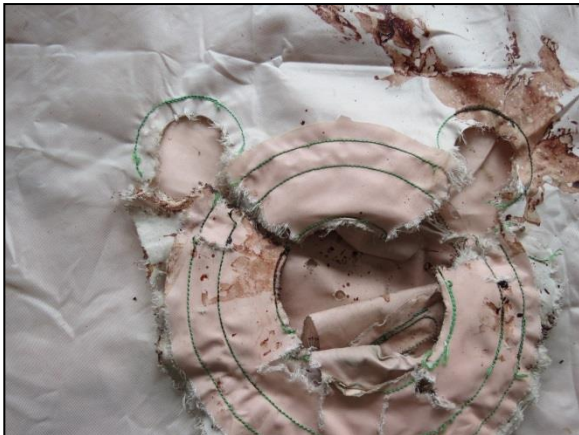
Figure 13. View of the rear aspect of the Honda's air bag and the tears in its fabric associated with its complete separation from the assembled module during the crash.

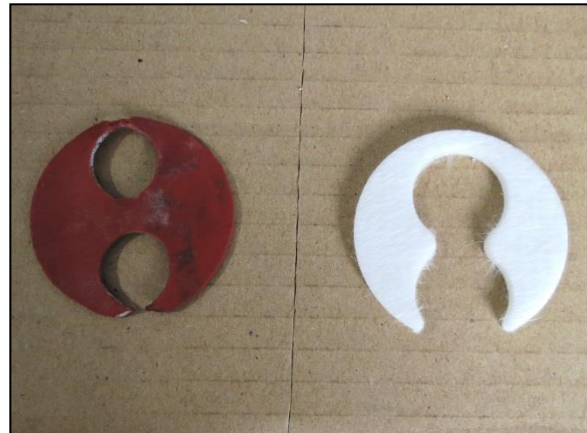
Figure 15. The involved Honda's cushioning piece (left) was an entirely different material and shape than the manufacturer component (right).

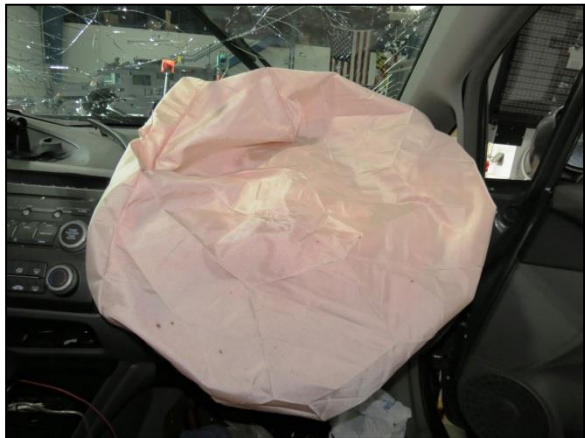
Figure 19. Deployed passenger’s frontal air bag in the 2009 Honda Civic.

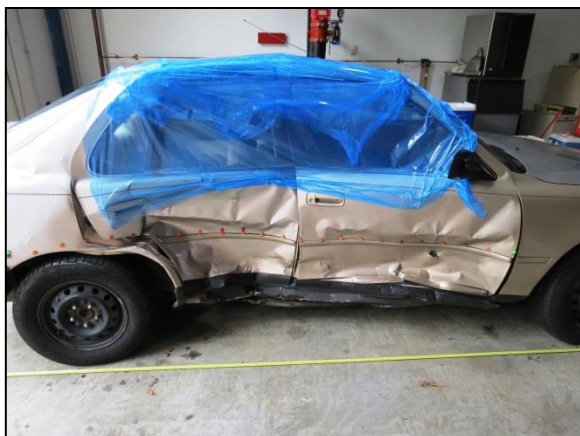
Figure 21. Right-plane damage pattern to the 1995 Toyota Camry.

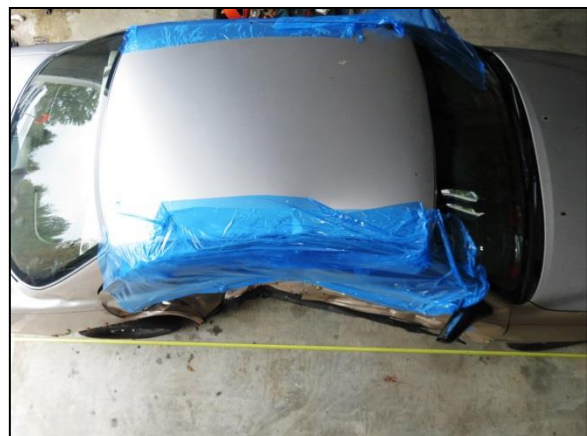
Figure 22. Overhead view of the right-plane damage profile to the 1995 Toyota Camry.
