DOT HS 813 012

July 2021

# **Special Crash Investigations: Remote Vehicle Fire/Child Restraint System Investigation; Vehicle: 2006 Chrysler Pacifica; Location: Missouri; Crash Date: March 2015**

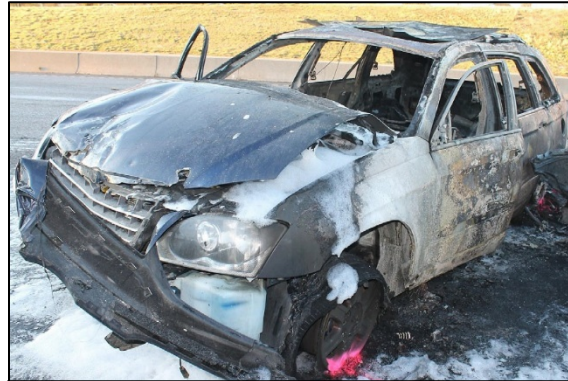
This report documents the remote vehicle fire/child restraint system (CRS) investigation of a post-crash fire in a 2006 Chrysler Pacifica (**Figure 1**) involved in a two-vehicle crash and the child occupants of the Chrysler who were seated in CRSs. The investigation is intended to determine the events leading to the fire, how quickly the fire spread to the occupant compartment, the magnitude of the fire, how quickly EMS and other responders arrived on-scene, occupant restraint usage, demographics, injury data, and CRS data. The crash was identified during a review of Fatality Analysis Reporting System (FARS) crash reports. The

**Figure 1.** 2006 Chrysler Pacifica (police image).

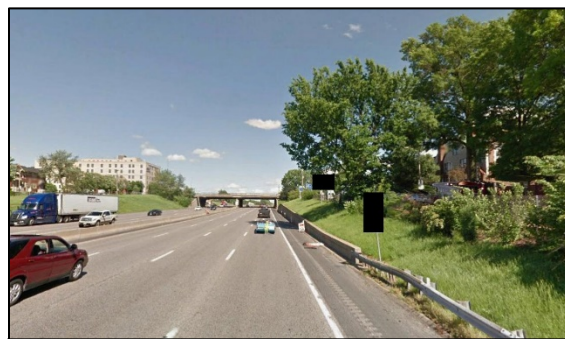
The crash site was in the eastbound lanes of a divided interstate highway (**Figure 2**). The asphalt roadway was straight and configured with four travel lanes in each direction. The travel lanes were separated by dashed white lines. The roadway was bordered on the right by a white fog line, a rumble strip, an asphalt shoulder, and a concrete wall. It was bordered on the left by a yellow fog line, an asphalt shoulder, and a concrete median barrier. The posted speed limit was 96 km/h (60 mph). The weather at the nearest reporting station was clear visibility, temperature of 27 degrees C (82 degrees F), 11 percent humidity, scattered clouds, and winds were out of the east southeast at 14 km/h (8.9 mph). A crash diagram is included at the end of this report.

**Figure 2.** Approach to area of impact, looking east (Google image).

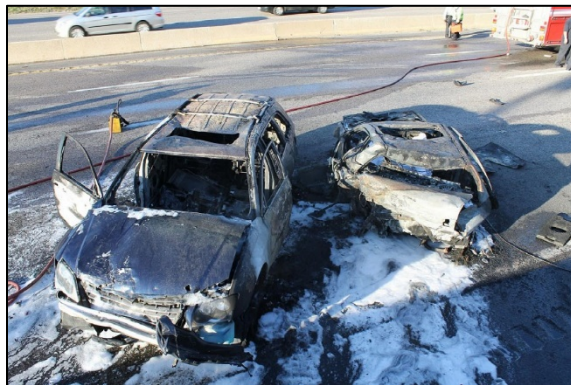
The Honda continued the rotation as it traveled east before coming to rest facing north approximately 34 m (110 ft) east of the initial point of impact. The Chrysler began a clockwise rotation and continued eastbound before coming to rest facing south 30 m (100 ft) east of the point of impact (**Figure 3**). Both vehicles caught fire (Events 3 and 4).

**Figure 3.** 2006 Chrysler Pacifica (left), 2002 Honda Accord (right), looking north (police photo).

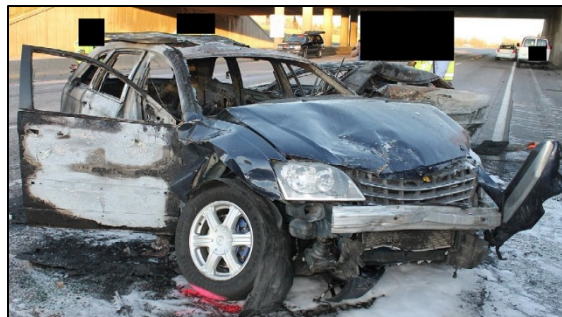
The Chrysler sustained moderate frontal damage from the rear-end impact with the Honda (**Figure 4**). The direct damage began at the right front bumper corner and extended approximately half-way across the frontal plane. The estimated Collision Deformation Classification (CDC) was 12FZEW2. Shortly after the vehicle came to rest, the fire from the other vehicle spread to this vehicle. The fire covered two-thirds of the exterior from the rear forward and entirely consumed the vehicle passenger compartment.

**Figure 4.** 2006 Chrysler Pacifica (police image).

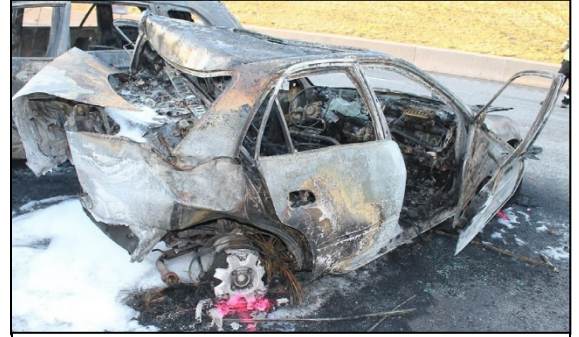
The Honda sustained severe damage to the rear plane from the impact with the front plane of the Chrysler (**Figure 5**). The estimated CDC was 06BYEW6. The Honda contacted the concrete wall with its left front during rotation (Event 2). The direct damage from this impact was obscured by fire damage. The gasoline tank was compromised during the crash and a fire ensued, consuming the entire vehicle.

**Figure 5.** 2002 Honda Accord (police image).
