DOT HS 813 019

**Special Crash Investigations:
Alleged Air Bag Inflator Rupture
Investigation;
Vehicle: 2002 Chrysler PT Cruiser;
Location: California;
Crash Date: January 2019**

Special Crash Investigations
Alleged Air Bag Inflator Rupture Investigation
Office of Defects Investigation
Case Number: DS19006
Vehicle: 2002 Chrysler PT Cruiser
Location: California
Crash Date: January 2019

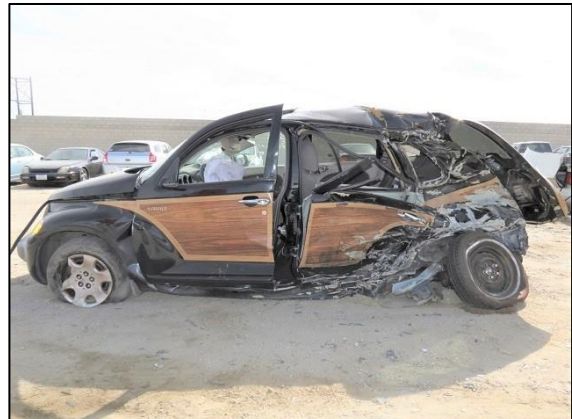
Figure 1. The 2002 Chrysler PT Cruiser.

This report documents the on-site investigation of an alleged air bag inflator rupture in a 2002 Chrysler PT Cruiser (**Figure 1**) involved in a crash in which the driver sustained fatal injuries. The case was initiated by the Special Crash Investigations (SCI) group of the National Highway Traffic Safety Administration following a notification received by the Office of Defects Investigations (ODI). The notification suggested that damage to the driver's deployed frontal air bag and seat belt was related to the fatal injuries sustained by the driver. The case was assigned to Dynamic Science, Inc., and field inspections were completed in April 2019. The SCI team obtained the county medical examiner/coroner report to obtain injury data and cause of death. The Chrysler was configured with an occupant restraint control (ORC) that was not supported by the Bosch Crash Data Retrieval (CDR) tool and therefore not imaged during the inspection.

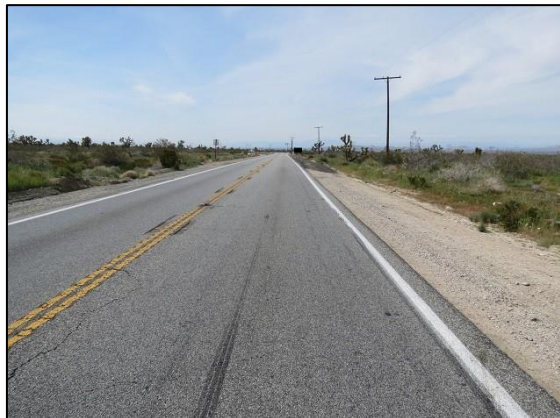
Figure 2. Crash site, westbound approach for the 2002 Chrysler PT Cruiser.

The crash site was a two-lane east/west State highway (**Figure 2**). The lanes were separated by double yellow painted stripes in fair condition with a centerline transverse rumble strip. The lanes measured 3.7 m (12.0 ft) in width. The roadway was bordered by solid white painted fog lines in fair condition. An additional 0.4 m (1.3 ft) width of pavement bordered the fog lines. The drop-off from pavement to shoulder measured approximately 15 cm (6.0 in). The roadway was bordered by gravel shoulders measuring 2 m (6.6 ft) in width on the north edge and 4 m (13.1 ft) in width on the south edge. The roadway was straight and level. The paved asphalt surface was in fair condition. Conditions at the time of the crash were dark without illumination, clear, and dry. The posted speed limit was 89 km/h (55 mph). A crash diagram is included at the end of this report.

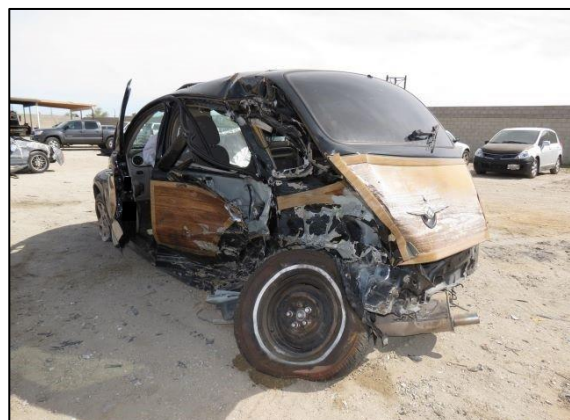
Figure 3. The 2002 Chrysler PT Cruiser.

The Chrysler sustained moderate severity crush damage to the left plane caused by the vehicle-to-vehicle impact (**Figure 3**). Direct damage began at the left rear bumper corner and extended forward

167 cm (65.7 in) spanning the back and passenger sectors and ending at the left B-pillar. The Field L began at the left rear bumper corner and extended forward 170 cm (66.9 in). The vertical aspect of direct damage extended upward from sill to the roof. Twenty measurements were taken using the Nikon total station and the Faro Blitz program calculated six crush measurements as follows: $C_1 = 37$ cm (14.6 in), $C_2 = 31$ cm (12.2 in), $C_3 = 35$ cm (13.8 in), $C_4 = 23$ cm (9.1 in), $C_5 = 11$ cm (4.3 in), and $C_6 = 6$ cm (2.4 in). Maximum crush located at the left rear bumper corner measured 37 cm (14.6 in) and the Collision Deformation Classification (CDC) for the Chrysler in Event 1 was 10LZAW3. Post-crash damage was present where responders forced open the driver's door.

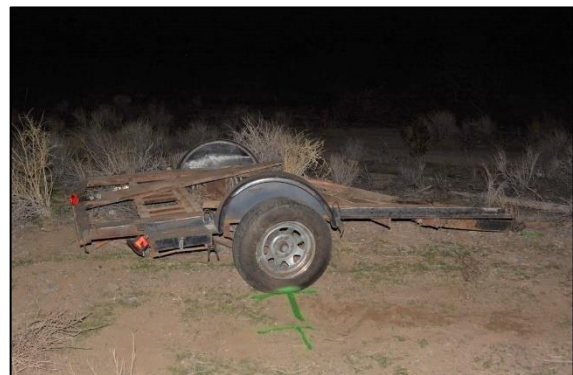
Figure 4. The 1999 utility trailer (on-scene police photo).

The trailer was displaced from the Chrysler during the crash. Police photos taken on-scene indicated that wood flooring was displaced from the trailer and the metal framework appeared to be bent (**Figure 4**).

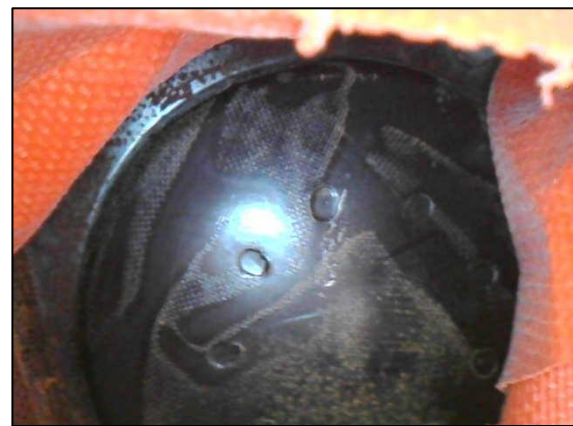
Figure 5. ARC Automotive, Inc., front air bag inflator, the 2002 Chrysler PT Cruiser.

The investigation determined the inflator was manufactured by ARC Automotive, Inc., in Knoxville, Tennessee. The inflator was unremarkable and revealed no evidence of rupture or other damage (**Figure 5**). The air bag fabric was fully intact and revealed no evidence of fraying

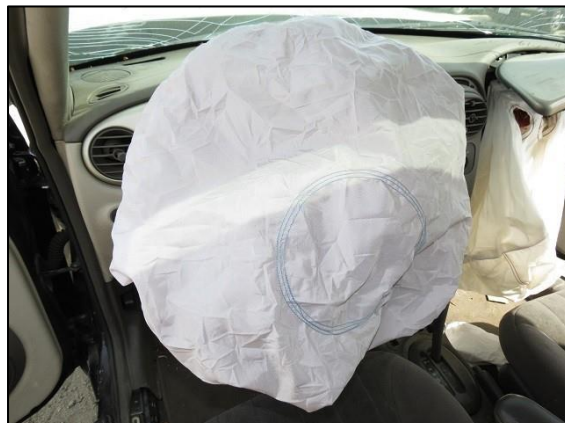
Figure 6. Driver's deployed front air bag, the 2002 Chrysler PT Cruiser.

or containment of foreign matter as was alleged in the notification (**Figure 6**). Labeling on the air bag indicated the year of manufacture was 2002. The passenger's deployed frontal air bag inflator was similarly unremarkable, and the air bag was undamaged. According to a vehicle recall search last queried in August 2020, the Chrysler's air bags were not subject to any open or past recalls. The vehicle had one prior owner from 2002 to 2014. A vehicle history report stated the Chrysler was involved in a non-deployment sideswipe configuration crash with another vehicle in 2005. A second crash of an unknown nature resulting in damage to the right front sector of the vehicle was reported in 2008. A third report of damage involving the back plane was reported in 2012.

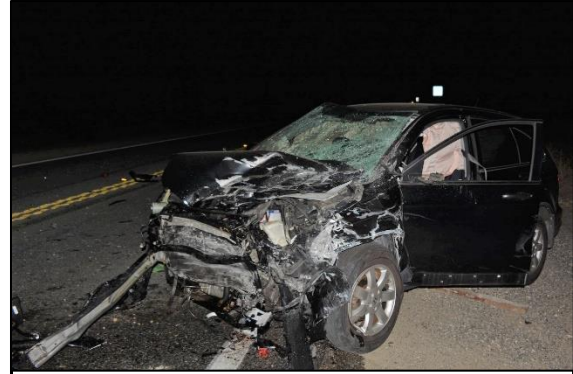
Figure 7. The 2009 Honda CR-V (police photo).

The Honda (**Figure 7**) sustained moderate to major severity damage distributed across the front plane. Police photos indicated the vehicle sustained direct damage to the front plane, distributed from bumper corner to bumper corner. The estimated CDC for the Honda in Event 1 was 12FDEW2. The estimated damage severity for Event 2 was minor. The estimated CDC for the Honda in Event 2 was 99L99999.
