DOT HS 813 031

Special Crash Investigations: Vehicle Fire Investigation; Vehicle: 2018 Hyundai Kona; Location: Arizona; Crash Date: September 2018

**Special Crash Investigations
Vehicle Fire Investigation
Office of Defects Investigation
Case Number: DS18030
Vehicle: 2018 Hyundai Kona
Location: Arizona
Crash Date: September 2018**

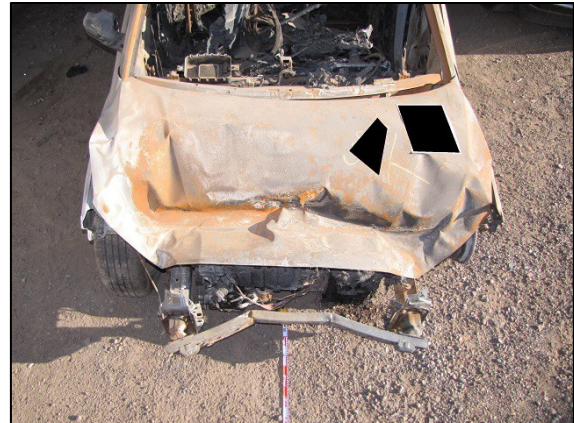
The Hyundai sustained minor severity damage to the front plane in Event 1. Several components were displaced or destroyed by fire including the front bumper fascia, grille, and headlamps. The backing bar was used for the purpose of measuring crush. Direct damage to the front plane was distributed across the length of the backing bar and measured 106 cm (41.7 in). Twelve crush measurements were taken in 10 cm (3.9 in) increments using a Nikon Total Station and the Faro Blitz program computed six crush measurements as follows: $C_1 = 3$ cm (1.2 in), $C_2 = 7$ cm (2.8 in), $C_3 = 15$ cm (5.9 in), $C_4 = 15$ cm (5.9 in), $C_5 = 9$ cm (3.5 in), and $C_6 = 1$ cm (0.4 in) (**Figure 3**). Maximum crush was located 20 cm (7.9 in) right of the longitudinal centerline and measured 15 cm (5.9 in). The Collision Deformation Classification (CDC) for the Hyundai in Event 1 was

12FDEW1. Exterior damage caused by the fire began at the leading edge of the front plane and extended rearward beyond the left B-pillar.

Figure 3. Front plane damage, the 2018 Hyundai Kona.

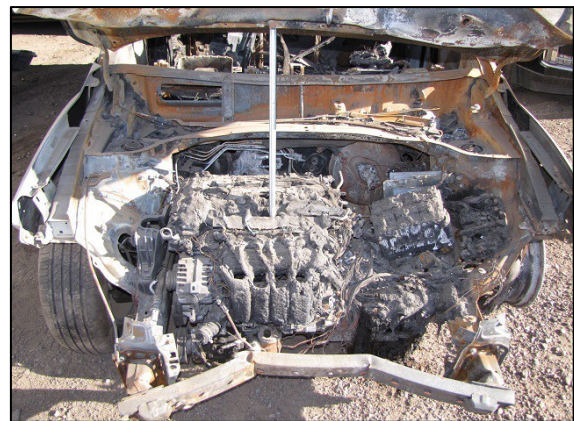
The Hyundai sustained a major severity fire combining the engine and occupant compartments, undercarriage, and tires. Exterior burn damage was present on the front, left, right, top and bottom planes and interior damage was present in the front and second rows. The burn damage flow suggested the fire originated in the engine compartment (**Figure 4**) and spread rearward to the occupant compartment. The fire damage included components of the fuel system but did not extend to the vehicle's fuel tank (**Figure 5**) or filler cap. The cause of the fire was not determined.

The fire incident report was obtained. The report stated that 14 personnel and eight apparatus arrived on-scene to find the vehicle fully involved with fire. They extinguished the fire using tank water and foam. The Ignition section of their report indicated the area of fire origin was "engine area, running." The heat source was identified only as "other." The item first ignited was "undetermined." Cause of ignition was "under investigation." Factors contributing to ignition were "undetermined/none." Human factors contributing to ignition were "none." The limited available data suggested the fire probably originated in the engine compartment and was caused by an undetermined source.

Figure 4. Engine compartment, the 2018 Hyundai Kona.

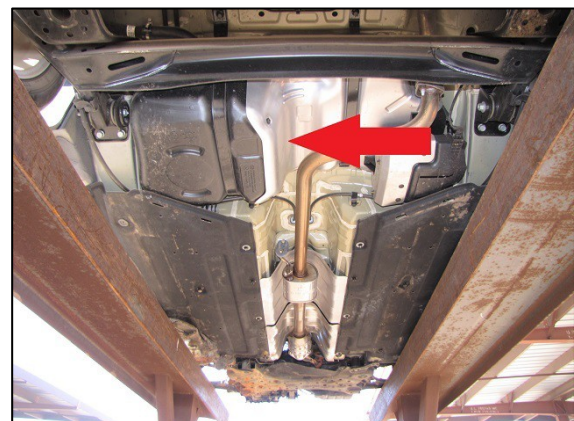
Figure 5. Fuel tank, the 2018 Hyundai Kona.

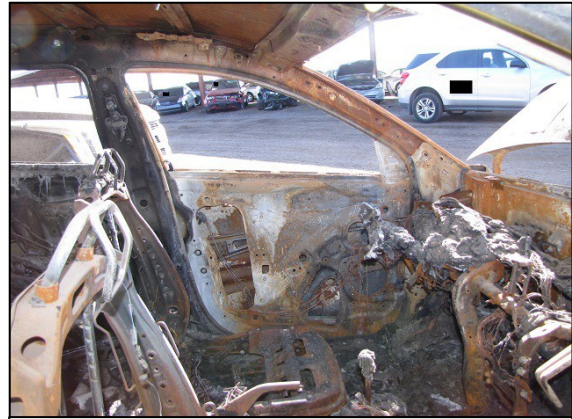
The Hyundai's front row was completely destroyed in the fire (**Figure 6**). The instrument panel, seats, carpet, trim, roof header, center console, seat belts, and air bags were destroyed. The

windshield and the front row side glass were disintegrated. The second row sustained significant burn damage less severe than the front row. The side glass was disintegrated. All the doors remained closed and operational. Some post-crash integrity loss and other damaged is suspected but not confirmed.

Figure 6. Interior damage, the 2018 Hyundai Kona.

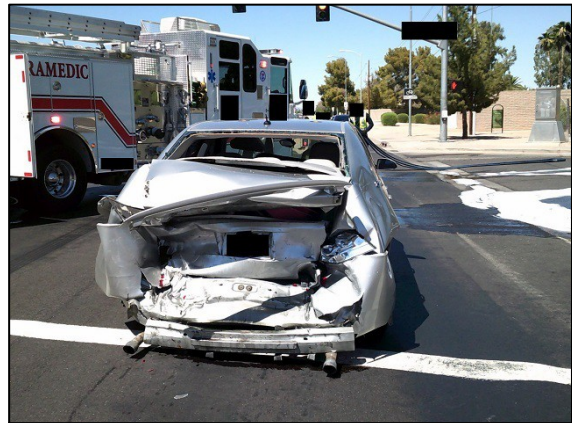
The Chevrolet sustained back plane damage caused in Event 1 (**Figure 7**) and front plane damage caused in Event 2. The estimated CDC for damage to the back plane was 06BDEW4. The estimated CDC for damage to the front plane was 12F9991. The vehicle was towed due to damage.

Figure 7. Back plane damage, the 2006 Chevrolet Impala (police photo).

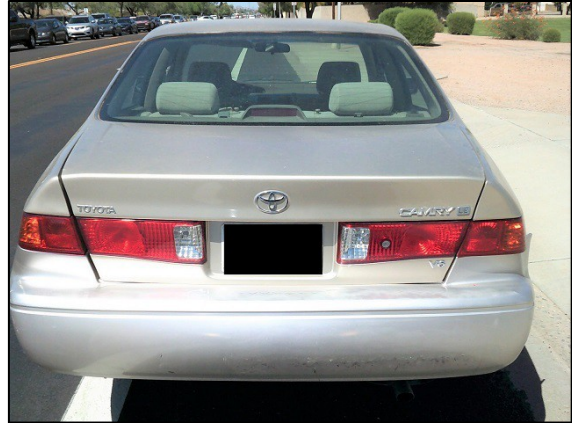
The Toyota sustained minor severity damage to the back plane caused in Event 2 (**Figure 8**). The estimated CDC for damage to the back plane was 06BZLW1.

Figure 8. Back plane damage, the 2000 Toyota Camry (police photo).
