DOT HS 813 036

# **Special Crash Investigations: Alleged Air Bag Injury Investigation; Vehicle: 2018 Volkswagen Passat; Location: Tennessee; Crash Date: January 2019**

**Special Crash Investigations  
Alleged Air Bag Injury Investigation  
Office of Defects Investigation  
Case Number: DS19005  
Vehicle: 2018 Volkswagen Passat  
Location: Tennessee  
Crash Date: January 2019**

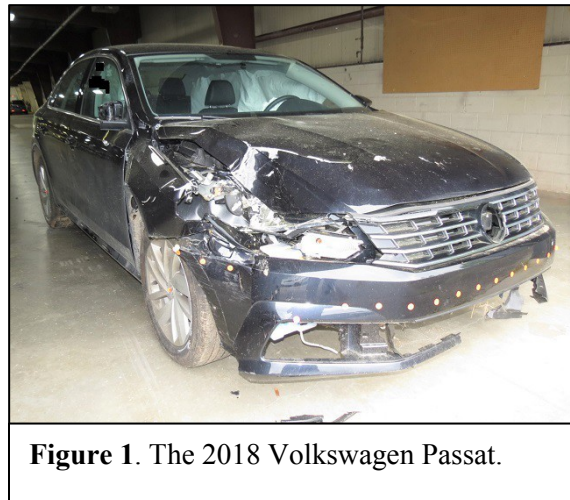
This report documents the on-site investigation of the alleged air-bag-related injuries sustained by the unbelted driver of a 2018 Volkswagen Passat (**Figure 1**). According to the Office of Defects Investigation (ODI) notification, the driver was accelerating from a stop when he lost control of the vehicle that struck a utility pole, causing air bag deployments. The driver reported injuries later confirmed to be fractures to vertebrae. The investigation was intended to include a crash reconstruction, assessment of manual restraint usage, air bag deployment data, crashworthiness functions, and assessment of vehicle speed control status at the time of the crash. The investigation did not reveal any speed-control-related issues, history of engine stalling, or unintended acceleration. The crash dynamics and the driver's kinematics during the crash suggested that, while multiple body regions possibly contacted the deployed frontal air bag, his injuries were more likely attributable to his unbelted status at impact. The vehicle inspection and the EDR report suggested that the vehicle's supplemental restraint systems performed as designed given the crash severity.

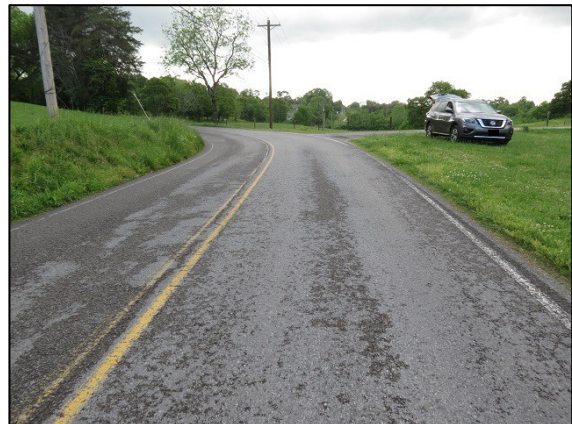
The crash site was a two-lane, east/west, county- maintained roadway (**Figure 2**). The surface was paved with asphalt in traveled and polished condition. The lanes each measured 2.9 m (9.5 ft) wide and were separated by a double yellow painted stripe and bordered by solid white painted fog lines. The roadside ground was grass-covered. The roadway alignment and profile varied in the eastbound approach to the area of impact (POI). At 91 m (300 ft) west of the POI, the roadway was straight and ascended at a positive slope of 1.6 percent; at 61 m (200 ft) west of the POI, it ascended at a positive slope of 0.4 percent; and at 30 m (100 ft) west of the POI, it ascended at a positive slope of 2.1 percent and began to curve left at a radius measuring 82 m (269 ft) at the right fog line. The roadway continued to curve left to the area of departure and POI, where the profile descended at a negative slope of -1.6 percent with a super-elevation measuring positive 2.6 percent. A wire fence aligned parallel to the roadway was located 2.0 m (6.6 ft) right of the right fog line. At the time of the crash site inspection, a newly erected wood utility pole measuring 32 cm (12.6 in) in diameter stood 2.7 m (8.9 ft) right of the right fog line that appeared to be the location of the pole. The ground around the pole had a descending negative slope measuring -100 percent. Conditions at the time of the crash were dark without illumination, clear, and dry. The posted speed limit was 48 km/h (30 mph). A crash diagram is included at the end of this report.

**Figure 2.** Crash site looking east.

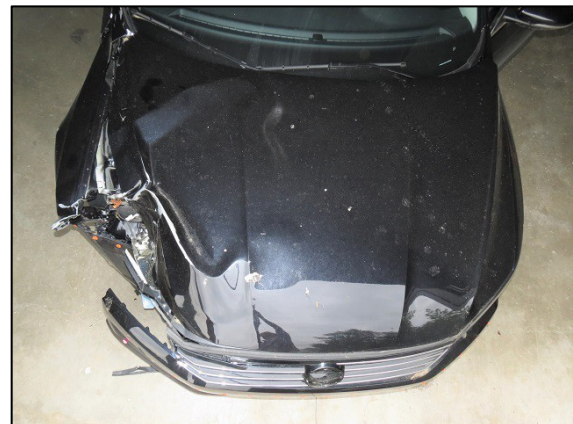
The Volkswagen sustained moderate severity crush damage to the front plane (**Figure 3**) caused by the pole impact and suspected minor overlapping damage caused by the fence impact. Direct damage to the front bumper fascia began at the front right bumper corner and extended 50 cm (19.7 in) to the left. Much of the crush damage was located right of the bumper backing bar, affecting the less rigid bumper corner, right front fender, and right front wheel well. The field L extended from bumper corner to bumper corner and measured 178 cm (70.1 in). Twenty-one measurements were taken using the Nikon total station and the Faro Blitz program calculated six crush measurements as follows:  $C_1 = 0$  cm,  $C_2 = 0$  cm,  $C_3 = 2$  cm (0.8 in),  $C_4 = 1$  cm (0.4 in),  $C_5 = 2$  cm (0.8 in), and  $C_6 = 40$  cm (15.7 in). Maximum crush located at the front right bumper corner and the Collision Deformation Classification (CDC) for the Volkswagen in Event 2 was 12FREW2.

**Figure 3.** Front plane crush, the 2018 Volkswagen Passat.

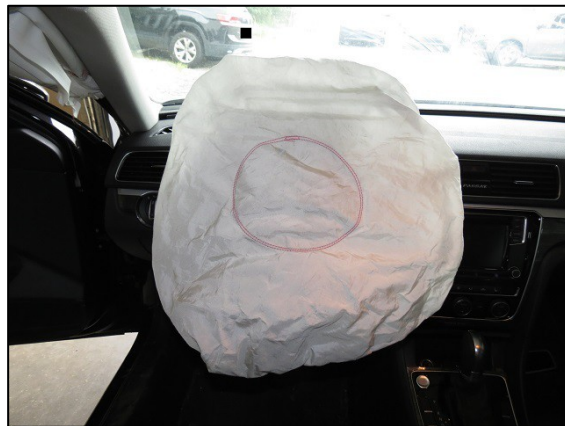
**Figure 4.** Driver’s deployed frontal air bag, the 2018 Volkswagen Passat.

According to the driver, he obtained it new and had leased it for approximately three months prior to the crash; the air bags were OEM and had not been serviced or replaced. At impact with the pole, the driver's frontal (**Figure 4**) and both IC air bags deployed at an EDR-reported time of 51 ms. The driver's frontal air bag deployed in the first stage (the second stage did not deploy) from the steering wheel hub. It appeared to have deployed normally, and neither the air bag nor cover flaps revealed damage or evidence of driver contact.

The vehicle owner's manual states that the frontal air bags are supplemental restraints intended to be used in combination with the vehicle's lap and shoulder seat belt, not as a substitute for using the belt. It states further that the air bag system works most effectively and efficiently when used in combination with a seat belt, and the force at which frontal air bags deploy can cause serious injury to those who are not properly restrained in a front crash. The manual states that during a crash the risk of injury is much higher to an occupant who is unrestrained. The evidence in this crash suggests that the unbelted status of the driver was a likely contributor to his injuries. The driver's seat belt pretensioner actuated in combination with the frontal air bag deployment, which suggested the functionality of both was appropriate to the crash severity.

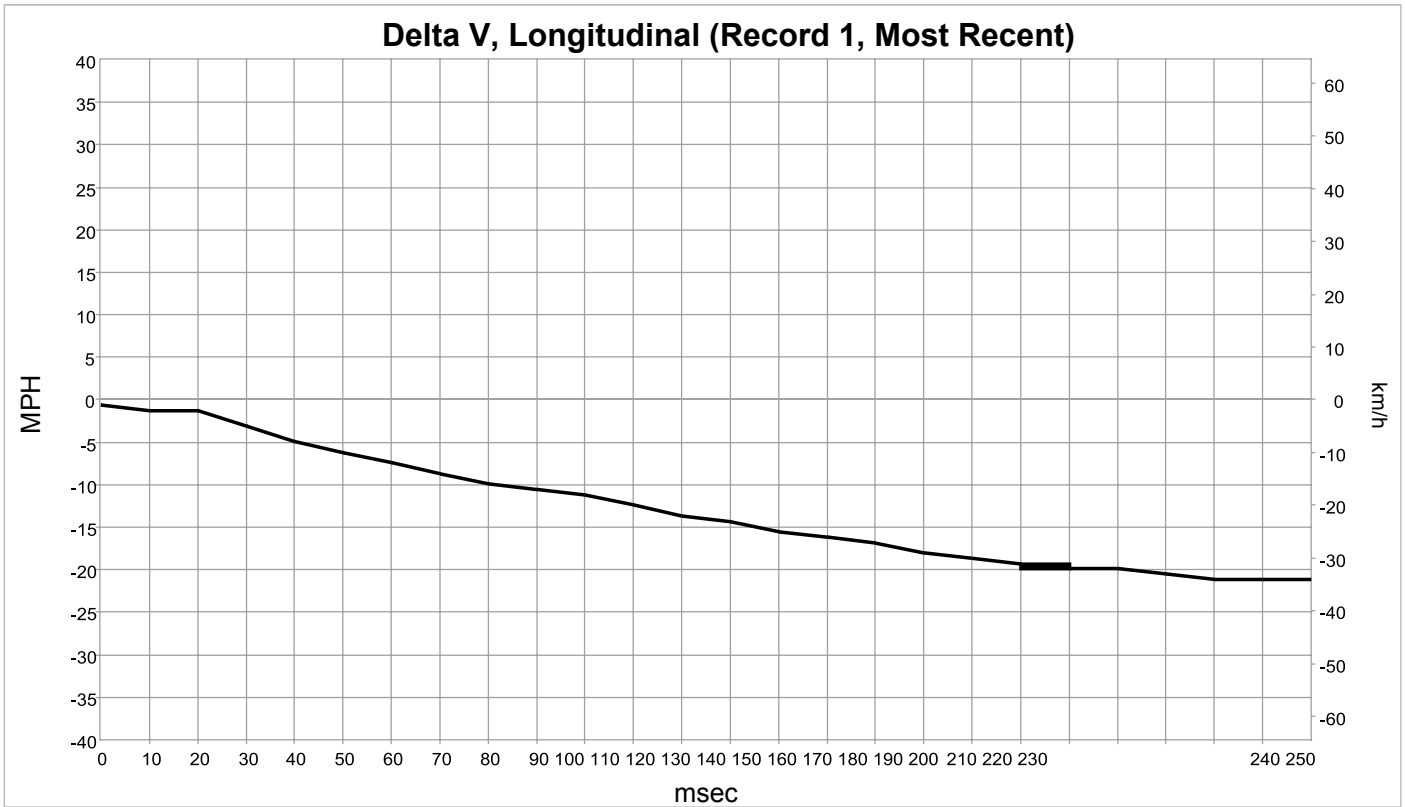
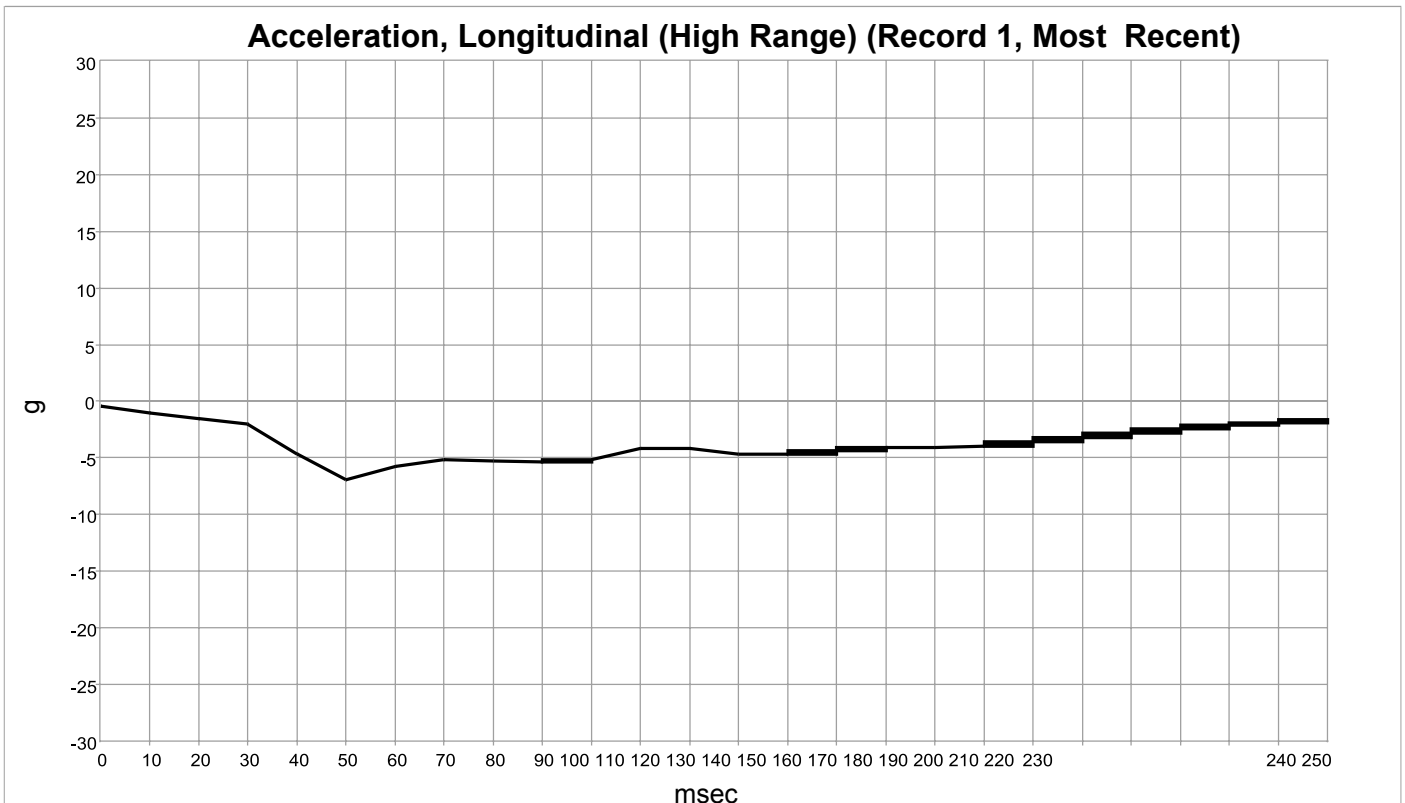
**Longitudinal Crash Pulse (Record 1, Most Recent)**

In Event 2, the WinSMASH barrier algorithm calculated a total delta V of 19 km/h (12 mph), longitudinal delta V of -19 km/h (-12 mph), lateral delta V of 0 km/h and a barrier equivalent speed (BES) of 19 km/h (12 mph). The pole fractured and yielded resulting in a borderline reconstruction. The WinSMASH results are included here for informational purposes and appear reasonable. The EDR reported a maximum longitudinal delta V of -35 km/h (-21.7 mph) at 295 ms and a maximum lateral delta V of -6 km/h (-3.7 mph) at 295 ms.
