DOT HS 813 045

# **Special Crash Investigations: On-Site ABS Failure Crash Investigation; Vehicle: 2008 Mercury Milan; Location: California; Crash Date: November 2018**

**Special Crash Investigations  
On-Site ABS Failure Crash Investigation  
Office of Defects Investigation  
Case Number: DS18027  
Vehicle: 2008 Mercury Milan  
Location: California  
Crash Date: November 2018**

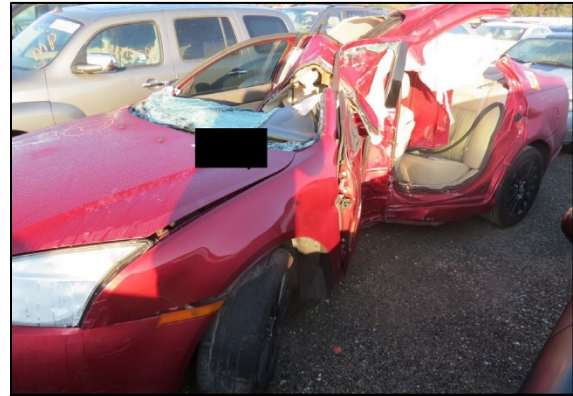
This report documents the on-site investigation of an antilock braking system (ABS) failure crash and the injuries sustained by the driver of a 2008 Mercury Milan (**Figure 1**) that was involved in a single-vehicle crash. The driver sustained serious injuries. This case was initiated in response to a notification made to the National Highway Traffic Safety Administration. The Special Crash Investigations (SCI) group assigned the case to Dynamic Science, Inc., in November 2018. SCI obtained the police report and contacted the driver's insurance company to secure cooperation. The investigation was intended to determine the crash circumstances and to harvest the ABS

**Figure 1.** The 2008 Mercury Milan.

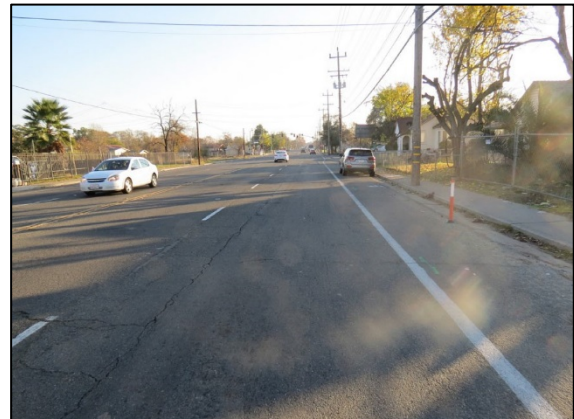
The crash site was in the southbound lanes of a four-lane, undivided, city roadway (**Figure 2**). The asphalt roadway was straight and level. There were two southbound lanes and two northbound lanes that were separated by double-yellow lines. The southbound lanes were bordered on the right by a solid white fog line, an asphalt shoulder, a 14 cm (5.5 in) concrete curb, and a concrete sidewalk. This crash occurred during the early morning. A wooden utility pole 38 cm (14.9 in) diameter was located to the right of the curb. The posted speed limit was 64 km/h (40 mph). The roadway was dry. The weather at the nearest reporting station was 13 °C (56 °F), 26 percent humidity, and cloudy. The winds were out of the north northwest at 28 km/h (18 mph). A crash diagram is attached at the end of this technical report.

**Figure 2.** Southbound approach of the 2008 Mercury Milan.

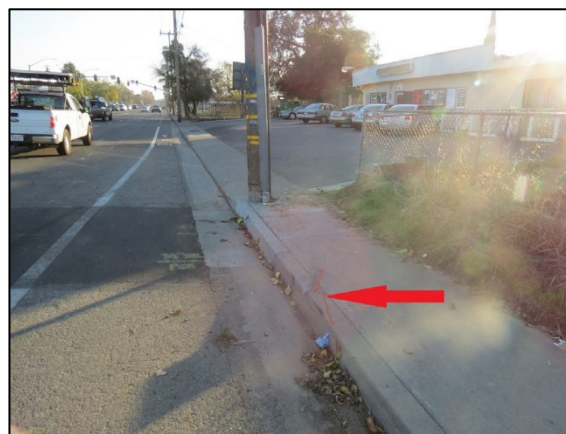
The Mercury departed the roadway on the right, and struck the curb with the left front wheel (**Figure 3**). The vehicle traveled an additional 5.1 m (17 ft) before striking a utility pole with the left plane (**Figure 4**). The barrier algorithm of the WinSMASH program calculated a total delta-V of 58 km/h (36 mph). The longitudinal and lateral components were 10 km/h (6 mph) and 57 km/h (35 mph), respectively. The collision fit the model and the results appear reasonable. The left IC and seat-mounted side air bags deployed at 8 milliseconds (ms). The driver seat belt pretensioner actuated at 8 ms.

**Figure 3.** Struck curb, looking south.

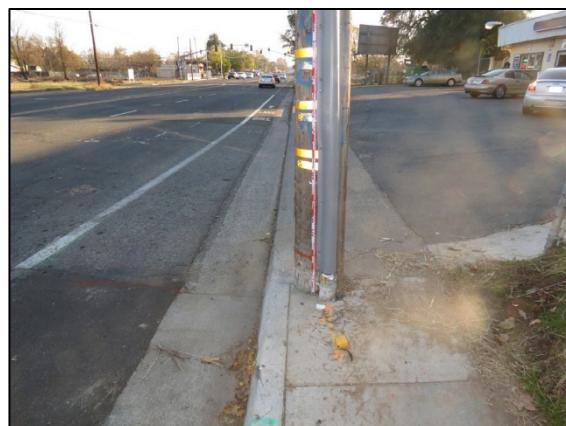
**Figure 4.** Struck utility pole, looking south.

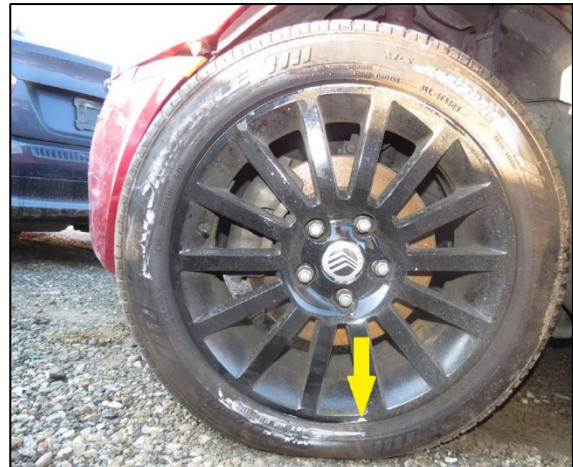
The Mercury sustained minor left front wheel damage from the impact with the curb (**Figure 5**). The Collision Deformation Classification (CDC) was 09LFWN1. The vehicle sustained severe left side damage from the impact with the wooden utility pole (**Figure 6**). The direct damage measured 40 cm (15.7 in). The direct damage began 100 cm (39.3 in) aft of the front axle and was primarily located at the rearward aspect of the front door and B-pillar. The vertical aspect of the direct damage ranged from the sill to the roof side rail. The Field L began 30 cm (11.8 in) aft of the front axle and measured 163 cm (64.1 in). Nineteen measurements were taken at the mid door level by the Nikon Total Station and the Faro Blitz program computed crush measurement in six

**Figure 5.** Left wheel damage, the 2008 Mercury Milan.

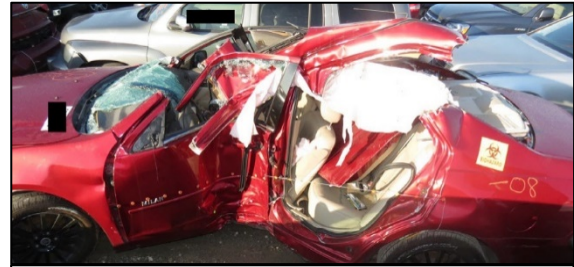
increments as follows:  $C_1 = 16$  cm (6.2 in),  $C_2 = 34$  cm (13.3 in),  $C_3 = 48$  cm (18.8 in),  $C_4 = 64$  cm (25.1 in),  $C_5 = 70$  cm (27.5 in), and  $C_6 = 30$  cm (11.8 in). The maximum crush measured 70 cm (27.5 in) and was located 115 cm (45.2 in) aft of the front axle. Both left doors were jammed shut due to the damage. The left rear door was removed during extrication. The height of the maximum crush was 41 cm (16.1 in). The left rear door (and the roof) were removed to extricate the driver. The CDC was 09LPAN4.

**Figure 6.** Left plane damage, the 2008 Mercury Milan.

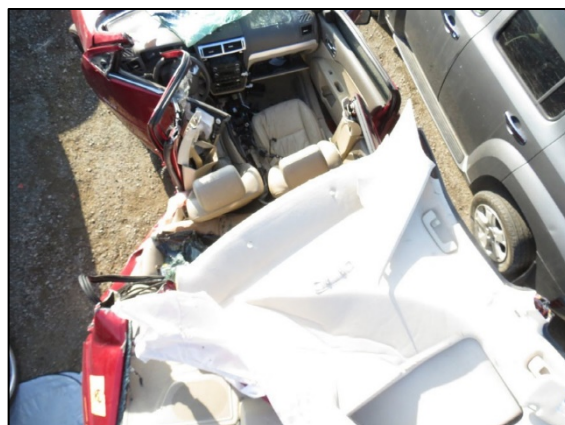
**Figure 7.** Interior damage, the 2008 Mercury Milan.

The Mercury sustained severe interior damage from intrusions, occupant contacts, and air bag deployments (**Figure 7**). The driver loaded the left door with his left hip and shoulder. He was displaced to the right and loaded the center console. There was lateral intrusion of the left door, left B pillar, floor, driver seat cushion, and left roof side rail. There was longitudinal intrusion of the driver's seat back into the second row.

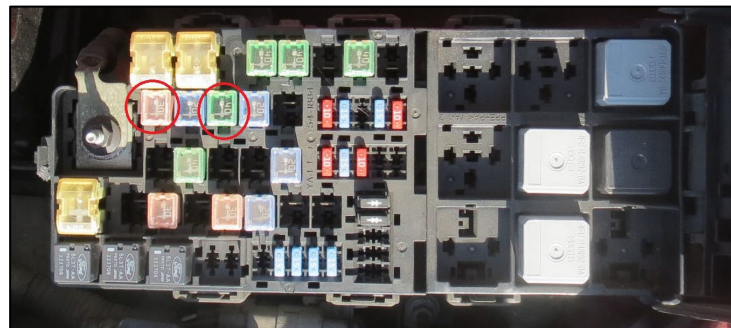
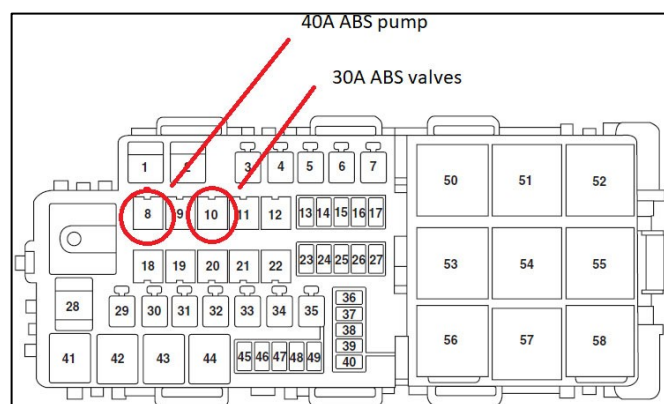
During the vehicle inspection, the air bag control module, ABS module, and powertrain control module were removed and secured by the VRTC representative for later imaging and/or valve observation. The brake fluid reservoir was examined; it was determined that the level was correct, and that the fluid was of the proper color. The brake pedal was manipulated by hand, and it had 5 cm (1.9 in) of travel, from 15 cm (5.9 in) to 10 cm (3.9 in) to the floorboard. As discussed earlier, the driver had indicated that he had pulled the ABS pump and ABS valves fuses at some point. During the inspection of the power distribution box, it was determined that, while the fuses were intact, they had been switched and

**Figure 8.** Fuse locations/amperage at the time of inspection, the 2008 Mercury Milan.

**Figure 9.** Power distribution box, fuse locations/amperage, the 2008 Mercury Milan.

were in the incorrect positions with a 30A fuse in the ABS pump slot and a 40A fuse in the ABS valves slot (**Figures 8 and 9**). In the driver interview, he indicated that the fuses were in place at the time of the crash. The investigation revealed that the ABS was active at the time of the crash. It appears that one tire did lock up and that the vehicle's loss of control was related to the lock up.
