DOT HS 813 125

# **Special Crash Investigations: On-Site Guardrail End Terminal Crash Investigation; Vehicle: 1998 Ford Ranger; Location: Missouri; Crash Date: August 2018**

**Special Crash Investigations**  
**On-Site Guardrail End Terminal Crash Investigation**  
**Case Number: DS18023**  
**Vehicle: 1998 Ford Ranger**  
**Location: Missouri**  
**Crash Date: August 2018**

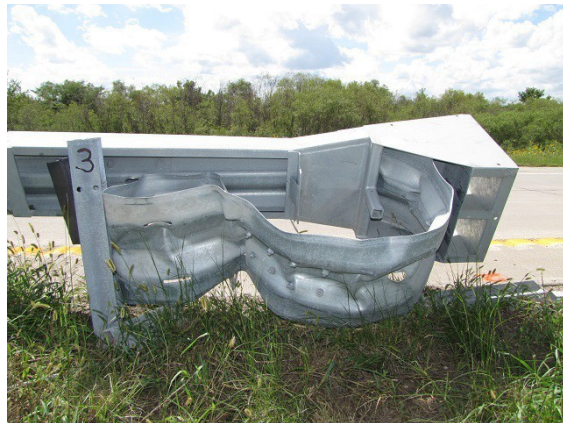
*Figure 2. SKT field side looking south*

The Ford departed the roadway on the left edge and struck the SKT end terminal on the left shoulder (Figure 2). The vehicle then crossed over two lanes to the right, departed the roadway on the right edge, and struck a guardrail face on the right shoulder. The Ford came to rest facing west on the right shoulder. The driver of the Ford was not injured or transported. The front row passenger sustained a minor severity injury. He was transported to a local hospital and then transferred to another hospital where he was treated for an unknown duration. The Ford was towed due to damage.

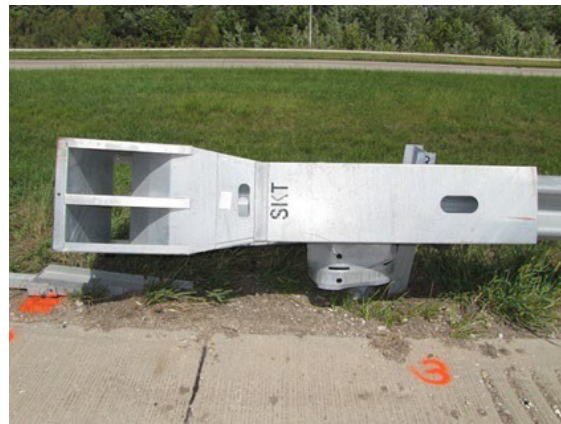
*Figure 4. SKT traffic side looking north*

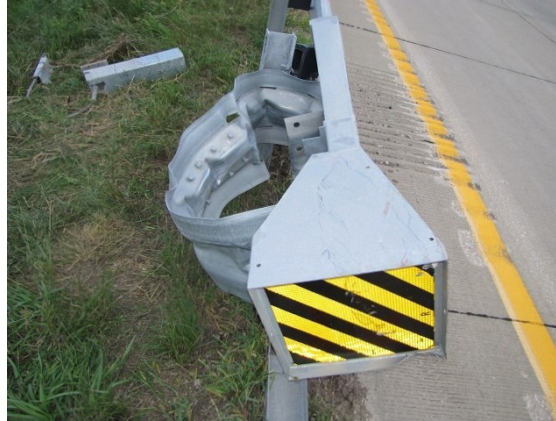
The SKT end terminal (Figure 5) guardrail was configured with a steel anchor cable system, steel ground strut, steel W-beams, steel posts, and composite offset blocks. The SKT was a 4-inch (10 cm) extruder-type end terminal. The rectangular impact face measured 51 cm (20.0 in) in width and 49 cm (19.5 in) in height. The guide chute exit height measured 48 cm (19.0 in). The guardrail was configured with a steel ground strut measuring 175 cm (69.0 in) in length located between Post 1 and Post 2, an anchor cable attached to Post 1, and an anchor bracket attached to the W-beam between Post 1 and Post 2. All posts for this guardrail were of steel construction.

*Figure 5. SKT guardrail, left shoulder looking east*

At impact from the Ford to the end terminal, the SKT was displaced approximately 3.1 m (10.2 ft) rearward along the W-beam with a section of W-beam measuring 2.9 m (9.6 ft) in length extruding to the field side. Posts 1 to 3 were damaged. Post 1 was pulled away from the bolts connecting it to the ground strut and came to rest on the field side. The leading end of the anchor cable remained attached to Post 1, and the trailing edge was pulled away from the W-beam. Post 2 remained bolted to the ground strut but was flattened to the ground. Post 3 was leaning slightly away from an upright orientation but remained grounded. The composite offset block was loosened from both the post and the W-beam. The damage to Post 3 appeared to have been caused by the extruded W-beam which remained in contact with the post after the crash. The SKT rotated slightly counterclockwise along its longitudinal axis, causing the W-beam to twist in a likewise direction ending at Post 4. The SKT channel and welds did not exhibit any fracturing or deformation caused by the impact or extrusion. The impact face sustained minor damage at the lower aspect and on the reflective sheeting. There were no kinks present.

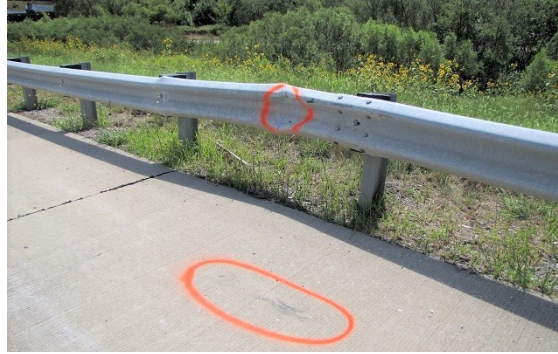
guardrail face on the right shoulder (Figure 6). Distance from POI1 to POI2 measured 31.0 m (101.7 ft). The guardrail was 71 cm (28.0 in) in height. Direct damage included a dent and scrape marks in the W-beam measuring 40 cm (16.0 in) in width. Two lengths of W-beam on either side of the impact were kinked, and two posts were tilted toward the field side of the impact.

*Figure 6. Second guardrail impact, right shoulder*

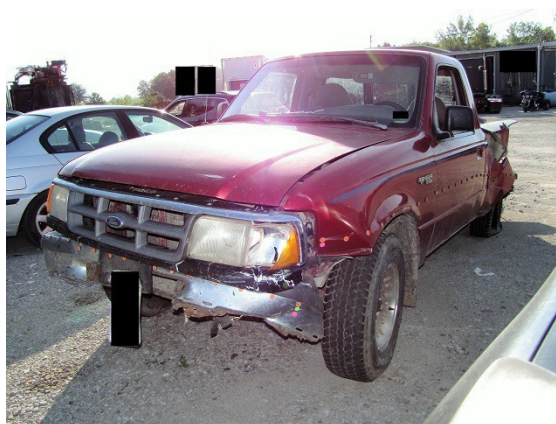
The Ford sustained minor severity damage to the front (Figure 7), left, and back planes during the crash. The left plane struck the SKT guardrail end terminal face tearing away sheet metal aft of the B-pillar and displacing the rear tailgate, the front plane struck the guardrail face, and the back bumper appeared to have snagged on either the SKT or a post, fracturing and displacing the bumper. Direct damage to the front plane began at the front left bumper corner and extended 30 cm (11.8 in) to the right. The Field L extended from bumper corner to bumper corner and measured 147 cm (57.9 in). The steel bumper was used to obtain 17 crush measurements in 10.0 cm (3.9 in) increments, and the Nikon Total Station and the Faro Blitz program computed crush measurement in six increments as follows:  $C_1 = 12$  cm (4.7 in),  $C_2 = 8$  cm (3.1 in),  $C_3 = 8$  cm (3.1 in),  $C_4 = 6$  cm (2.4 in),  $C_5 = 5$  cm (2.0 in), and  $C_6 = 0$ . Direct and induced damage measuring 459 cm (180.7 in) continued down the left side, the more severe damage located aft of the B-pillar. The cargo bed sheet metal was torn away, the left rear wheel was bent, and the tire was torn and holed. The Collision Deformation Classification for the Ford in Event 1 was 12FLEE9.

*Figure 7. Front plane damage, the 1998 Ford Ranger*
