DOT HS 813 127

**Special Crash Investigations:  
On-Site Guardrail End Terminal  
Crash Investigation;  
Vehicle: 2005 Dodge Dakota;  
Location: Missouri;  
Crash Date: June 2018**

**Special Crash Investigations  
On-Site Guardrail End Terminal Investigation  
SCI Case No: IN18009  
Vehicle: 2005 Dodge Dakota  
Location: Missouri  
Crash Date: June 2018**

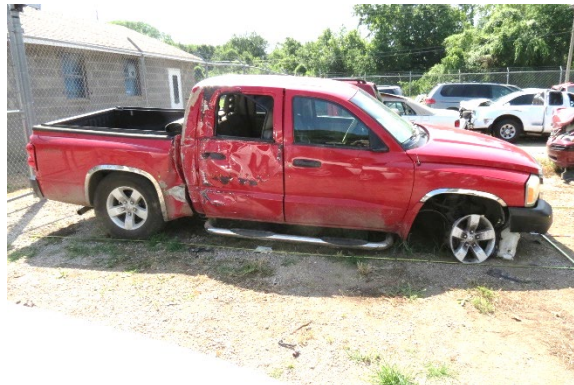
*Figure 1. Right side view of the Dodge.*

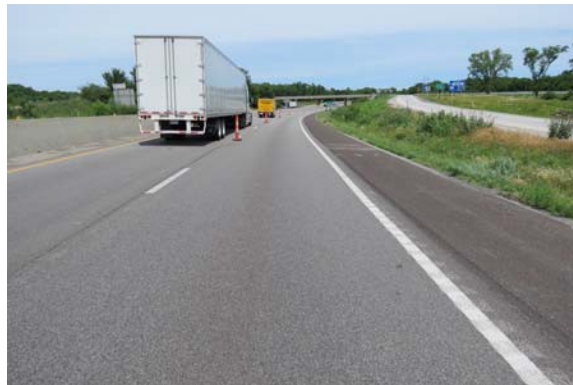
This crash occurred at night on the east roadside of an unlighted, four-lane, divided, interstate highway. The weather conditions at the time of the crash were cloudy with 16 km (10 miles) visibility, southeast winds at 13 km/h (8 mph), a temperature of 22.7 °C (73 °F), and a dew point of 13.3 °C (56 °F), according to the local weather reports. The roadway curved to the right and had two bituminous northbound lanes that were separated from the southbound lanes by a concrete Jersey barrier (Figure 2). The calculated radius of curvature was 3,077 m (10,093 ft). The superelevation was +2%. The travel lanes were approximately 4 m (13 ft) wide and were bordered by 1.7 m (5.6 ft) and 2.4 m (7.9 ft) wide bituminous shoulders on the west and east, respectively. Pavement marking consisted of a broken white lane line, a solid white east edge line and a solid yellow left edge line. Rumble strips were cut into the east shoulder. On the approach to the crash site, the east roadside was grass surfaced that transitioned to a shallow drainage ditch. A road sign mounted on two multi-directional breakaway slipbase posts was located in the grass roadside. A blocked-out W-beam guardrail equipped with an SKT end terminal was located along the east roadside and protected northbound traffic from an overpass. The posted speed limit was 113 km/h (70 mph). A crash diagram is included at the end of this report.

*Figure 2. Northbound view of the roadway.*

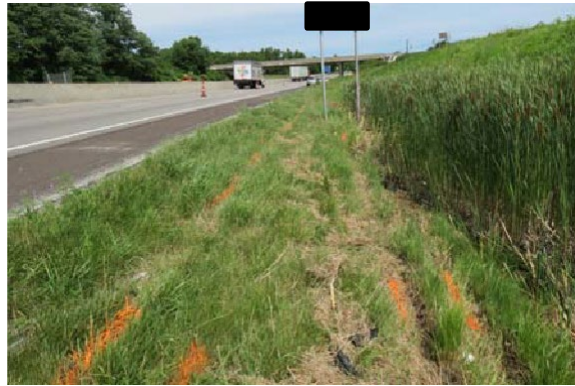
The Dodge struck the roadside sign mounted on two round posts, each with a breakaway slip-base attachment (Figure 3). The front plane right aspect struck and separated the left post (Event 1) and the right plane struck the right post (Event 2). The force direction for both events was in the 12 o'clock sector. The damage algorithm of the WinSMASH program could not be used for either event since yielding objects are out of scope for the program. However, the barrier equivalent speed (BES) algorithm of WinSMASH was used to calculate a BES of 14 km/h (8.7 mph) for Event 1. The right plane impact (Event 2) was a sideswipe with overlapping damage. WinSMASH could not be used for this impact due to the overlapping damage from the guardrail terminal head impact.

*Figure 3. North approach to the sign posts impacts.*

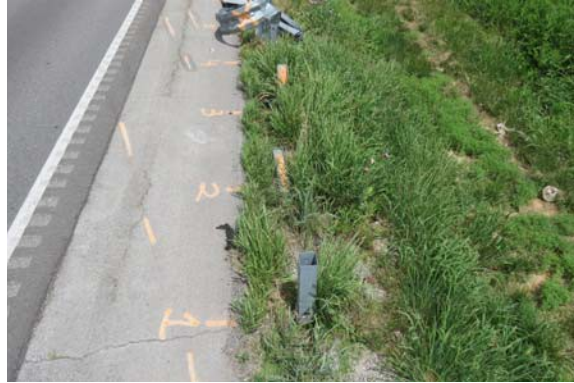
The vehicle continued northwest on the roadside for approximately 105 m (344 ft) as the driver began to steer the vehicle left, back toward the roadway. The Dodge yawed counterclockwise on the approach to the field side of the end terminal. Immediately prior to the guardrail impact, the driver steered back to the right as he was about to reenter the northbound travel lanes. The right front tire and wheel struck the end terminal and displaced the end terminal from post 1 and further displaced the terminal head along the W-beam. As the Dodge reentered the east shoulder, the front right undercarriage overrode the base of post 1 and struck post 2 causing damage to the undercarriage. The right plane struck the end terminal and extruded 4.4 m (14.4 ft) of guardrail to the field side, kinked the W-beam at two locations (Event 3, Figure 4), and damaged a total of 7.8 m (25.6 ft) of guardrail and five guardrail posts. WinSMASH could not be used for this event since yielding objects are out of scope for the program and there was no damage to the front bumper from this impact. Furthermore, there was overlapping damage from the right-side post impact. None of the air bags deployed during the crash sequence.

*Figure 4. North-facing overhead view of the damaged guardrail.  
(Post 1 reinserted to pre-crash location)*

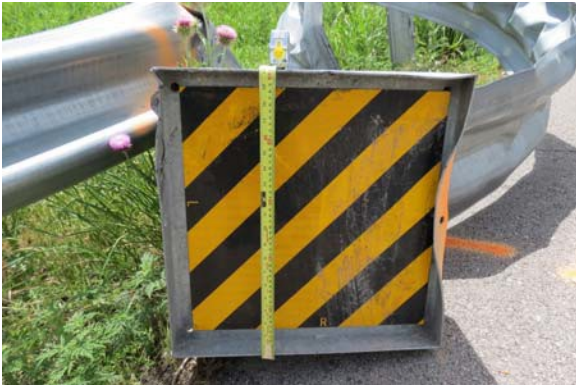
The right front tire and wheel of the Dodge initially struck the SKT end terminal as the driver attempted to return to the travel lanes. The angle of impact originated from the field side of the guardrail. The end terminal head measured 50 cm (19.7in) wide and 51 cm (20.0 in) high and sustained minor damage to the protruding flange (Figure 5). Initially, post 1 became detached from its hinged base. The SKT end terminal extruded 4.4 m (14.4 ft) of guardrail toward the field side. The guardrail separated from post 2 as the undercarriage of the Dodge overrode the post that collapsed downstream to the ground from its pivot base. Post 3 was displaced downstream approximately 20 degrees off vertical and its composite offset block, as well as the guardrail became detached. Post 4 remained upright but detached from the guardrail and composite offset block. Post 5 remained upright but rotated clockwise approximately 20 degrees and remained bolted to the composite offset block and guardrail. Post 6 to 12 were undamaged and remained attached to their composite offset blocks and the guardrail. The total length of the damaged guardrail was 7.8 m (25.6 ft). The guardrail kinked 180 degrees at post 4 and approximately 30 degrees at post 5 (Figure 6). The FHWA Guardrail Form is attached to the end of this report in the Appendix.

*Figure 5. Southerly view, impact face.  
(Note - vertical tire tread)*

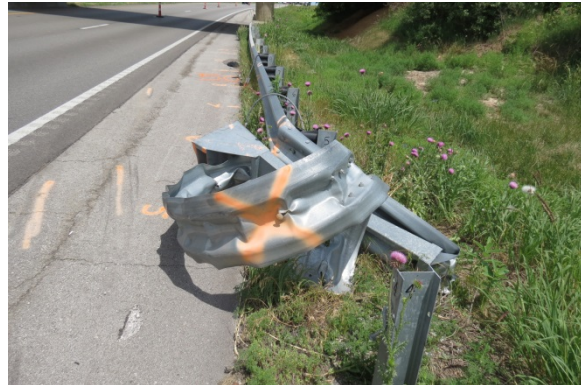
*Figure 6. Northerly view, extruded and  
kinked guardrail.*

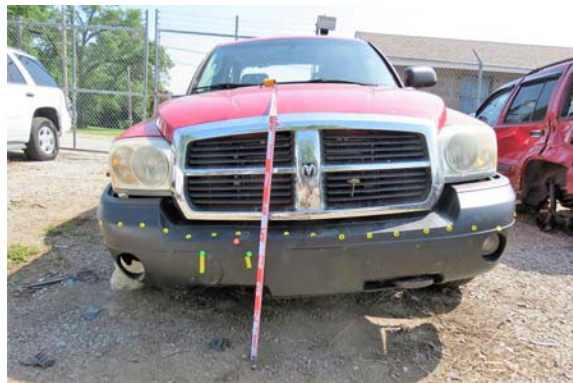
The Dodge sustained minor severity damage to the right aspect of the front bumper from impact with the left break-away sign post. The direct contact damage to the front bumper fascia (Figure 7) began 43 cm (16.9 in) left of the right front bumper corner and extended 17 cm to the right. Crush measurements were documented along the bumper profile and yielded a maximum crush of 3 cm (1.2 in), located 28 cm (11.0 in) right of the vehicle's centerline. The compression of the bumper fascia against the bumper beam and mounting bracket produced a semi-circular punch out-type cut to the fascia. A matching transfer was present on the struck post. The Collision Deformation Classification (CDC) for this event was 12FZLN1 (10 degrees).

*Figure 7. Front plane impact to the sign post.*

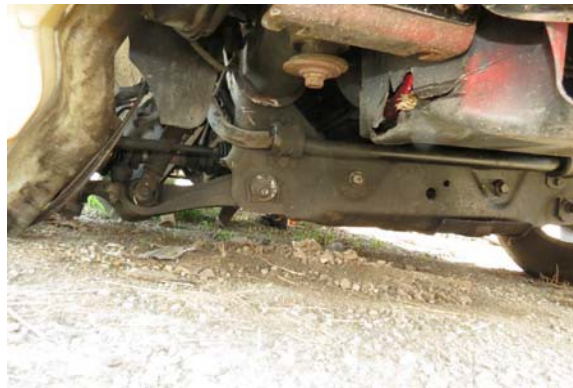
As the Dodge approached the end terminal, it was in a slight counterclockwise yaw. This exposed the aft aspect of the tire and wheel to the face of the end terminal at impact. The end terminal impact fractured the wheel rim and the right undercarriage (Figure 8) of the Dodge struck and overrode the base of post 1 and post 2. The aft portion of the lower control arm fractured and the right frame rail and sway bar were gouged. Undercarriage protective shields and the washer fluid container were contacted and fractured.

*Figure 8. Undercarriage damage from the guardrail posts.*

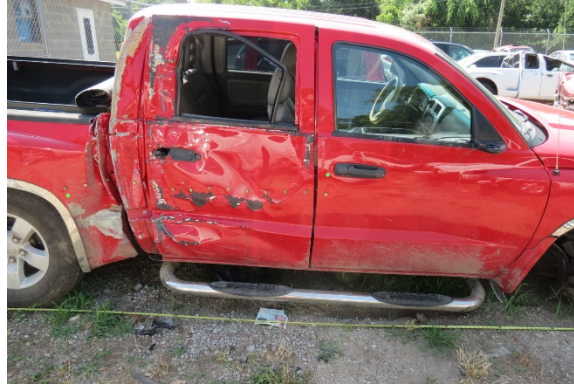
The right plane of the Dodge struck the right break-away sign post. The initial contact involved the right outside rear view mirror. The mirror was separated from the window frame mounting point. Sideswipe-type damage began on the trailing edge of the right front door at the beltline area and continued onto the right rear, window frame, C-pillar, and the leading edge of the cargo box. The severity of this impact damage was minor due to the break-away type post. This area of damage was subsequently struck by the deformed guardrail which overlapped and masked the post-impact damage. The estimated CDC for the Event 2 damage was 12RYAS2.

As the Dodge progressed forward, its engagement with the end terminal in conjunction with the driver's clockwise steering maneuver reversed the Dodge's yaw from counterclockwise to clockwise. The right plane of the Dodge contacted the displaced end terminal, compressed the end terminal, and kinked the W-beam in a northerly direction. This impact damage overlapped the damage from the Event 2 post and involved the right rear door, C-pillar, and the cargo box. In the overlapping damage patterns were horizontal creases from the deformed guardrail, snagging at the midpoint of the door window frame gasket and trailing edge of the window frame. The C-pillar was crushed and rolled rearward and the leading edge of the cargo box was crushed laterally and rearward (Figure 9). The direct damage began 178 cm (70.1 in) forward of the right rear axle and extended 135 cm (53.1 in) forward. Crush measurements were documented at the mid-door level and the maximum crush was 6 cm (2.4 in), occurring on the right rear door located 76 cm (29.9 in) forward of the right rear axle. The CDC for the event damage was 01RDEW2.

*Figure 9. Overlapping right plane damage to the Dodge from the sign post and end terminal.*
