DOT HS 813 128

# **Special Crash Investigations: Remote Vehicle Fire/Child Restraint System Investigation; Vehicle: 2009 Ford Focus; Location: Missouri; Crash Date: September 2017**

**Special Crash Investigations**  
**Remote Vehicle Fire/Child Restraint System Investigation**  
**Case Number: DS19021**  
**Vehicle: 2009 Ford Focus**  
**Location: Missouri**  
**Crash Date: September 2017**

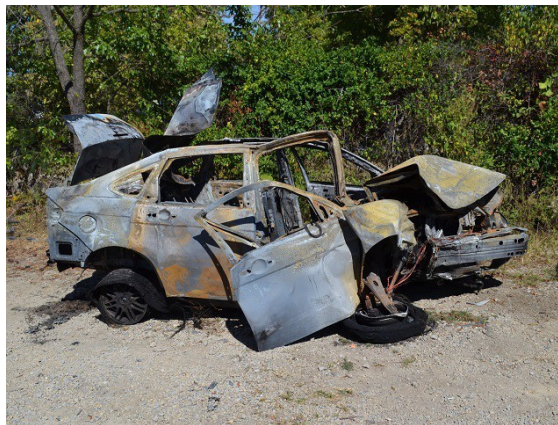
This report documents the remote vehicle fire/child restraint system (CRS) investigation of a 2009 Ford Focus (Figure 1) involved in a single-vehicle crash and post-crash fire with a child occupant seated in a CRS. The investigation is intended to examine the events leading to the fire, how quickly the fire spread to the occupant compartment, the magnitude of the fire, the time sequence in which emergency medical services (EMS) and other responders arrived on-scene, occupant restraint usage, demographics, injury data, and CRS usage. The crash was identified during a review of Fatality Analysis Reporting System (FARS) crash reports. The criteria for the crash type includes an impact not involving the back plane, a fire that spreads to the occupant compartment, and at least one occupant seated in a CRS. The Special Crash Investigations (SCI) group of the National Highway Traffic Safety Administration assigned the case in August 2019.

*Figure 1. 2009 Ford Focus (police photo)*

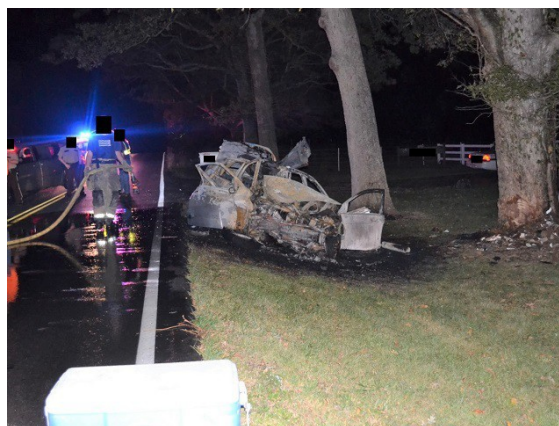
The crash included five events. After departing the roadway and traveling approximately 23 m (75 ft), the vehicle's front plane struck a mail box post (Event 1). It continued in the same trajectory for 25 m (82 ft) before striking a telephone utility junction box (Event 2), then continued another 10 m (34 ft) before striking a vinyl fence (Event 3), and finally striking a mature tree (Event 4) having a diameter greater than 30 cm (11.8 in). The calculated impact speed for Event 4 was 54.4 km/h (33.8 mph). Following the tree impact, the Ford was displaced to the left and rotated clockwise, coming to rest on the roadside and facing south (Figure 2). Following the crash, a major fire originated from an unknown source, which burned all exterior planes and fully consumed the interior (Event 5).

*Figure 2. Crash site looking north, struck tree on right (police photo)*

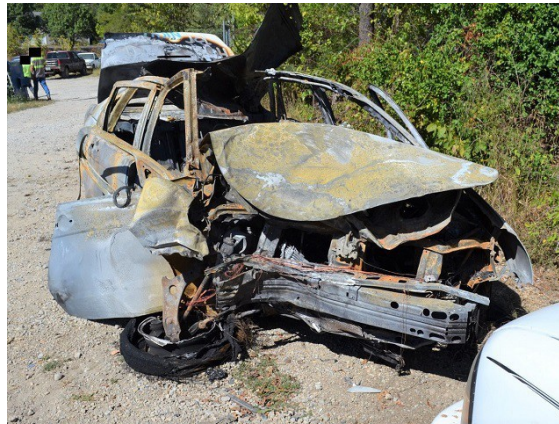
The Ford sustained severe crush to the front plane in the impact with the mail box post, utility box, fence, and tree (Figure 3), and additional damage to all planes caused by the fire. The front bumper fascia and grille were missing and the bumper backing bar was used to estimate crush to the front plane. The damage flow suggested direct damage began at the front right bumper corner and extended right to the approximate longitudinal centerline. End shift to the right was present. The estimated Collision Deformation Classification for the Ford in the Event 4 tree impact was 12FZEW4. Damage to the front end caused by prior impacts were masked by the tree impact damage.

*Figure 3. Front plane damage, 2009 Ford Focus (police photo)*

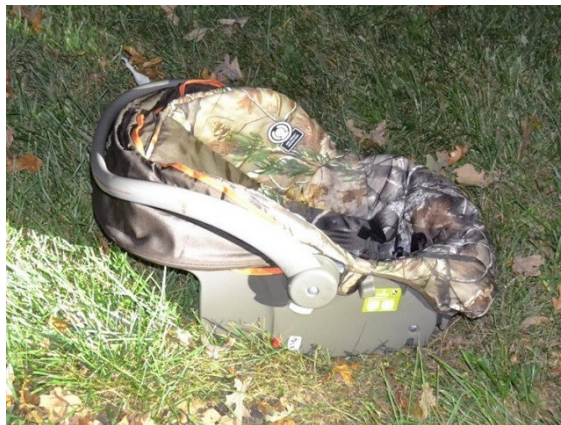
The 3-month-old male occupant was seated in a Cosco Light ‘N’ Comfy Realtree Infant Safety Seat (ISS) (Figure 4). The manufacture date was February 16, 2016. A partial serial number visible in police photos was x229AVQx and the model number was illegible. The seat was intended for rear-facing orientation only and was configured with a detachable, stay-in-vehicle base, adjustable carry handle, 5-point harness, fabric canopy, removable cushion, side impact protection, 4-position harness adjustment, multi-position recline adjustment, and Lower Anchors and Tethers for Children (LATCH).

*Figure 4. Cosco Light ‘N’ Comfy infant safety seat (police photo)*

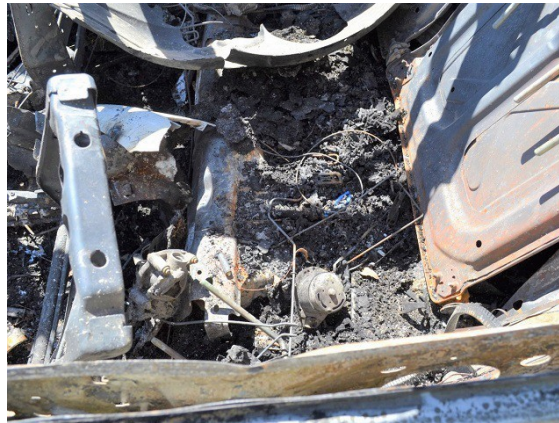
The Ford's interior sustained catastrophic damage caused by fire (Figure 5). Post-crash integrity loss was documented in medical records. Crash-related damage to the interior was unknown.

*Figure 5. Second row left seat, 2009 Ford Focus (police photo)*
