DOT HS 813 140

**Special Crash Investigations:  
Remote Vehicle Fire/Child  
Restraint System Investigation;  
Vehicle: 2001 Ford Windstar;  
Location: Kansas;  
Crash Date: June 2016**

**Special Crash Investigations**  
**Remote Vehicle Fire/Child Restraint System Investigation**  
**Case Number: DS19023**  
**Vehicle: 2001 Ford Windstar**  
**Location: Kansas**  
**Crash Date: June 2016**

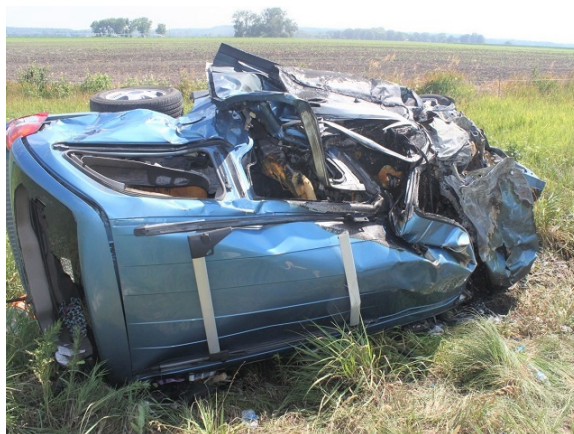
*Figure 1. The 2001 Ford Windstar, final rest position  
(police photo)*

and came to rest on its right plane. The Windstar then caught fire that spread to the occupant compartment. The driver and second-row left occupant of the Windstar were trapped. The unbelted front-row passenger was fully ejected. All three were declared deceased on-scene. The 3-year-old and 5-year-old females were assisted from the vehicle by passersby and transported to a local hospital, where they were admitted for two days while being treated for minor injuries. The cab of the Ranger separated from the chassis and cargo bed, overturned, and came to rest on the roadway. The unbelted Ranger driver was fully ejected and declared deceased on-scene.

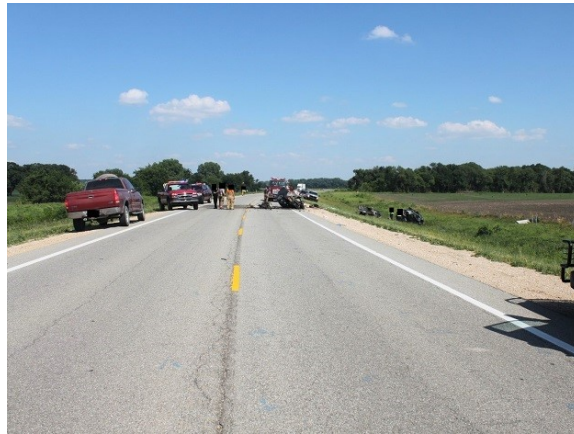
The crash site was an undivided, two-lane, east/west, U.S. highway in a rural area of Kansas (Figure 2). The surface was paved with asphalt in traveled condition. The roadway was configured with lanes measuring 2.7 m (12.0 ft) wide from the centerline to the fog line with additional pavement measuring 0.8 m (2.7 ft) wide from the fog line to the edge of the pavement. The roadway was bordered by unpaved shoulders measuring 2.6 m (8.5 ft) wide, and the roadside consisted of sloping ground leading to drainage ditches. The centerline was a dashed yellow painted stripe configured with a continuous rumble strip. The fog lines were solid white painted stripes. In the eastbound direction, the roadway curved right in a radius measuring 1,160 m (3,805 ft) from the right fog line. The speed limit was 104 km/h (65 mph). Conditions at the time of the crash were daylight, clear, and dry. Temperature was 35.5 °C (96 °F), relative humidity was 41 percent, and winds were southerly at 13 km/h (8 mph). A crash diagram is included at the end of this report.

*Figure 2. Crash site looking east (police photo)*

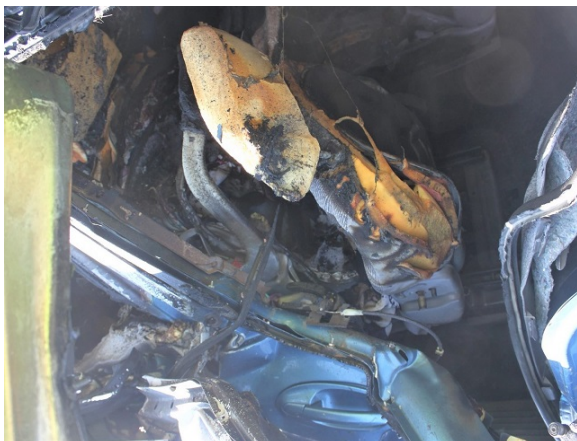
The child using this seat met the weight and height parameters. The CRS sustained burn damage and was likely damaged due to being compressed between the front and second-row seat backs. According to the police report, this child was trapped in the vehicle and required extrication. In addition to severe head injuries, she sustained injuries to the upper and lower extremities consistent with the loading of the harness straps.

*Figure 3. Baby Trend EZ Flex-Loc infant safety seat, second-row left seat position, the 2001 Ford Windstar (police photo)*

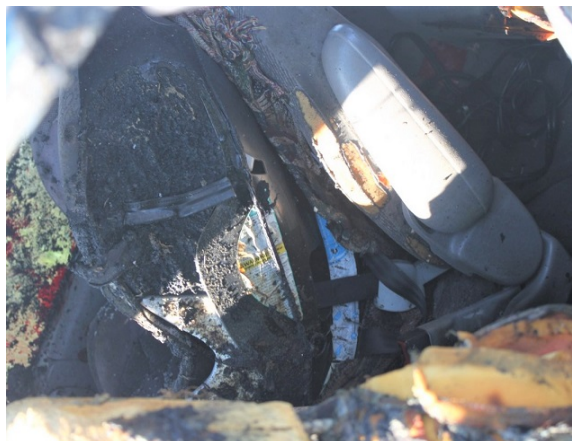
*Figure 4. Unknown make/model CRS, second-row right seat position, the 2001 Ford Windstar (police photo)*

The 3-year-old female in the second-row right position was seated in a forward-facing CRS of an unknown make/model. Police images indicate that the CRS was installed using LATCH lower anchors (Figure 4). It was unknown if the tether was used. This CRS remained inside the vehicle and sustained fire damage after the occupant was removed. The occupant's medical records indicate she sustained abrasions to both shoulders caused by loading of the harness straps, suggesting the harness was used. The parameters for using this CRS installed with LATCH in a forward-facing orientation are unknown, and no further data were available.

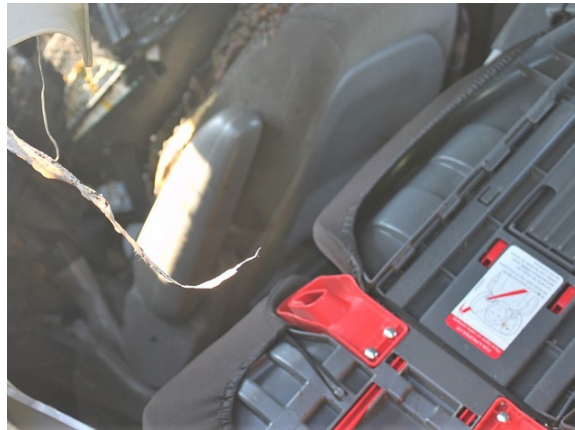
The 5-year-old female in the third-row left position was seated in a forward-facing Graco TurboBooster Highback CRS (Figure 5), in combination with the vehicle's lap and shoulder seat belt. It had an optional high-back support, adjustable headrest and armrests, a removable seat cushion, a cup holder, shoulder belt guides, and a belt-positioning clip. The parameters for using this CRS with the back support are as follows:

*Figure 5. Graco TurboBooster Highback CRS, third-row left seat position, the 2001 Ford Windstar (police photo)*

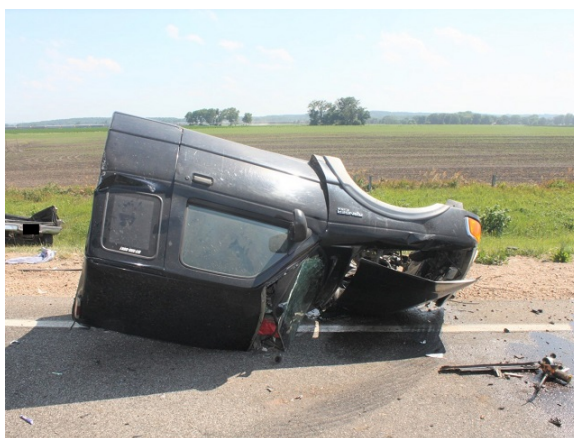
The Ranger sustained major damage at impact with the other vehicle. The cab separated from the chassis, overturned onto its right plane, and came to rest in the eastbound lane. The chassis and cargo bed departed the roadway and came to rest on the roadside. The estimated CDC for the Ranger in Event 1 was 02RYEW99, and the estimated CDC for Event 3 was 00R99O99.

*Figure 6. The 1995 Ford Ranger cab, final rest position (police photo)*
