DOT HS 813 166

# **Special Crash Investigations: Remote Vehicle Fire/Child Restraint System Investigation; Vehicle: 1999 Dodge Durango; Location: California; Crash Date: June 2016**

**Special Crash Investigations**  
**Remote Vehicle Fire/Child Restraint System Crash Investigation**  
**Case Number: DS19019**  
**Vehicle: 1999 Dodge Durango**  
**Location: California**  
**Crash Date: June 2016**

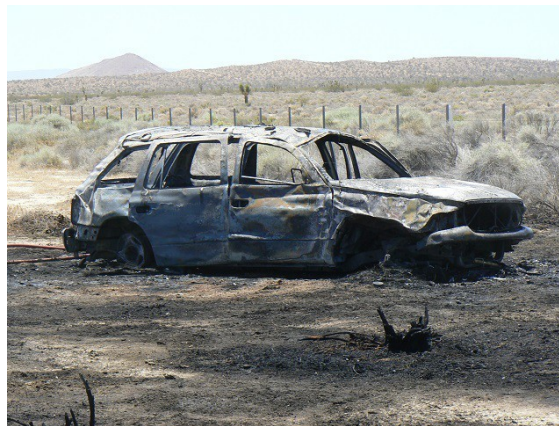
This report documents the remote vehicle fire/child restraint system (CRS) investigation of a post-crash fire in a 1999 Dodge Durango (Figure 1) in a single-vehicle rollover crash and the CRS usage by four children riding in it. The investigation is intended to examine the events leading to the fire, how quickly the fire spread to the occupant compartment, the magnitude of the fire, the time sequence in which emergency medical services (EMS) and other responders arrived on-scene, occupant restraint usage, demographics, injury data, and CRS usage. The crash was identified during a review of Fatality Analysis Reporting System (FARS) crash reports. The criteria for the crash type include an impact that does not involve the back plane, a fire that spreads to the occupant compartment, and at least one occupant seated in a CRS. The Special Crash Investigations (SCI) team obtained the on-scene images, and the SCI group of the National Highway Traffic Safety Administration initiated the case in August 2019.

*Figure 1. The 1999 Dodge Durango (police photo)*

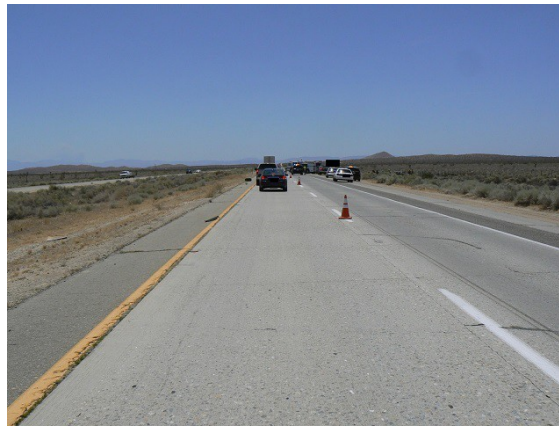
The crash site was a southbound, two-lane, divided State highway in rural California (Figure 2). The roadway was straight and level with a paved asphalt surface in traveled condition. The lanes measured 3.6 m (12.0 ft) and were separated by a dashed white painted stripe. The roadway was bordered on the left by a solid yellow painted stripe and on the right by a solid white fog line. A paved shoulder measuring 3.2 m (10.5 ft) in width included a rumble strip at the fog line. The speed limit was 113 km/h (70 mph). The roadside on the right consisted of level, unpaved ground and scattered sagebrush. Conditions at the time of the crash were daylight, clear, and dry. Weather conditions at the time of the crash were 32.8 °C (91.0 °F), 24 percent humidity, clear visibility, and winds west at 11.3 km/h (7.0 mph). A crash diagram is included at the end of this report.

*Figure 2. Crash site, looking south (police photo)*

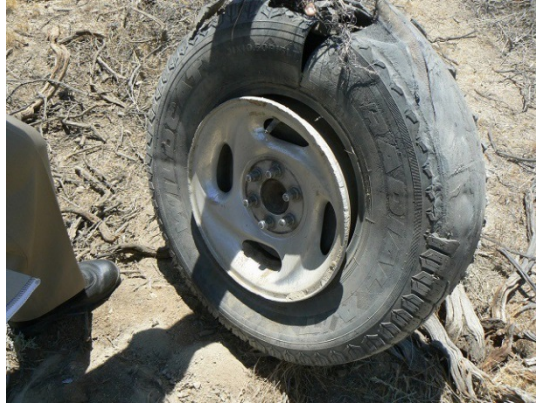
The Dodge was traveling south in the second lane from the right at a police-estimated speed of 113 km/h (70 mph) when the left-rear tire delaminated and flattened, causing the driver to lose control of the vehicle. The left-rear tire and wheel deposited marks on the roadway measuring approximately 113 m (370 ft) long during which time the tire de-beaded and separated from the rim. The Dodge initiated a clockwise rotation and departed the roadway on the right edge while in a left-side-leading yaw.

*Figure 3. Left-rear tire, the 1999 Dodge Durango (police photo)*

The left-side tires furrowed into the ground, causing the vehicle to trip left-side-leading and overturn along its longitudinal axis four quarter-turns over a roll distance of 40 m (130 ft). The Tire Identification Number of the left rear tire was not legible. It was purchased used by the vehicle owner, so the tire's age and history were unknown. The other tires were destroyed during the fire.

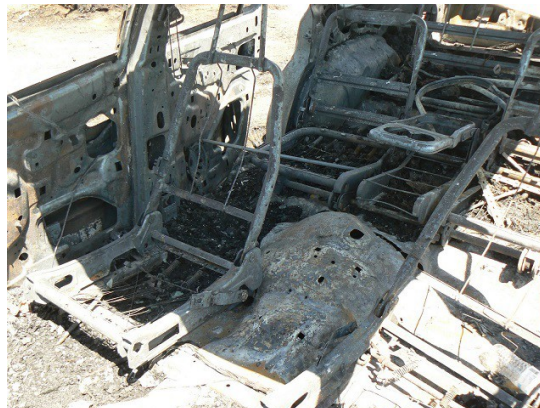
The Dodge's interior sustained damage caused by impact forces and fire (Figure 4). All windows were disintegrated or removed. The seats and other interior components were destroyed by the fire.

*Figure 4. Front and second rows, the 1999 Dodge Durango (police photo)*
