DOT HS 813 220

# **Special Crash Investigations: On-Site Alleged Driver Air Bag Fatality Crash Investigation; Vehicle: 2009 Saturn Aura; Location: Indiana; Crash Date: January 2020**

**Special Crash Investigations**  
**On-Site Alleged Driver Air Bag Fatality Crash Investigation**  
**SCI Case No: CR20014**  
**Vehicle: 2009 Saturn Aura**  
**Location: Indiana**  
**Crash Date: January 2020**

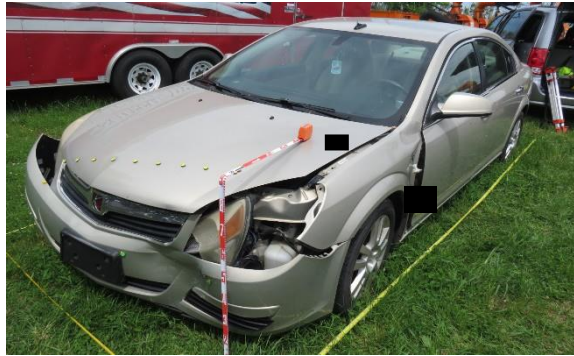
*Figure 1. 2009 Saturn Aura*

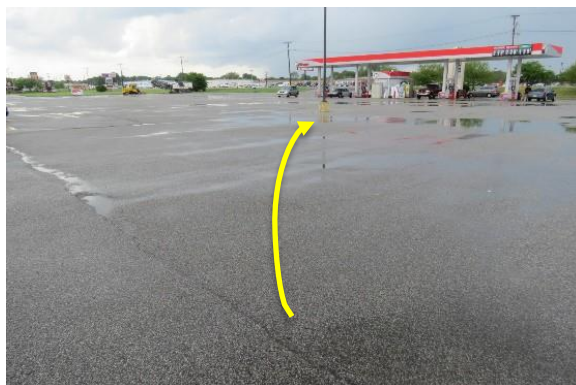
The police investigation determined that the driver of the Saturn drove northwestward through the parking lot (Figure 2) and was intending to meet an acquaintance who was parked near the fuel pumps in the northern part of the same lot. The Saturn traveled through the parking lot at EDR-recorded speeds ranging from 19 to 31 km/h (12 to 19 mph). The driver was steering to the right and the vehicle traversed a clockwise arcing trajectory (Figure 2). EDR data indicated she applied the brakes 2.0 seconds prior to algorithm enable (AE). One second prior to AE, the vehicle was traveling 29 km/h (18 mph).

*Figure 2. Northwest view of the Saturn's estimated approach to the point of impact*

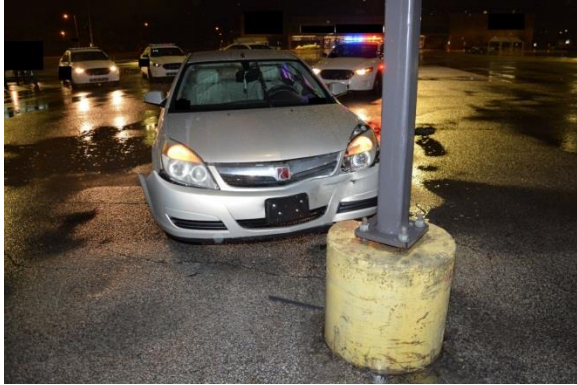
The front plane, left and center aspects of the Saturn struck the concrete base of the light pole (Figure 3), which measured 63 cm (24.8 in) in diameter. The direction of force was in the vehicle's 12 o'clock sector. The driver's frontal air bag deployed and both front-row seat belt retractor pretensioners actuated. The Saturn crushed and then rebounded, coming to final rest approximately 46 cm (18.1 in) south of the concrete base (Figure 4).

*Figure 3. South-facing on-scene police image of the Saturn and the struck concrete base of the light pole*

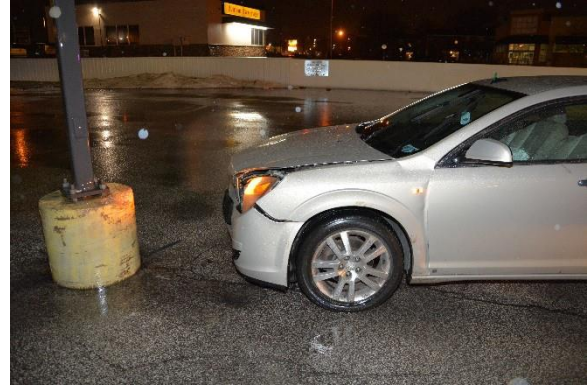
*Figure 4. East-facing on-scene police image of the Saturn at final rest*

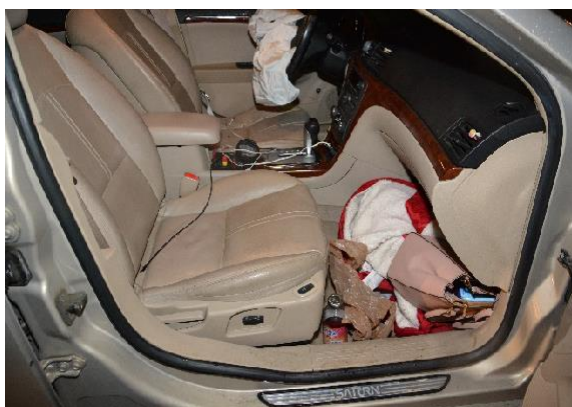
The front row was equipped with leather-upholstered bucket seats with adjustable head restraints. The driver's seat track was adjusted to a middle position (Figure 5) and the bottom of the driver's head restraint was 5 cm (2.0 in) above the top of the seatback.

*Figure 5. Front row of the Saturn. Note: seat track position for driver. (On-scene police image)*

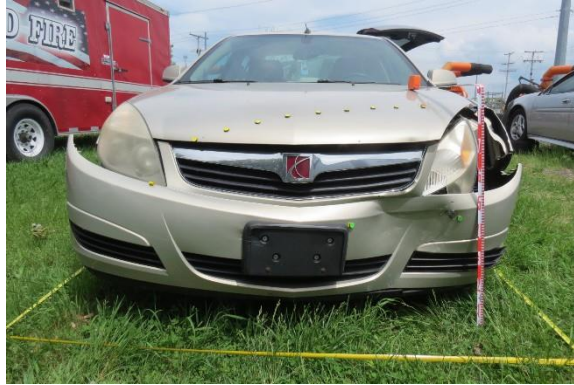
The Saturn sustained direct contact damage to the left and center aspects of the front plane from impact with the concrete base of the light pole (Figure 6). The bumper beam, bumper fascia, grille, left head and turn light assemblies, and hood were directly damaged. The direct contact started 21 cm (8.3 in) left of the centerline and extended 40 cm (15.7 in) left. The crush measurements were documented on the front bumper beam and the Field L was 104 cm (40.9 in). For demonstrative purposes, the magnets across the hood of the Saturn in Figure 6 represent the approximate location of the deformed bumper beam. The residual crush values were C1 = 28 cm (11.0 in), C2 = 23 cm (9.1 in), C3 = 16 cm (6.3 in), C4 = 9 cm (3.5 in), C5 = 5 cm (2.0 in), C6 = 0 cm. The maximum residual crush was 28 cm (11.0 in) and was located 49 cm (19.3 in) left of center.

*Figure 6. Front plane damage to the Saturn*

The barrier algorithm of the WinSMASH program was used to calculate the severity of the crash. The Saturn's total delta V was 29 km/h (18.0 mph). The longitudinal and lateral velocity changes were -29 km/h (-18 mph) and 0 km/h, respectively. The results appear reasonable. The EDR-recorded longitudinal delta V was -28.3 km/h (-17.6 mph). The Collision Deformation Classification for the front plane impact was 12FYEN2 (0 degrees).

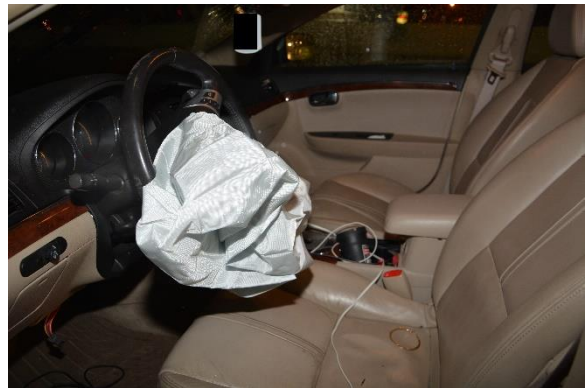
*Figure 8. On-scene police image of the Saturn's interior. The steering wheel is rotated an estimated 30 degrees to the left (counter-clockwise)*

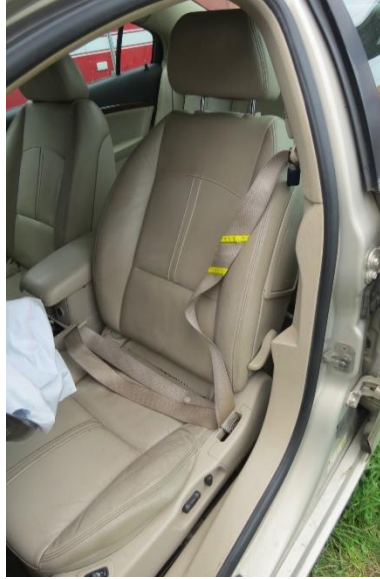
The Saturn was equipped with manual 3-point lap and shoulder seat belts for the five occupant positions. The driver's seat belt system consisted of continuous loop webbing that retracted onto an emergency locking retractor (ELR) with a sliding latch plate. The D-ring was adjusted to the full-down position. The EDR reported that the retractor pretensioner actuated. At inspection, the retractor was not locked. The belt webbing could be extended and retracted; however, did not operate smoothly. The driver was restrained by her lap and shoulder seat belt as evidenced by load marks on the seat belt and D- ring (Figure 9). A 6 cm (2.4 in) load mark on the belt webbing from contact to the D-ring was located 168 cm (66.1 in) from the seat frame left anchor point. Additionally, subtle load marks were also noted on both sides of the latch plate belt guide.

*Figure 9. The Saturn driver's seat belt evidence*

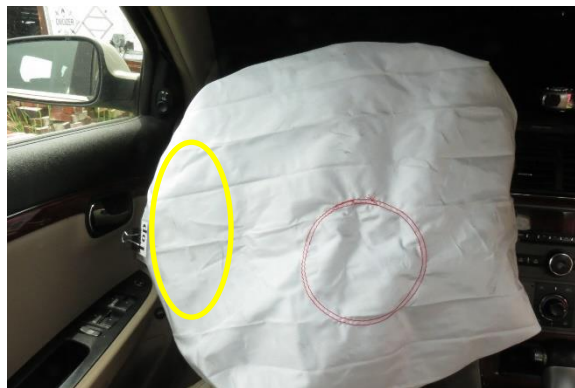
The driver's frontal air bag (Figure 10) was located in the steering wheel hub. The air bag measured 52 cm (20.5 in) in diameter in its deflated state. There was minor scuffing located at the 12'clock sector of the air bag. Note that the steering wheel is turned 90-degrees to the left in the figure. The module cover was a two-flap configuration made of semi-rigid vinyl, with a vertical tear seam in the center. The flaps were 5 cm (2.0 in) wide and 14 cm (5.5 in) in height. The cover flaps opened at the designated tear seam and were undamaged.

*Figure 10. Driver's frontal air bag of the Saturn*

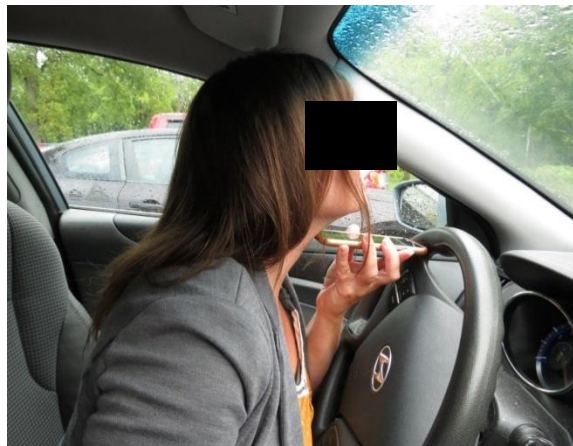
Based on police records, cell phone records, the SCI crash reconstruction, and the sustained injuries and injury patterns, the driver was most likely out-of-position, forward with her head turned to the left. This position was due in part to the rainy conditions that obstructed her view out the side window. She was most likely looking through the cleared portion of the windshield attempting to locate the vehicle of her acquaintance that was parked forward and left of the Saturn's movement. In this driving position, the cell phone was most likely held forward of her torso/face in close proximity to the steering wheel rim/spoke as depicted in Figure 11. The surrogate in the figure is the same height as the Saturn driver and the seat is adjusted to a mid-track position.

*Figure 11. Image depicting the probable position of the Saturn driver and the cell phone at impact with the concrete base of the light pole*

The front plane/left and center aspect of the Saturn struck the concrete base of the light pole. The resultant direction of force was 12 o'clock. The out-of-position driver initiated a forward trajectory in response to the impact force. Her anterior neck likely engaged the edge of the horizontally held cell phone and captured the phone against the steering wheel rim/spoke, causing a fracture of the thyroid cartilage with vocal cord involvement, a pharynx laceration, and an abrasion and contusion over the midline of the neck. The dimensions of the focal contusion and cartilage

fracture approximated the edge loading of the cell phone. The thyroid and pharynx injuries resulted in the pneumomediastinum.<sup>1</sup> This cell phone engagement occurred prior to air bag deployment as the driver responded to the frontal crash forces. At the time of deployment, the Saturn had experienced a longitudinal velocity change of 15.3 km/h (-9.5 mph). The air bag deployment was commanded at 54 milliseconds after AE.
