DOT HS 813 246

January 2022

**Special Crash Investigations:
Remote Crash Avoidance
Technology Investigation;
Vehicle: 2019 Honda Accord;
Location: California;
Crash Date: September 2019**

Special Crash Investigations
Remote Crash Avoidance Technology Investigation
Case Number: DS20003
Vehicle: 2019 Honda Accord
Location: California
Crash Date: September 2019

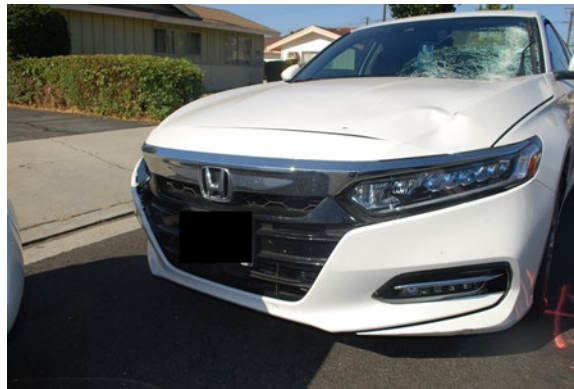
Figure 1. The 2019 Honda Accord (police image)

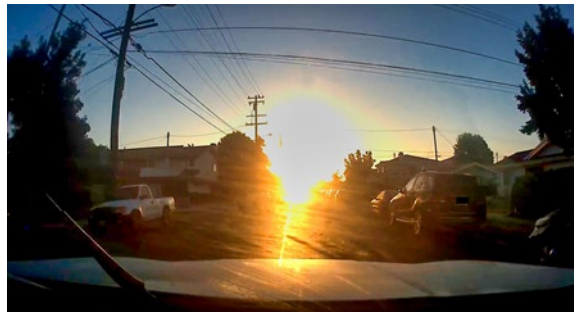
The driver was traveling from his residence to his parents' place of work. The windshield wipers were on for an unknown reason. The driver reported that the visor was down and that the sun was in his eyes (Figure 2). He was not wearing sunglasses. The driver had several medical conditions that limited his mobility. He drives using only his right hand. The vehicle was equipped with an after-market car camera system (Atom Gold Model EQ5000) that was in operation at the time of the crash. The camera was later removed by police investigators and secured as evidence. A copy of the video was obtained by SCI. The Honda was traveling eastbound and had stopped at an intersection approximately 54 m (178 ft) west of the area of impact. The driver accelerated from the stop eastbound (Figure 3) for approximately six seconds to an SCI-calculated speed of 49 km/h – 56 km/h (31 mph – 35 mph¹).

Figure 2. Driver's view prior to crash, extracted from onboard video

The environmental conditions at the time of the crash, particularly driving into low sunlight, probably caused the PAEB system not to identify the pedestrian early enough to apply the brakes.

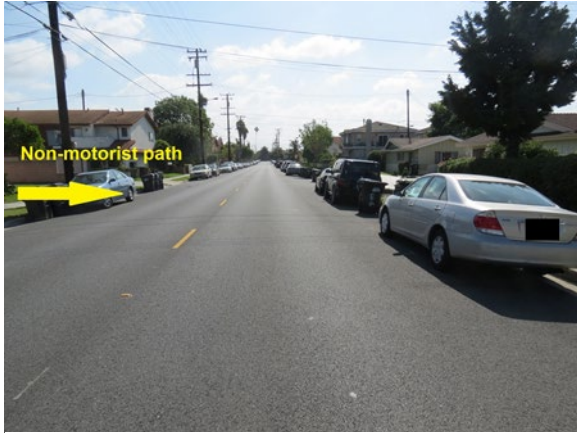
Figure 3. The 2019 Honda Accord approach to area of impact, looking east

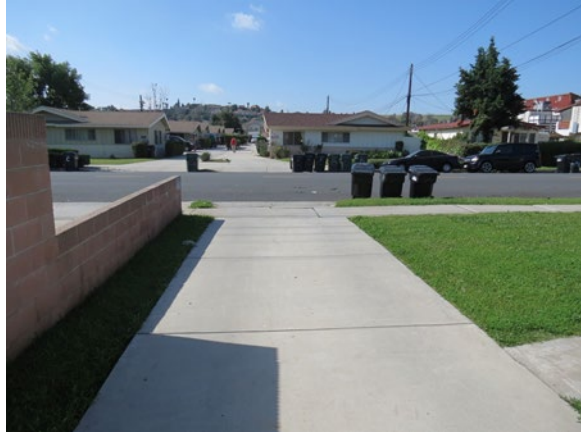
The pedestrian was walking southbound (Figure 4) and using a cane. He traveled approximately 6.4 m (21 ft) into the roadway prior to impact. It is unknown if he walked at a constant speed as he crossed the roadway or if he stopped at the roadway and then began crossing. In the first instance, using a 50th percentile walking velocity for people 60 years and older of 4.1 fps, he would have been in the roadway for 5.1 seconds. In the second instance, starting from a stop with a normal walking acceleration rate of 1.6 f/s/s, he would have reached walking speed in 2.6 seconds and would have been in the roadway for 6.4 seconds.

Figure 4. Pedestrian's path, looking south

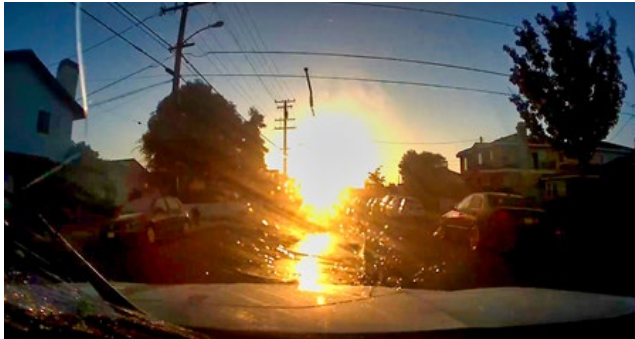
As the pedestrian crossed the westbound lane and entered the eastbound lane, he was struck by the front of the Honda (Figure 5). According to the police report, he was thrown 24.4 m (80.3 ft) to the east to the westbound travel lane (Figure 6). The driver of the Honda stopped, put the vehicle in reverse, and then backed up a certain distance before parallel parking the vehicle.

Figure 5. Driver view post-impact, extracted from onboard video

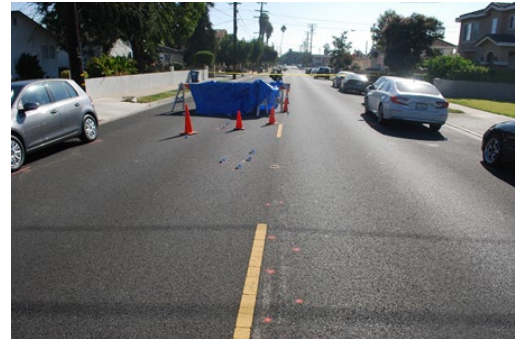
Figure 6. Pedestrian's path to final position, looking east (police image)

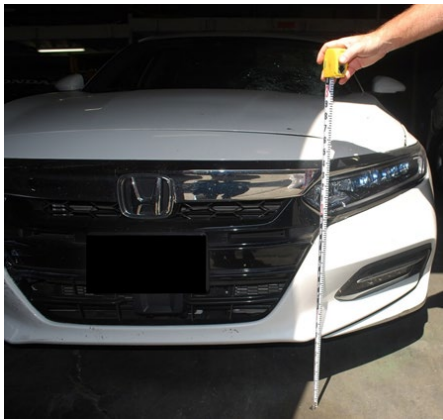
The Honda sustained moderate damage from the impact with the pedestrian (Figures 7–8). The left side of the hood had an indentation and a blue scuff mark. The aft side of the driver side hood was slightly deformed. The driver side windshield was fractured and pushed inward with blood and hair on the windshield. The collision deformation classification (CDC) was 12FLHW6. There was minor damage to the right side of the vehicle that was related to a previous collision, according to the driver.

Figure 7. Frontal damage, the 2019 Honda Accord (police image)

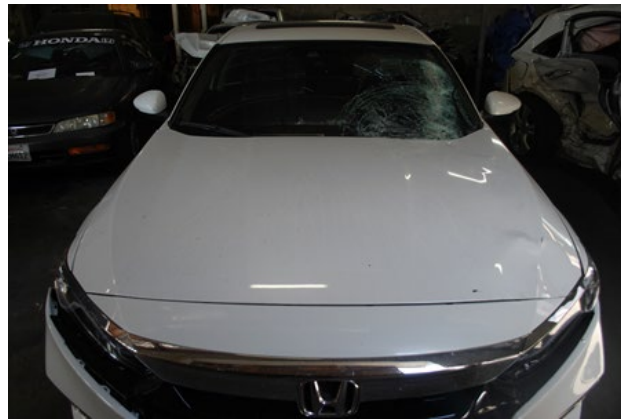
Figure 8. Windshield damage, the 2019 Honda Accord (police image)

There were no reports of any interior damage, other than the fractured windshield caused by the pedestrian impact.
