DOT HS 813 263

# **Special Crash Investigations: On-Site Driver Air Bag Non- Deployment Crash Investigation; Vehicle: 2007 Cadillac Escalade; Location: Texas; Crash Date: August 2020**

**Special Crash Investigations  
On-Site Driver Air Bag Non-Deployment Crash Investigation  
Office of Defects Investigation  
Case Number: CR20030  
Vehicle: 2007 Cadillac Escalade  
Location: Texas  
Crash Date: August 2020**

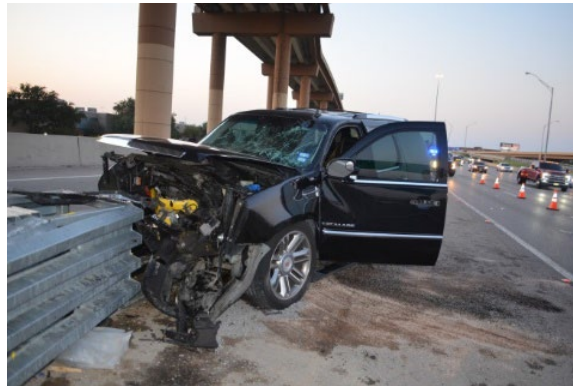
This on-site investigation documented the fixed-object crash of a 2007 Cadillac Escalade and the non-deployment of the driver's frontal air bag system (Figure 1). The Cadillac was originally equipped with certified advanced compliant frontal air bags, seat-mounted side impact air bags, inflatable curtain (IC) air bags, and front-seat belt pretensioners. The crash occurred when the unbelted 41-year-old male driver lost control of the vehicle during a lane change maneuver, according to the police report. The front plane of the Cadillac struck an impact attenuator in the gore area at an exit ramp on a multi-lane interstate highway. None of the air bags in the Cadillac deployed, and the pretensioners did not actuate. The driver sustained fatal injuries.

*Figure 1. On-scene police image showing the Cadillac and the frontal damage (image provided by the investigating police department)*

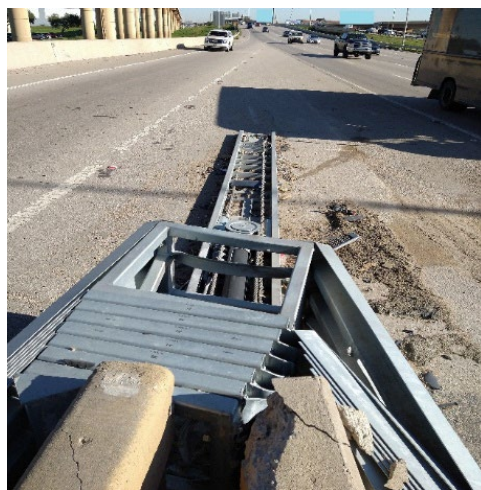
The front plane of the Cadillac struck the face of the impact attenuator. This face plate remained engaged to the deformed front plane of the Cadillac at the time of the SCI inspection. The direction of the impact force was in the 12 o'clock sector. The energy of the crash was absorbed by the attenuator, as it fully compressed (an estimated 6 m [20 ft]) against the V-shaped edge of the intersecting concrete Jersey barriers (Figure 5). The leading edge of the concrete barrier was fractured from engagement of the attenuator. The compression of the attenuator and vehicle deformation suggested an impact speed in excess of 89 km/h (55 mph) based on level 3 MASH testing.<sup>2</sup> In the MASH TL3 test, a full compression of the attenuator was observed with a 2,270 kg (5,000 lb) pickup truck test vehicle at 100 km/h (62 mph). However, the compressed attenuator from the test configuration could be reset and reused.

In the crash under investigation, the Cadillac weighed an estimated 2,585 kg (5,700 lb). Therefore, equivalent momentum dictates that an impact speed, comparable with the test configuration, would be approximately 89 km/h (55 mph). In the crash, the attenuator fully compressed, struck, and cracked the concrete barrier. The attenuator was deformed laterally, and it did not appear that it could be reused. The damaged condition of the attenuator suggested that the impact speed was more than 89 km/h (55 mph).

*Figure 5. North-facing lookback view of the deformed attenuator*

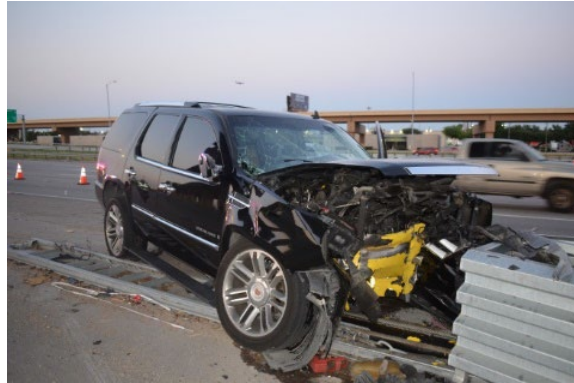
The Cadillac rebounded from the compressed impact attenuator and rotated clockwise approximately 20 degrees (Figure 6). Passersby notified the emergency response system; the police, fire, and emergency medical personnel were dispatched to the crash site. The driver was removed from the Cadillac and transported to a local trauma center. Cardiopulmonary resuscitative efforts were attempted; however, the driver was pronounced deceased approximately 40 minutes after the crash. The Cadillac was subsequently towed from the crash site to a police impound facility, where it was inspected for this SCI investigation.

*Figure 6. Northeast view, on-scene police image of the Cadillac engaged with the compressed impact attenuator*

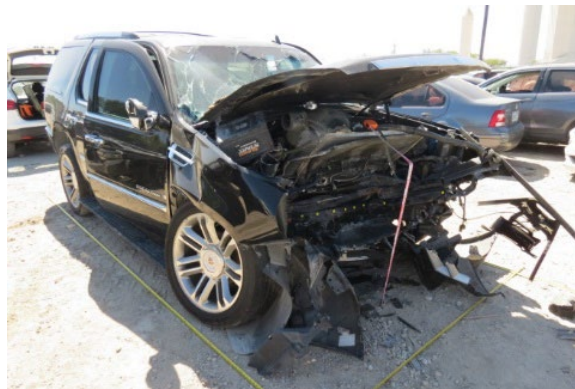
*Figure 7. Front right oblique view showing the severity of the frontal damage*

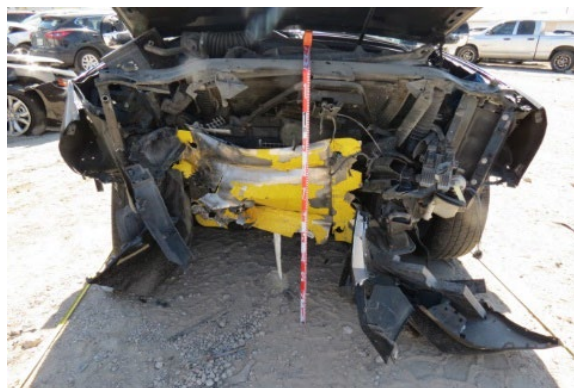
The Cadillac sustained severe frontal damage from its impact with the attenuator. The combined width of direct and induced damage involved the full 168 cm (66.0 in) width of the deformed end plane (Figure 8). The direct contact damage began 38 cm (15.0 in) left of center and extended 85 cm (33.5 in) to the right involving the left, center, and right aspects of the plane. The impact separated the bumper beam from the left frame rail mount and crushed the beam and right frame rail rearward. The engine and transmission were displaced rearward.

The crush profile was measured on an 87 cm (34.3 in) wide Field L. The maximum crush was 79 cm (31.1 in) located at the right frame rail, 54 cm (21.3 in) right of center. The residual crush profile documented across the deformed bumper beam was as follows: C1 = 16 cm (6.3 in), C2 = 76 cm (29.9 in), C3 = 75 cm (29.5 in), C4 = 75 cm (29.5 in), C5 = 77 cm (30.3 in), and C6 = 79 cm (31.1 in). The right wheelbase was shortened 9 cm (3.5 in). All four doors remained closed during the crash. Rescue personnel opened the driver's door at the crash scene to evaluate and remove the driver. The right front door was opened at a later time. Both doors were not re-latched due to body distortion. The windshield was completely fractured and starred by driver contact. There was no deformation to the hood. The collision deformation classification (CDC) assigned to the damage was 12FDEW4.

*Figure 8. Frontal damage to the Cadillac with the face of the attenuator still engaged in the damage*

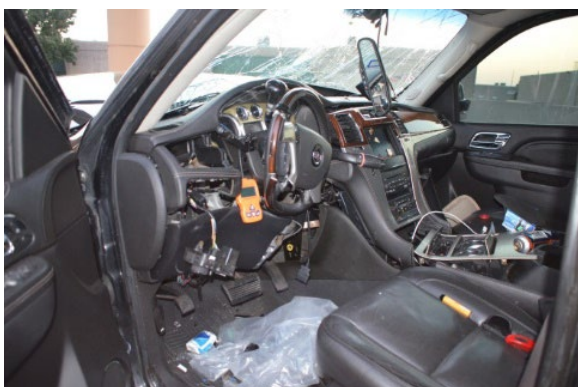
The unbelted Cadillac driver contacted interior components directly forward of his seated position, causing substantial damage. Most notably, he loaded, deformed, and fractured the alloy steering wheel rim and spokes. The lower sector of the rim was displaced forward 6 cm (2.4 in) and displaced vertically approximately 3 cm (1 in). The spokes/mounting flange was fractured, resulting in complete separation of the wheel from the column. The driver's loading force also fully compressed the energy-absorbing steering column. Compression of the steering column fractured the column-mounted transmission shift lever from the column. The on-scene police images showed the steering wheel in place, compressed against the instrument panel (Figure 9).

*Figure 9. Overall view of the driver's compartment and the occupant contact to the frontal components (image provided by the investigating police officer)*

- Images obtained from the police showed the steering wheel resting atop the column (Figure 9 above). It was determined that the unbelted driver loaded the steering wheel rim and fractured the alloy hub and spokes of the steering wheel, completely separating the wheel from column. However, the initial observation by the SCI investigator found the steering wheel hanging from the column by three wire bundles (Figure 10 above). The exposed wiring looked irregular. A local Cadillac dealer, who was queried about the wiring, confirmed that it was not an OEM (Original Equipment Manufacturer) part.

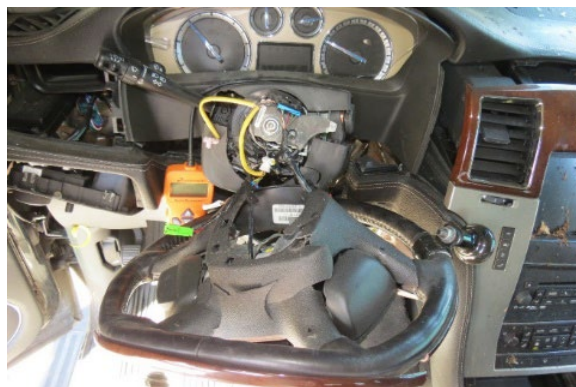
At the time of the SCI inspection, the fractured and deformed steering wheel rim was separated from the steering column, hanging by three wire bundles (Figure 10). The wires, which were connected to the horn, heated the steering wheel control and the switches that operated the cruise control. The wiring appeared to be irregular and not original. This was corroborated at a local GM dealership. The connectors on the two yellow air bag wires from the clockspring were not connected to the squibs of the air bag inflator. Refer to the Supplemental Restraint Systems and Air Bag Non-Deployment section of this report for more details on the driver air bag, its condition, and the wiring.

*Figure 10. SCI inspection image of the observed position of the fractured steering wheel rim and wiring*

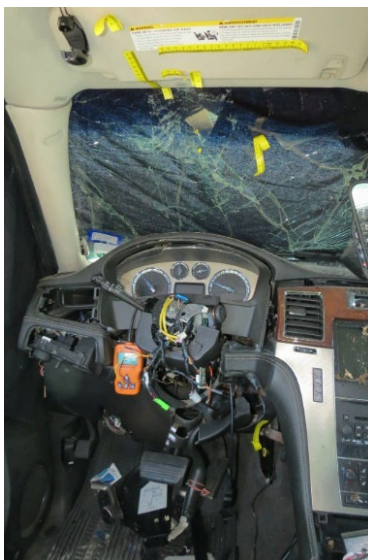
The lower left instrument panel/knee bolster was deformed from driver contact. The driver's left knee/lower leg contacted the intruding left aspect of the knee bolster. The polymer panel was deformed with compression of the steel backer panel. His right knee deformed and fractured the polymer panel, also deforming the backer panel.

The laminated windshield was fractured full height and width due to frontal structure displacement. There was no bond separation or holing of the laminated windshield. The driver's forehead struck and fractured the windshield in a star pattern directly below the windshield header (Figure 11). Hair was observed embedded into the fracture site. His scalp contacted the fabric-covered windshield header and sun visor directly above the windshield contact point. The header and visor were scuffed with hair on the visor. The visor was not damaged or displaced.

*Figure 11. Overall image of the left forward interior showing the driver contacts*

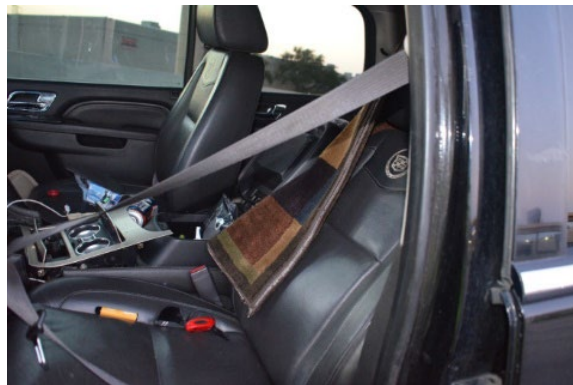
The police inspected the seat belt and found the webbing intact (Figure 12). At the time of the SCI inspection, the webbing was cut for unknown reasons, and the latch plate was missing. The location of the cut was on the lap belt portion of the webbing. Inspection of the webbing was unremarkable for contact or crash-related loading evidence. The webbing could be extended and retracted as designed. The observed evidence suggested that the pretensioner did not actuate. However, due to the lack of EDR data, status of pretensioner actuation is unknown. The physical evidence observed at the SCI inspection indicated that the driver was not belted at the time of the crash.

*Figure 12. On-scene police image documenting the intact driver's seat belt system prior to being cut for unknown reasons*

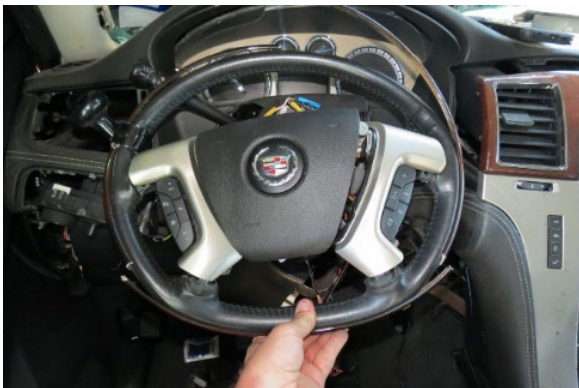
The driver's frontal air bag was mounted in the center of the four-spoke steering wheel rim (Figure 13). Driver loading of the steering wheel/column fractured the steering wheel spokes and center hub, thus separating the steering wheel and air bag module from the column.

During the SCI inspection, the driver's frontal air bag module was separated from its mounted location in the steering wheel rim and inspected (Figure 13). The driver air bag inflator was identified by Part No.: AB14?M1M?150 and Generator Type BA01090 (the question marks denote undetermined characters, possibly 8 or 0). An additional identifier of BAM-PT-1073 was stamped below the generator type. The manufacturer was Autoliv of Ogden, Utah. A date of 2012 was stamped on the inflator, indicating that this inflator was a replacement, although the Cadillac had no Carfax-reported history of air bag deployment or replacement. Furthermore, an

*Figure 13. Driver's frontal air bag module in the fractured hub/spokes of the steering wheel*

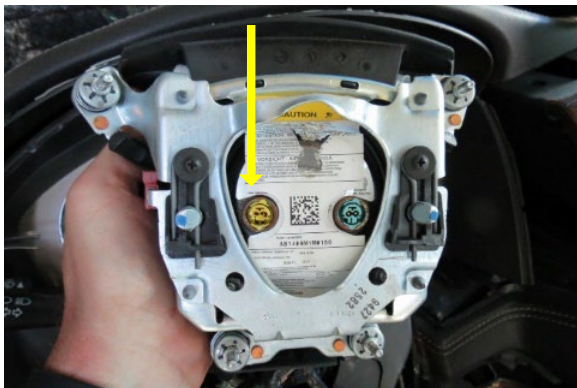
online search was conducted for exemplary OEM inflators, and it was observed that the wiring connectors were pink and white, not green and yellow as seen on the inflator in question (Figure 14).

*Figure 14. Backside of the driver's frontal air bag module and the inflator*

During the inspection of the driver's frontal air bag module, it was observed that the manufacture date of 2012 was stamped on the driver's frontal air bag inflator with the manufacturer identified as Autoliv. This indicated that the air bag was replaced at some point during the vehicle's history without documentation in the history report.

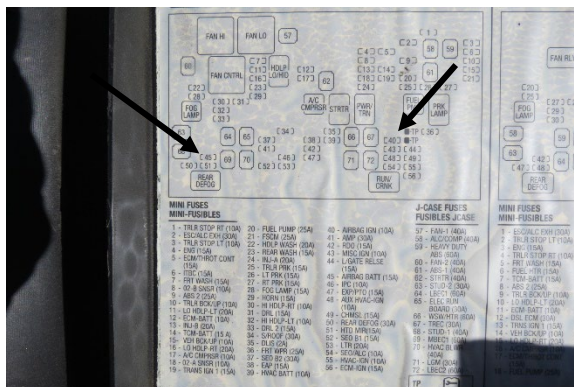
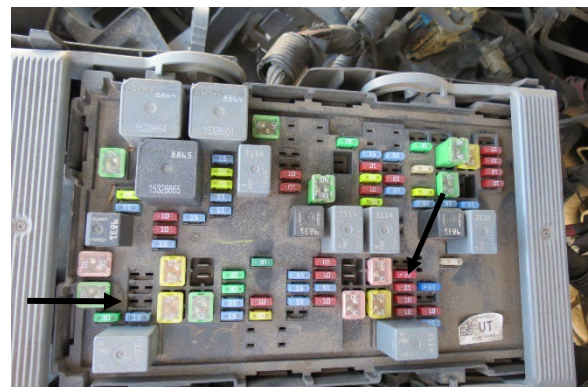
For reference, a review of the 2007 Cadillac Escalade owner's manual<sup>3</sup> determined that the underhood fuse panel layout differed from the inspected panel. The air bag fuses labeled in the manual were #39 and #51, with the corresponding layout in Figure 17. Although undetermined, the differences in the fuse panels may be related to the salvage title and rebuild of the Cadillac.

Figure 15. An image showing the map of the Cadillac's fuse locations

Figure 16. Image showing the underhood fuse panel of the Cadillac

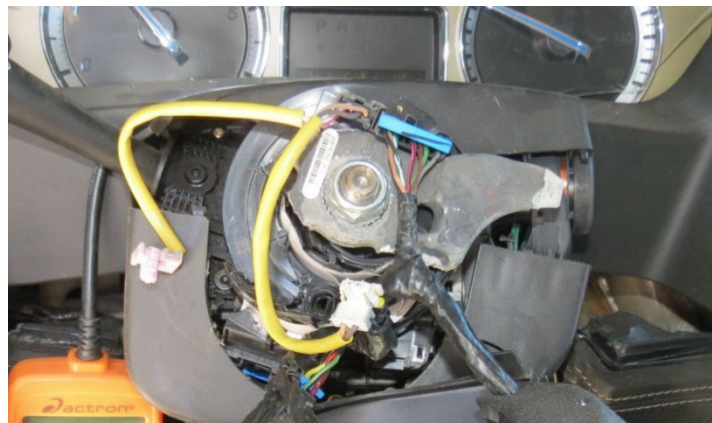
- The yellow wire-jacketed leads from the clockspring were not connected to the squibs on the inflator of the driver's frontal air bag. During the driver's contact and compression of the wheel, the fracture of the alloy structure allowed the backside of the driver's frontal air bag inflator to contact the steering column shaft and containment nut. This contact gouged the label on the inflator and bent the mounting bracket. The plastic housing surrounding the clockspring also fractured. Additionally, the polymer connector of the inboard squib was fractured, and the terminal was displaced (Figure 14 above). The corresponding connectors on the aforementioned air bag wiring leads were not damaged (Figure 18). Further, had the connectors been engaged to the terminals, the isolated damage to the squib would not have occurred. It is the conclusion of the SCI investigation that the air bag wire connectors from the clockspring were not connected to the replacement driver's air bag module at the time of the crash.

Figure 18. Close-up image showing the two wire leads from the clockspring and the undamaged squib connectors
