U.S. Department
of Transportation

**National Highway
Traffic Safety
Administration**

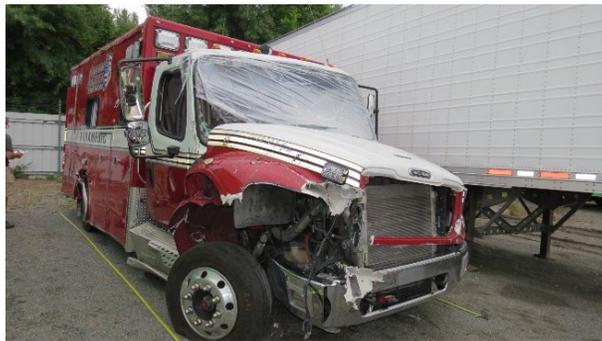
Figure 1. Forward-right oblique view of the 2012 Freightliner M2 Type I ambulance at the time of the SCI inspection

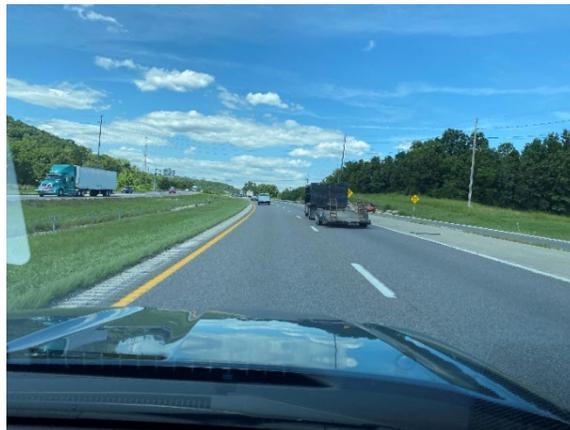
Figure 2. North-facing view of the roadway and pre-crash approach of the Jeep

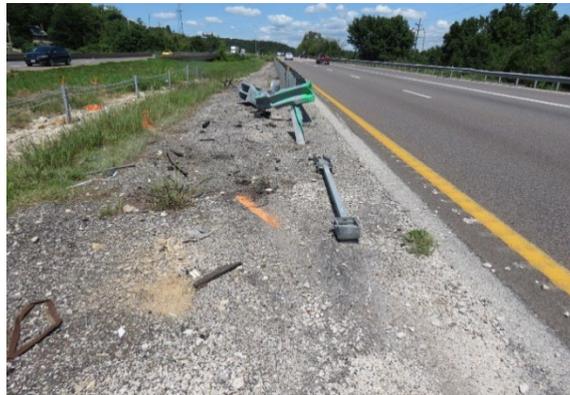
Figure 3. Northeast view of the guardrail struck by the right plane of the ambulance

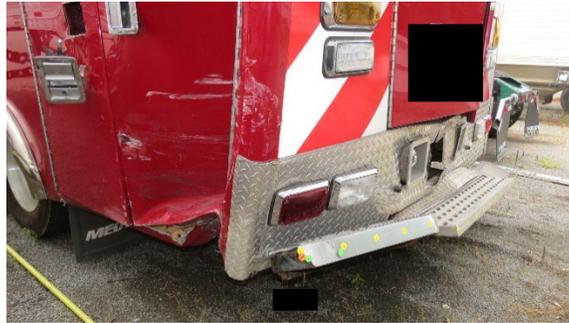
Figure 6. Left-rear oblique view of the 2012 Freightliner depicting the Event 1 damage

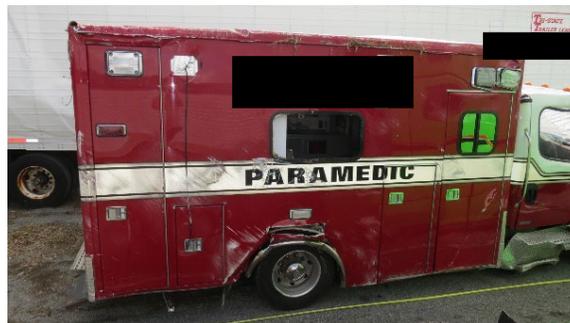
Figure 7. Right-plane view of the 2012 Freightliner depicting the damage sustained from Event 2 and Event 4

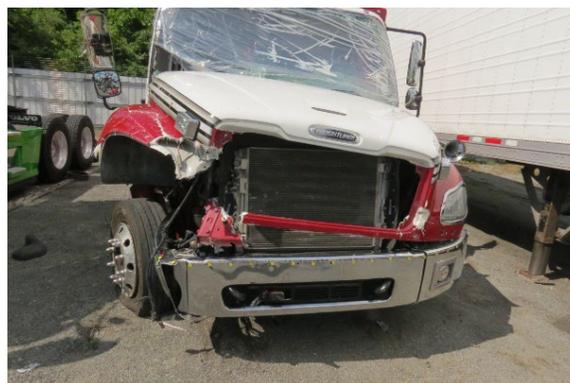
Figure 8. Front-plane view of the 2012 Freightliner depicting the Event 3 damage

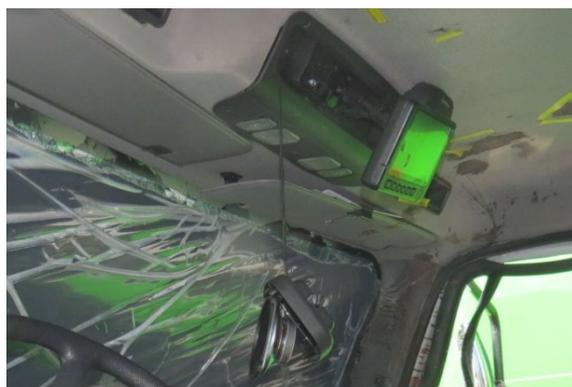
Figure 9. View of the 2012 Freightliner cab interior depicting the broken speaker

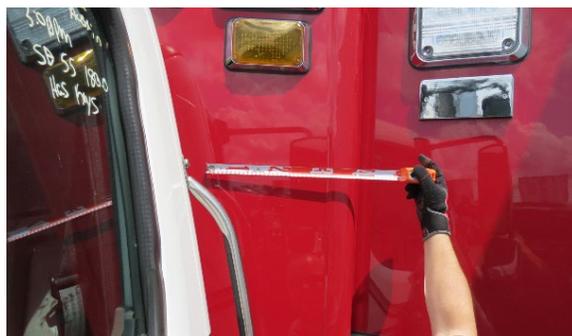
Figure 10. Leftward shifting of the patient compartment

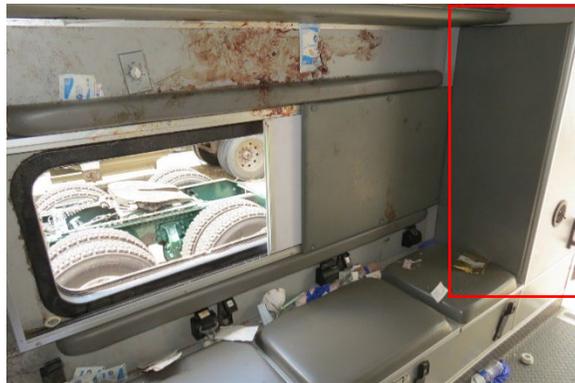
Figure 11. View of the right bench rear wall of the patient compartment where the paramedic contacted with his back

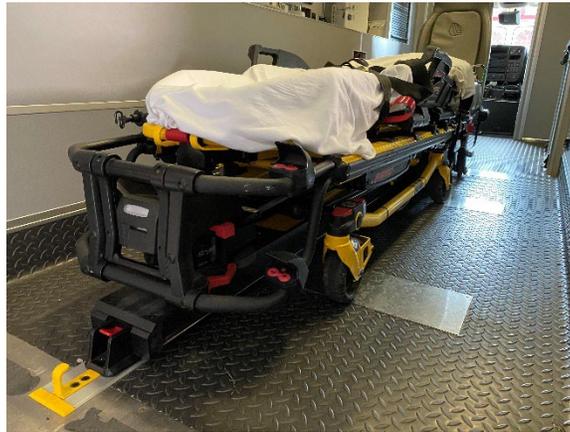
Figure 14. Image of an exemplar patient cot secured to the Stryker Power-LOAD cot fastening system

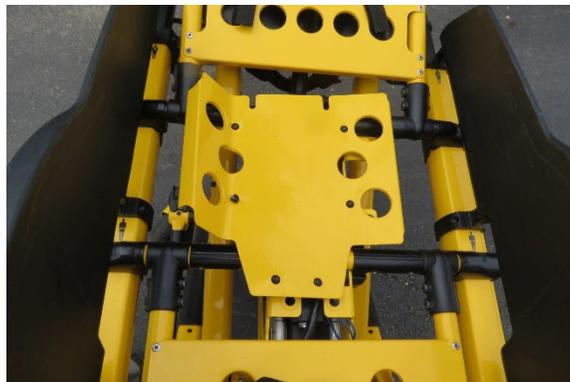
Figure 15. Image of the damaged plate on the patient cot

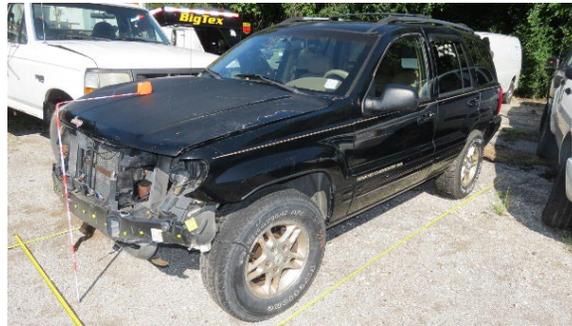
Figure 16. Front-left oblique view of the 1999 Jeep Grand Cherokee

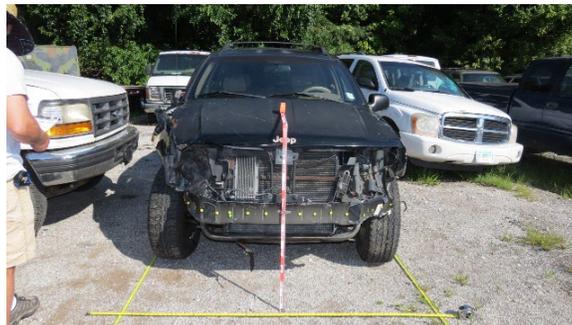
Figure 17. Front-plane view of the Event 1 and Event 6 damage sustained by the Jeep

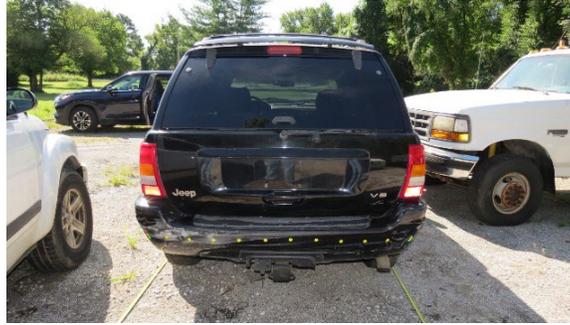
Figure 18. Rear-plane view of the Event 5 damage sustained by the Jeep
