DOT HS 813 302

# **Special Crash Investigations: On-Site Reported Vehicle Component Malfunction Investigation; Vehicle: 2017 Dodge Challenger; Location: Arkansas; Crash Date: June 2020**

**Special Crash Investigations  
On-Site Reported Vehicle Component Malfunction Investigation  
Office of Defects Investigation  
Case Number: CR20020  
Vehicle: 2017 Dodge Challenger  
Location: Arkansas  
Crash Date: June 2020**

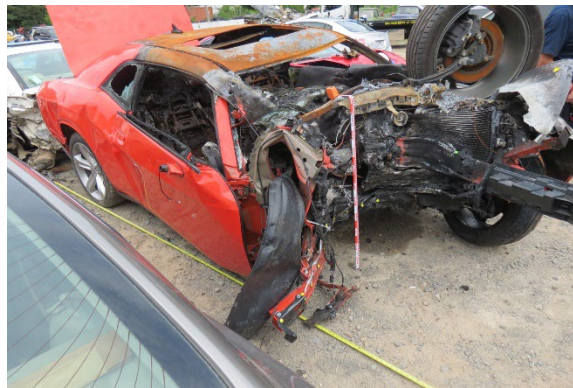
This report documents the claim of a right-front-wheel malfunction separation and the crash and fire of a 2017 Dodge Challenger (Figure 1) that struck an iron fence and a large tree. The crash resulted in police-reported “C” (possible) injuries to the 23-year-old male driver. The crash occurred during the dark morning hours of June 2020 and was investigated by a local police agency. The driver claimed that the “entire front passenger wheel completely broke off” and resulted in loss of control of the vehicle. He notified the National Highway Traffic Safety Administration of the crash in July 2020. The investigation was assigned to the Special Crash Investigations team at Crash Research and Analysis, Inc., in July 2020. The team contacted the driver as well as the tow yard holding the vehicle and established cooperation to inspect the vehicle. The vehicle and scene inspections as well as the driver interview were all completed in July 2020.

*Figure 1. The 2017 Dodge Challenger*

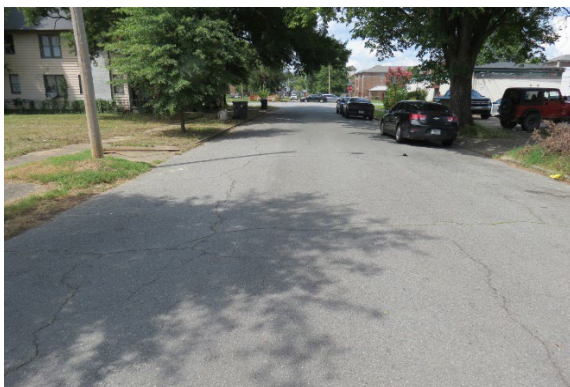
The Dodge was northbound on the undivided street and approached the intersection (Figure 2) at high but unknown rate of speed. This determination is based solely on the significant damage to the front plane of the vehicle since there was no supporting EDR data and the driver could not remember anything from the crash sequence. As the Dodge approached the intersection, its right front tire/rubber created a mark (Figure 3) that began on the two-lane street and extended into the crossing street. The tire mark arced to the left and began as a full tread width mark. The mark then appeared to narrow and wobble, transitioning to a scratch on the sidewalk located at the curb cut-out in the northwest quadrant of the intersection. This scratch was most likely caused by contact from the right front wheel rim, as the tire may have deflated at some point along this trajectory. The total length of the tire and wheel mark was 31.5 m (103.3 ft). There was no evidence of a curb strike along this trajectory. The physical evidence of the mark on the roadway appeared to be consistent with a tire that was airing out or going flat, allowing the rim edge to scratch the road/sidewalk. The cause of the air-out remains undetermined. It was possible that the Dodge struck a curb earlier during this drive-cycle. A small dent to the right front rim was observed during the SCI vehicle inspection.

*Figure 2. North view, the Dodge's approach to the T-intersection*

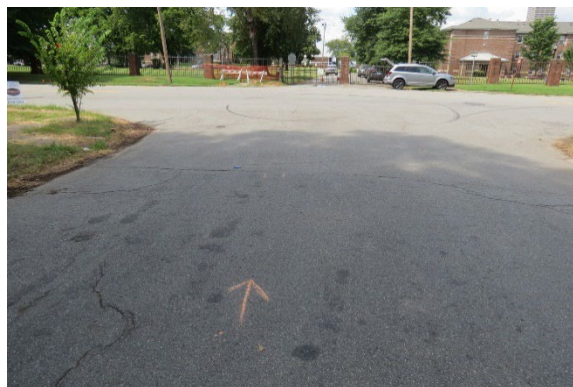
*Figure 3. North view, start of tire mark and approach to the intersection*

The driver's impression of a control loss may be related to the possibility that the right front tire had aired out on the approach to the crash site. This air-out was evidenced by the transition of the pre-crash tire mark from a wide tread pattern that narrowed to a scratch mark caused by the outer rim edge as it contacted the surface of the sidewalk. At the inspection, a small dent was noted on the inside surface of the right front wheel rim that might be the source of the air-out. This dent may have been caused by a curb strike earlier during the vehicle drive cycle. Alternatively, it may have occurred at the tree impact. The exact cause of this dent remains undetermined.

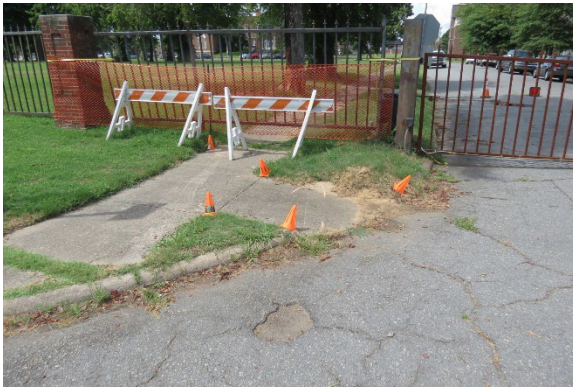
The front of the Dodge struck and penetrated the iron fence (Event 1, Figure 4) that was located 6.4 m (21 ft) north of the curb and extended east and west, parallel to the roadway. The fence was an aged, decorative structure that was attached at four points to a masonry column and a steel post. The Dodge then continued north 6 m (19.7 ft), where the front plane struck a tree (Figure 5) which was 63 cm (24.8 in) in diameter (Event 2). During the SCI interview, the driver presented a video he had obtained from the police, which showed the vehicle remaining in contact with the tree at final rest. The video also showed that a major fire (Event 3) developed as a result of the crash, which consumed a significant portion of the vehicle. The fire was extinguished by the responding firefighters. This video could not be copied to an SCI thumb drive and was not obtained.

*Figure 4. North view, roadway departure and impact with fence (replaced since crash)*

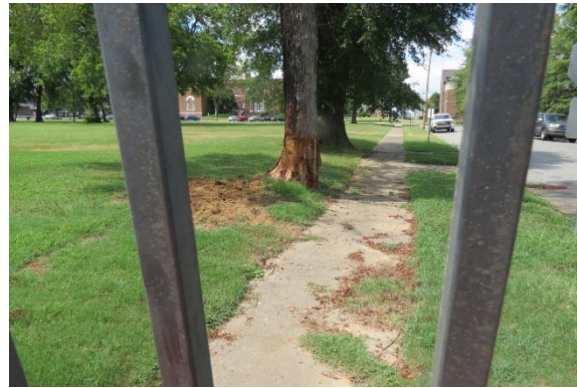
*Figure 5. North view, tree point of impact and fire*

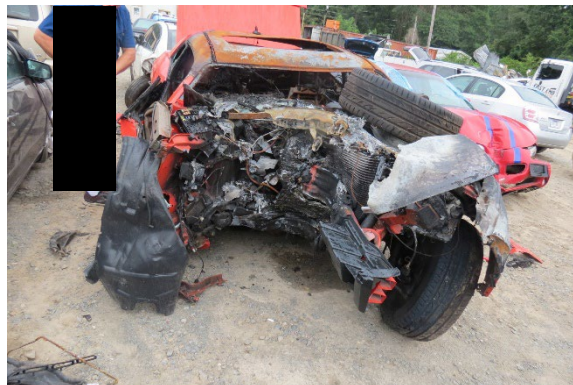
The Dodge sustained front plane damage from the impact with the tree, which measured 63 cm (24.8 in) in diameter. The bumper beam, bumper fascia, grille, hood, left and right headlamp and turn lamp assemblies, radiator, and engine were directly damaged (Figure 6). It was during this impact that the right-front-wheel assembly became detached from the vehicle. The direct damage started 16 cm (6.3 in) left of the right end of the bumper beam and extended 107 cm (42.1 in) to the left. The crush measurements were documented on the front bumper beam; the Field L was 117 cm (46.1 in). The final residual crush values were C1 = 5 cm (2.0 in), C2 = 53 cm (20.9 in), C3 = 91 cm (35.8 in), C4 = 123 cm (48.4 in), C5 = 108 cm (42.5 in), and C6 = 93 cm (36.6 in). The maximum residual crush was 123 cm (48.4 in) and was located 70 cm (27.6 in) left of the right end of the bumper beam.

*Figure 6. Front plane damage on the Dodge*

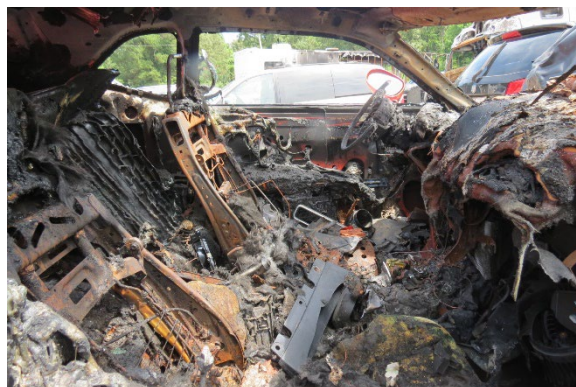
The interior of the Dodge was mostly consumed by the fire (Figure 7). No glazing remained, and both doors were jammed shut. All combustible material in the vehicle's interior, including the seat coverings and cushions, polymer trim panels/fascia, door and floor coverings, headliner, and all other interior components were mostly or totally consumed by the fire. Charred and melted remnants of the various materials covered the floor of the vehicle.

*Figure 7. Completely burned front row*

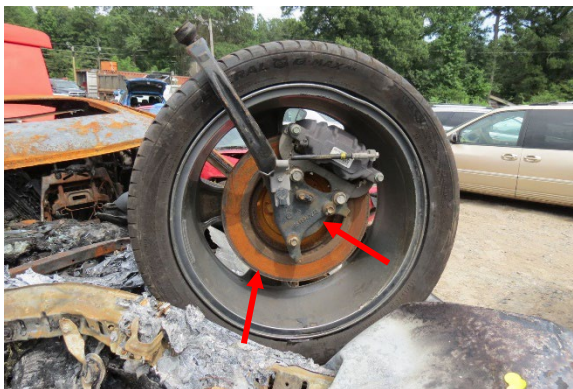
The concern of the driver was the possible malfunction/separation of the right-front-wheel assembly, which was claimed to have separated from the vehicle while traveling and led to loss of control and the subsequent crash. This claim was not supported by the physical evidence observed during the SCI scene inspection. Had the tire separated during the vehicle's approach to the fence and tree, the right front undercarriage would have contacted and gouged the ground leading up to the impacts. Additionally, a ground contact of this nature would likely have altered the vehicle's pre-crash dynamics, causing it to rotate clockwise as it slid toward the tree.

*Figure 8. Image depicting the separated right-front-wheel assembly of the Dodge. The fracture points are denoted by arrows.*

At the inspection, the right-front-wheel assembly and its support knuckle were lying with the damaged vehicle (Figure 8). It was observed that the cast knuckle had fractured at its connections with the steering struts (Figure 9). The nature and pattern of the casting fracture was indicative of a blunt impact force. The orientation of the tree impact was offset to the right of the vehicle centerline, and the depth of crush involved the right-front-wheel assembly and its supporting structures. This blunt impact fractured the casting and caused the right-front-wheel separation. The SCI investigation determined that there was no anomaly concerning the Dodge's right-front-wheel assembly.

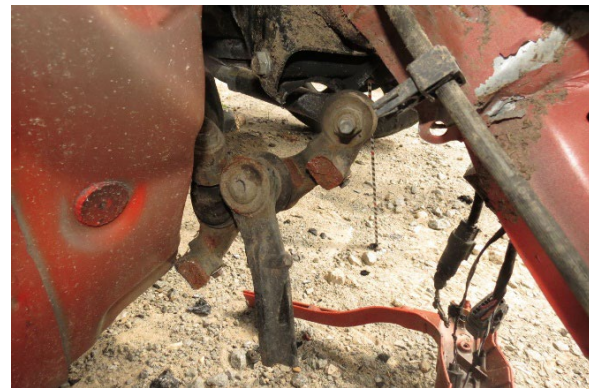
*Figure 9. Image depicting the fractured lower knuckle and steering components of the Dodge*

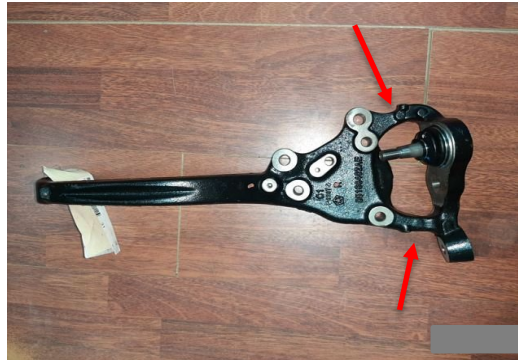
For reference, Figure 10 is an image of an undamaged right front suspension knuckle for a Dodge Challenger with the fracture areas highlighted. The knuckle was identified by the MOPAR part number 5168420AE.

*Figure 10. Exemplar Dodge Challenger right front suspension knuckle*
