DOT HS 813 308

# **Special Crash Investigations: On-Site Reported Unintended Acceleration Crash Investigation; Vehicle: 2006 Chrysler 300; Location: Michigan; Crash Date: May 2018**

**Special Crash Investigations  
On-Site Reported Unintended Acceleration Crash Investigation  
Office of Defects Investigation  
Case Number: DS18012  
Vehicle: 2006 Chrysler 300  
Location: Michigan  
Crash Date: May 2018**

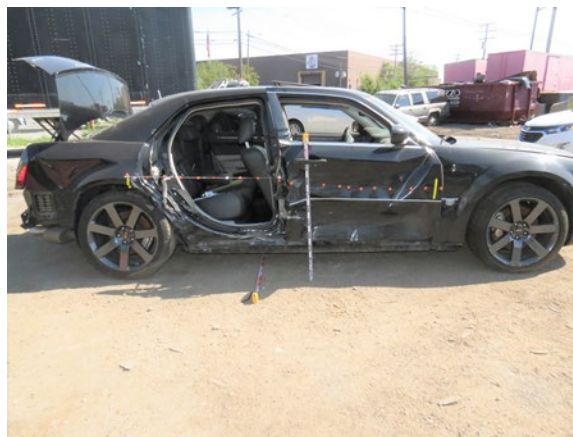
*Figure 1. The 2006 Chrysler 300, right-plane damage*

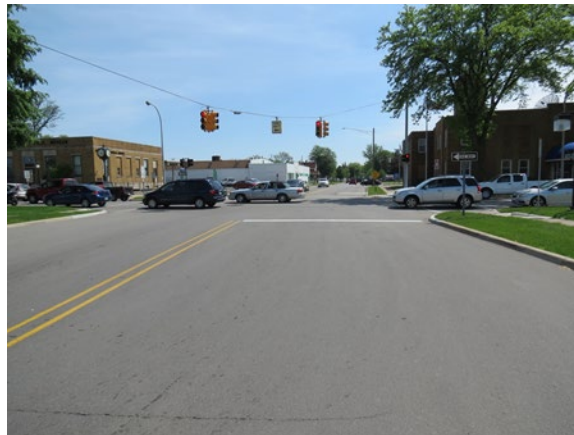
*Figure 2. Southbound approach*

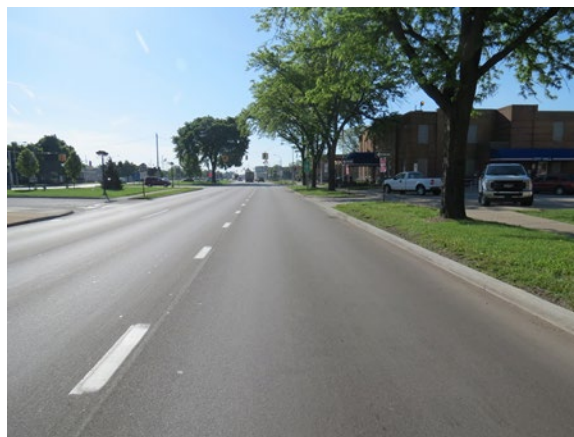
*Figure 3. Westbound approach*

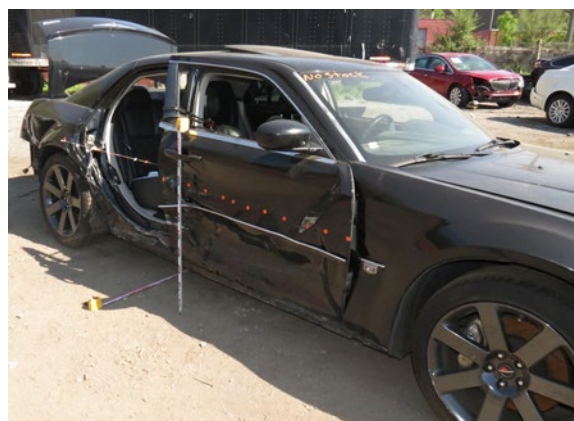
The direct damage from the impact with the Fusion began 8 cm (3.1 in) forward of the right rear axle and extended 230 cm (90.5 in) forward (Figure 4). Twenty-one measurements were taken at the mid-door level by the Nikon Total Station and the Faro Blitz program computed crush measurements in six increments as follows: C1 = 6 cm (2.3 in), C2 = 10 cm (3.9 in), C3 = 15 cm (5.9 in), C4 = 0 cm, C5 = 0 cm, and C6 = 0 cm. The collision deformation classification (CDC) was 01RPEW2. Both right plane doors were jammed shut post-crash and required opening and removal by the fire department. The right-rear door was removed and was not located.

*Figure 4. Right-plane damage, the 2006 Chrysler 300*

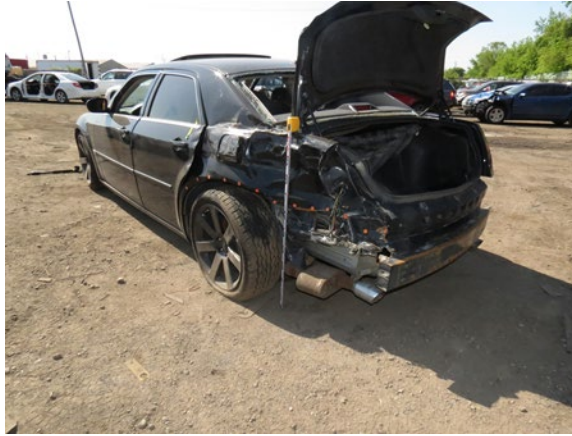
The direct damage from the impact with the Expedition began 31 cm (12.2 in) forward of the left-rear axle and extended 134 cm (52.7 in) rearward (Figure 5). Thirteen measurements were taken at the mid-door level by the Nikon Total Station and the Faro Blitz program computed crush measurements in six increments as follows: C1 = 30 cm (11.8 in), C2 = 25 cm (9.8 in), C3 = 17 cm (6.6 in), C4 = 4 cm (1.5 in), C5 = 2 cm (0.8 in), and C6 = 6 cm (2.3 in). The CDC was 10LZAW3.

*Figure 5. Left-plane impact, the 2006 Chrysler 300*

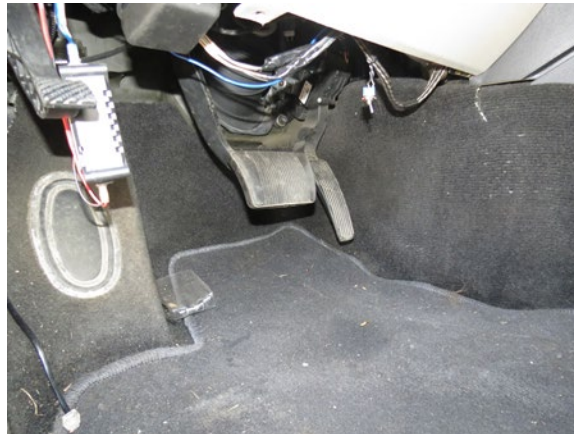
vehicle suddenly accelerated at a high rate. The vehicle accelerated through the extended median and into the eastbound roadway. During the on-scene vehicle inspection, the accelerator pedal and floor mat were examined (Figure 6). The accelerator pedal assembly (manufacturer part number 04861681AA) moved smoothly without any impingement. The travel distance was 9.5 cm (3.7 in) to 1.0 cm (0.4 in) above the floor. The vehicle had an OEM SRT8 floor mat (Figure 7). The mat was properly attached at the aft end by the attachment hook. At the time of the vehicle inspection, the mat was flat on the floor and not restricting the movement of the accelerator or brake pedal.

There were insufficient data available in this investigation to support the driver's claim of unintended acceleration.

*Figure 6. Foot controls and toe pan, the 2006 Chrysler 300*

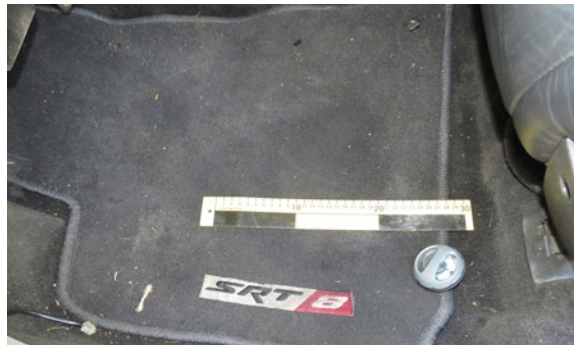
*Figure 7. Floor mat, the 2006 Chrysler 300*
