DOT HS 813 312

# **Special Crash Investigations: On-Site Driver Air Bag Inflator Rupture Crash Investigation; Vehicle: 2006 Ford Ranger; Location: Louisiana; Crash Date: March 2017**

**Special Crash Investigations  
On-Site Driver Air Bag Inflator Rupture Crash Investigation  
Office of Defects Investigation  
Case Number: CR18013  
Vehicle: 2006 Ford Ranger  
Location: Louisiana  
Crash Date: March 2017**

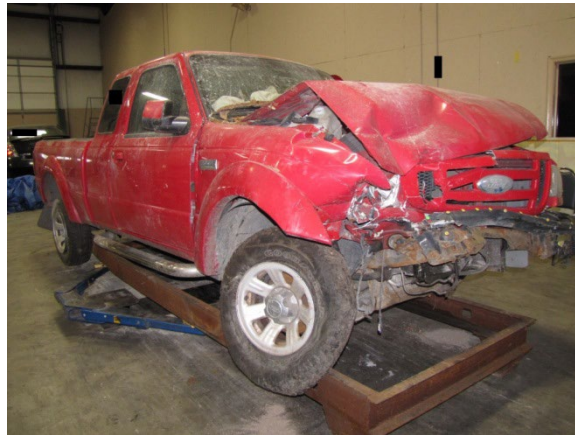
This report documents the on-site investigation of the rupture of the driver's frontal air bag inflator in a 2006 Ford Ranger (Figure 1) during a frontal impact with a parked 2005 Nissan Armada. The 52-year-old male driver suffered police-reported A-level (incapacitating) injuries during the event. The legal representative for the driver provided notification of the crash to the National Highway Traffic Safety Administration in April 2018. The notification was forwarded to the Special Crash Investigations (SCI) group and assigned for an on-site investigation in May 2018. Safety systems in the Ford included 3-point lap and shoulder seat belts with buckle pretensioners, and single-stage driver's and passenger's frontal air bags.

*Figure 1. Front-right oblique view of the damage to the 2006 Ford Ranger*

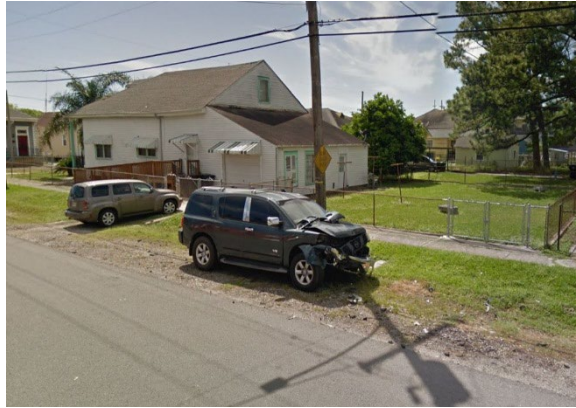
The front of the Ford struck the front of the Nissan (Figure 3) in an off-set head-on configuration involving impact forces within the 12 o'clock sector to both vehicles. Structurally, the damage was concentrated on the front-plane, right, and center aspects of both vehicles. The crash forces

*Figure 3. Oblique view of the Nissan at its final rest position (image obtained from an online mapping software)*

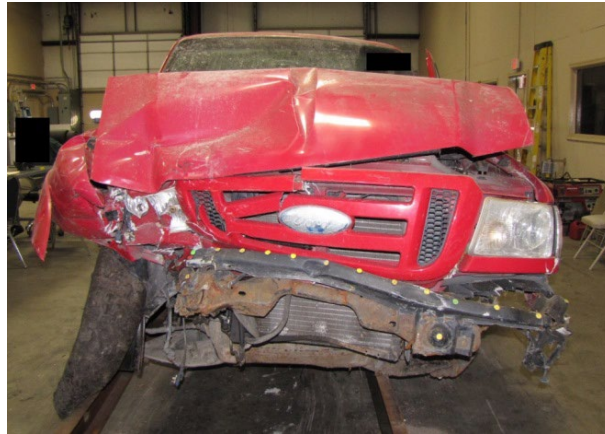
Damage to the exterior of the Ford was located on the front end, biased to the center and right aspects (Figures 5 and 6). At the time of the vehicle inspection, the front-bumper fascia and the left-front tire and wheel were separated from the vehicle and missing. The frontal damage consisted of deformation to the bumper beam, both front-frame rails, the lower radiator support, the grille, the hood face, the right-headlamp assembly, and the right-front fender. The right-frame rail was deformed 8 cm (3.1 in) to the left. The left-frame rail deformed to the left 3 cm (1.0 in). The right wheelbase was reduced 6 cm (2.4 in). The right door was operational at the inspection, but slightly restricted by body panel deformation. The left door was open and would not latch closed. There was no glazing damage.

*Figure 5. Frontal damage to the Ford*

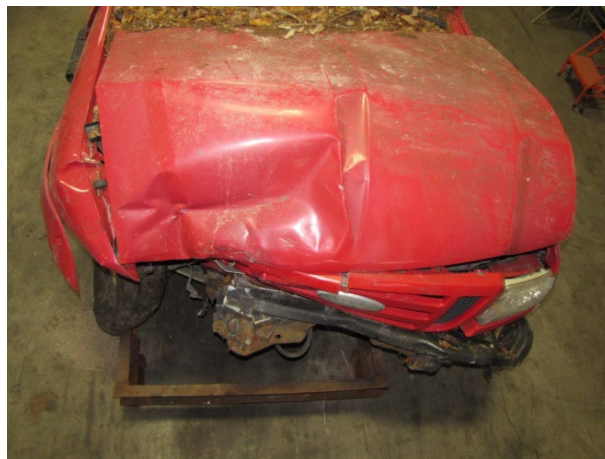
*Figure 6. Overhead view of the crush profile to the Ford*

A crush profile was documented and measured using a Nikon Nivo 5.M+ total station mapping system. The direct contact damage began 39 cm (15.5 in) left of the center and extended 115 cm (45.5 in) to the right corner of the vehicle. The combined induced and direct contact damage spanned the Ford's entire 152 cm (60.0 in) frontal width. The unsupported right aspect of the bumper beam outboard the frame rail had sheared and was missing. The frontal crush was measured along the bumper beam from the deformed location of the right-frame rail to the left corner. This Field L measured 117 cm (46.0 in). The bumper beam crush profile less freespace was as follows: C1 = 0, C2 = 0, C3 = 8 cm (3.1 in), C4 = 15 cm (5.9 in), C5 = 20 cm (8.0 in), and C6 = 26 cm (10.2 in). Maximum crush was 26 cm (10.2 in) located at the right corner; however, this value was underestimated due to the shearing and separation of the end of the bumper beam. The collision deformation classification for this damage was 12FDEW2.

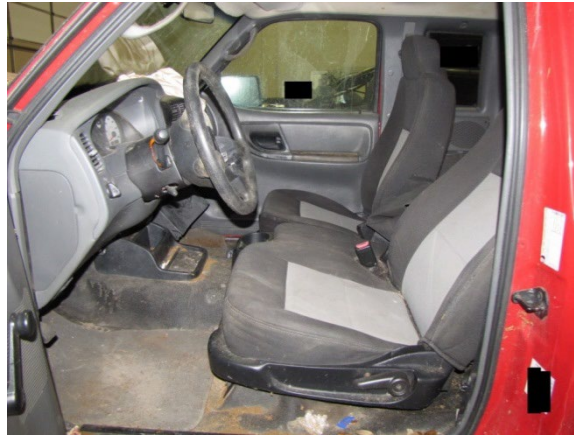
The interior of the Ford (Figure 7) was inspected for crash-related intrusion, damage, and occupant contact. There was no intrusion into the occupant compartment space, nor was there any interior damage associated with the crash events. Aside from pre-crash wear to the vehicle's

interior, the only discernable interior crash-damage was related to the deployment of the supplemental restraint systems and the rupture of the driver's frontal air bag inflator. A hole with staining and sagging of the headliner above the front-row right occupant position was noted, but it was not attributed to this crash. Its location was inboard of the right B-pillar.

*Figure 7. Left lateral view of the Ford's interior*

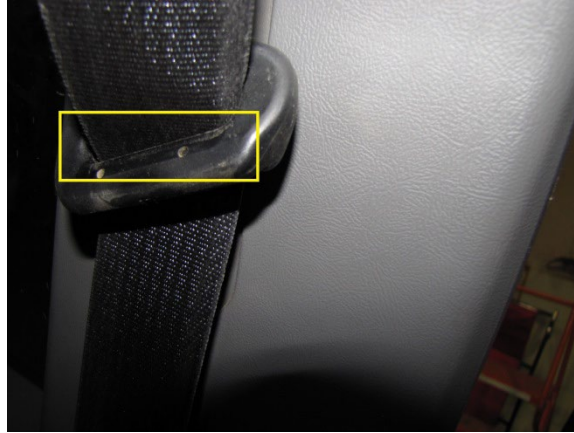
At the time of the SCI inspection, the driver's seat belt system was found retracted against the left B-pillar. The D-ring was adjusted to its lowest height. No loading evidence was observed on the webbing. Subtle frictional abrasions were present on the polymer surfaces of the latch plate and the D-ring (Figure 8) from driver loading in response to the frontal crash forces. Based on the observations of the SCI investigator and the post-crash condition of the seat belt system, it was determined that the driver's seat belt system was in use at the time of the crash.

*Figure 8. Frictional abrasions to the polymer surface of the D-ring from the driver loading*

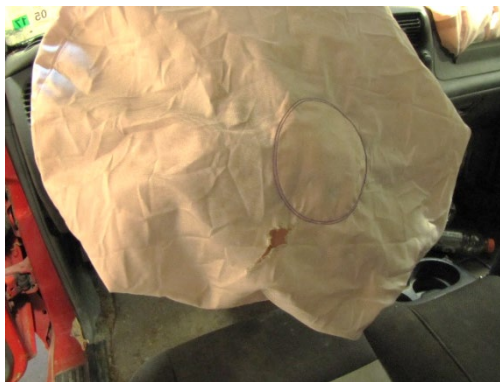
The initial inspection of the deployed driver's frontal air bag revealed several tears in the fabric on both the front and back aspects (Figures 9 and 10). These were determined to have resulted from the rupture and separation of metal fragments from the inflator during the early stages of deployment as the air bag began to unfold. On the face of the air bag, a 7 cm (2.75 in) straight-line tear originated 7 cm (2.75 in) from the center of the air bag and extended toward the 8 o'clock position (Figure 11). A 19 cm (7.5 in) horizontal tear was located on the back side of the air bag near the top surface and extended through the left-side (with respect to the vehicle) vent port (Figure 12). The tear was located 25 cm (9.75 in) from the center of the air bag. In its deflated state, the air bag measured 61 cm (24.0 in) in overall diameter, with a 15 cm (5.9 in) diameter center tether stitch pattern.

*Figure 9. Overall view of the tear in the face of the deployed driver's frontal air bag prior to removal from the Ford*

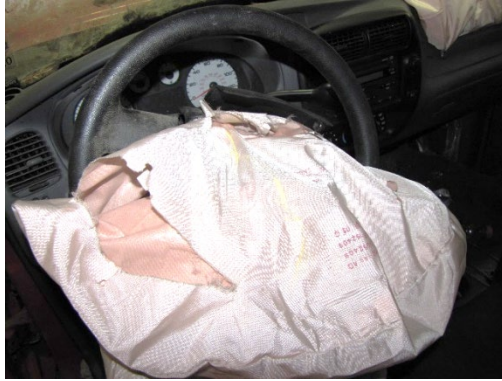
*Figure 10. View of the tear in the fabric on the back side of the driver's frontal air bag in the Ford*

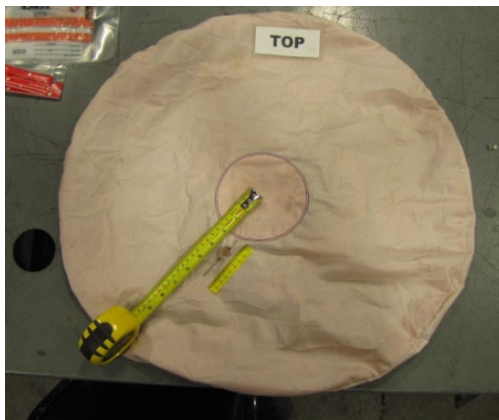
*Figure 11. Tear to the lower left quadrant face of the driver's frontal air bag removed from the Ford*

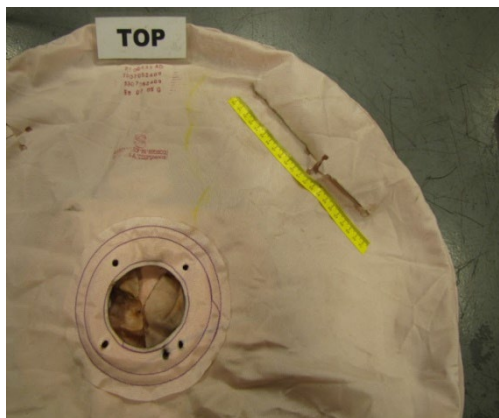
*Figure 12. Tear to the back side of the driver's frontal air bag removed from the Ford*

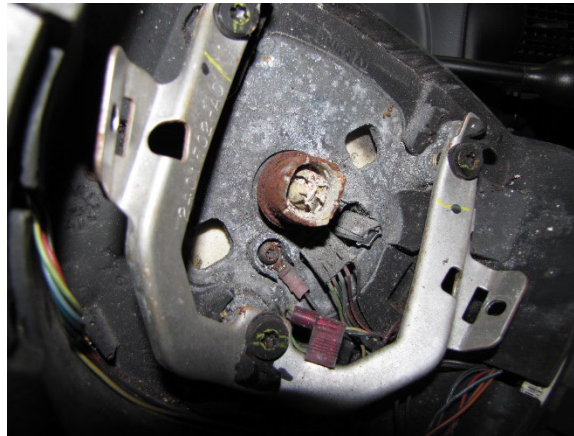
mounting bracket, which indicated that the deployment had separated the squib from the inflator (Figure 13).

*Figure 13. Close-up image of the center aspect of the Ford's steering wheel and the driver's frontal air bag squib separated during the deployment*

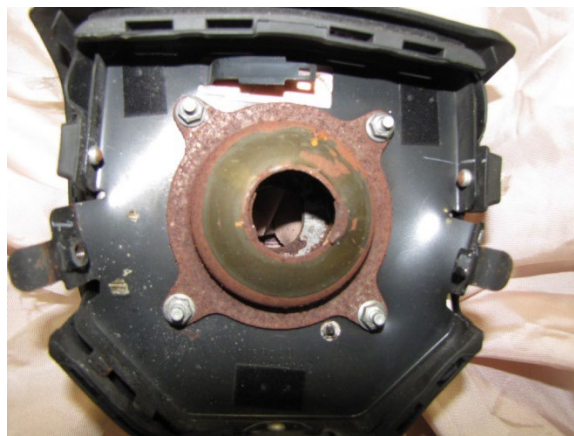
The inflator housing was removed from the air bag module's housing for further inspection (Figures 14 and 15). This was accomplished by removing the four nuts from the mounting bracket studs. The inflator contained six symmetrical portals surrounding the circumference of the inflator, all of which were clearly open. The internal filtering mesh remained intact on the inside circumference of the inflator. The center aspect of the forward portion of the inflator (area directed toward driver) separated from the inflator housing during the deployment and was missing. This circular diameter steel fragment was believed to have penetrated through the air bag's fabric and struck the right-upper quadrant of the driver's chest. The police reported that a metal fragment was surgically removed from the driver. This fragment was not retained as evidence or available for inspection.

*Figure 14. Back side of the driver's frontal air bag module and inflator removed from the Ford*

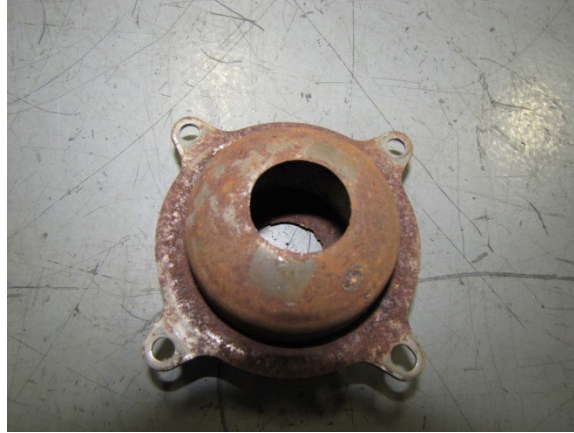
*Figure 15. Front aspect of the inflator depicting the separated top area of the Ford's inflator. The separated (missing) fragment penetrated the air bag fabric and struck the driver's chest.*

During the deployment sequence, the driver's frontal air bag inflator experienced an explosive rupture. The metallic casing of the inflator fragmented and separated, which projected a metallic fragment rearward at a high velocity. The fragment tore through the air bag fabric and entered the occupant compartment, where it struck and penetrated the upper right chest area of the driver.

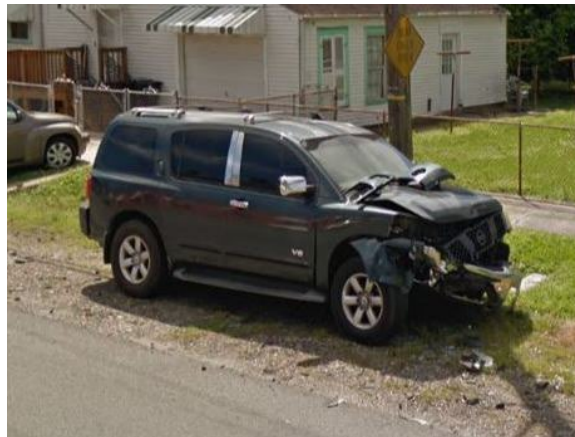
The Nissan sustained frontal damage that was distributed across the right and center aspects (Figure 17). The damage consisted of crush to the front bumper with fracturing of the grille and right-headlamp assembly and deformation of the hood and right-front fender. The estimated CDC for this damage is 12FZEW1.

*Figure 17. Exterior damage to the Nissan Armada  
(street-view image obtained from an internet  
mapping website)*
