DOT HS 813 335

# **Special Crash Investigations: On-Site Heavy Truck Underride Crash Investigation; Vehicle: 2014 Peterbilt; Location: Alabama; Crash Date: August 2019**

**Special Crash Investigations**  
**On-Site Heavy Truck Underride Crash Investigation**  
**Case Number: CR19032**  
**Vehicle: 2014 Peterbilt**  
**Location: Alabama**  
**Crash Date: August 2019**

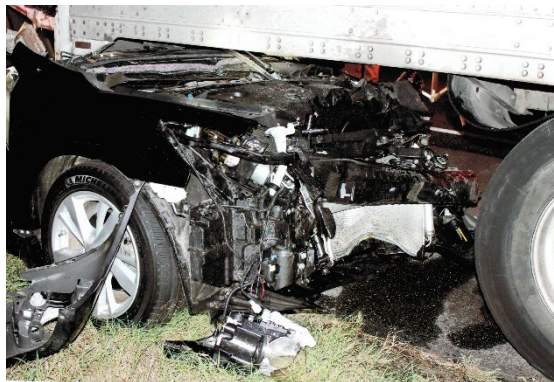
This on-site investigation documents the underride crash to an unknown make/model semi-trailer (Figure 1) of a 2013 Nissan Altima. The Nissan underrode the back plane of the semi-trailer hauled by a 2014 Peterbilt truck-tractor as both vehicles were traveling south on an interstate highway. According to the police crash report, the Peterbilt's 47-year-old driver was belted and uninjured. The impact to the rear of the trailer resulted in the rear impact guard separating from the trailer frame at the right vertical support beam. The rear impact guard rotated counterclockwise on the left vertical support beam as the Nissan underrode the tractor-trailer. The tractor-trailer was driven away from the crash site at the conclusion of the on-site police investigation and was not available for inspection. The occupant compartment of the Nissan sustained severe damage as it impacted the rear-impact guard and underrode the back plane of the semi-trailer (Figure 2). The Nissan was equipped with multiple inflatable supplemental restraints to include front seat belt pretensioners, certified advanced 208-compliant frontal air bags, front seat mounted side impact air bags, and inflatable curtain (IC) air bags mounted to the roof side rails. The driver's seat belt pretensioner actuated and the driver's frontal air bag deployed as a result of the crash. The belted 31-year-old male Nissan driver sustained police-reported A-level (incapacitating) injuries and was transported by ambulance for treatment and hospitalized for 10 days. The Nissan was towed from the crash site by a local towing company.

*Figure 1. Left front oblique view of the Nissan under the trailer towed by the 2014 Peterbilt. Local law enforcement provided image.*

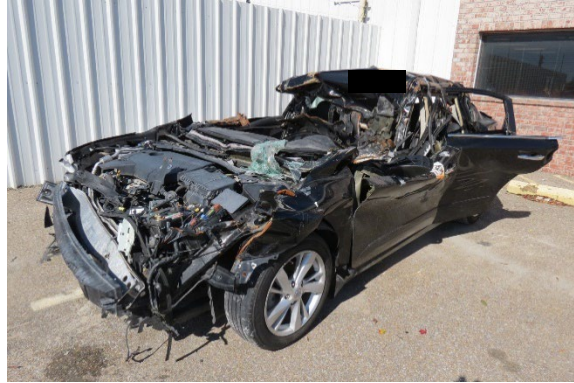
*Figure 2. Left front oblique view of the Nissan*

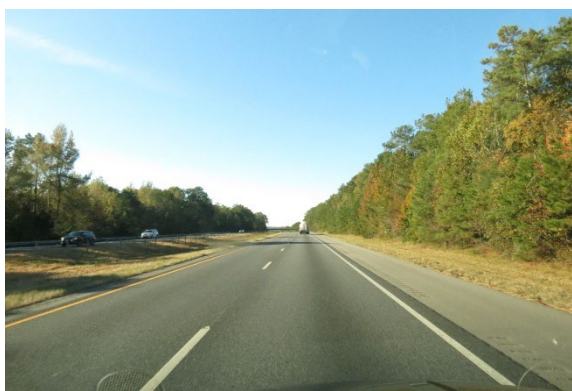
*Figure 3. Southbound view of the roadway for the Peterbilt's and Nissan's pre-crash travel*

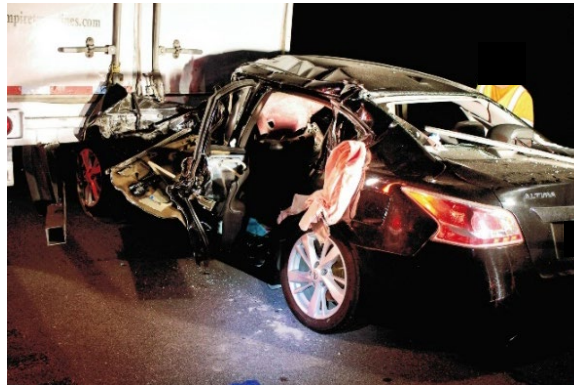
The front of the Nissan struck the back of the trailer. The impact was offset to the trailer's right (Figure 4) and underrode the trailer 252 cm (99.2 in) based on the length of damage to the Nissan. The driver of the tractor-trailer stated to the police that he felt a bump when the impact occurred. He then started to slow down and steered to the right shoulder. The tractor-trailer

*Figure 4. The Nissan at final rest. Local law enforcement provided image.*

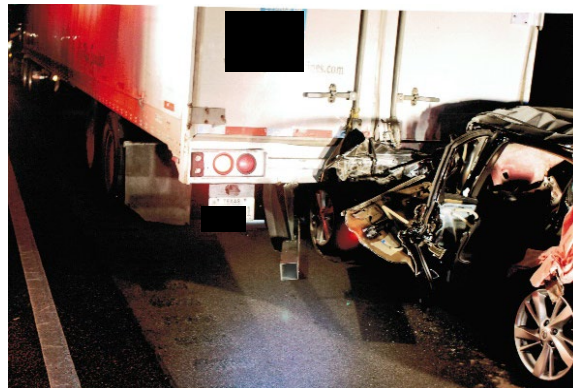
The trailer pulled by the 2014 Peterbilt sustained damage to the rear plane from the impact (Figure 5). The impact to the rear of the trailer resulted in the rear impact guard separating from the trailer frame at the right vertical support beam, allowing the Nissan to underride the trailer 252 cm (99.2 in) forward. According to on-scene images, the rear impact guard appeared to comply with FMVSS 224 standards. Conspicuity tape was visible on the rear of the tractor-trailer and the rear impact guard appeared to extend the width of the trailer.

*Figure 5. Damage to rear of trailer. Image supplied by police investigation.*

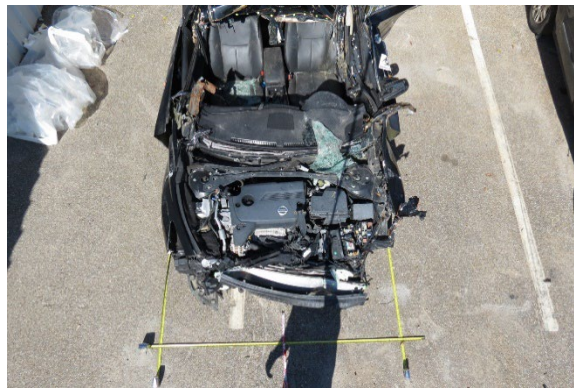
*Figure 6. Overhead view of the Nissan depicting the frontal underride damage*

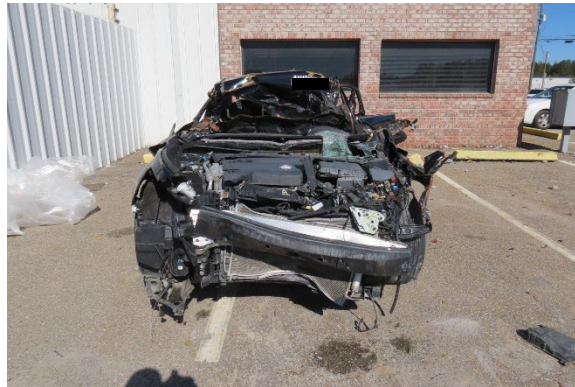
The Nissan sustained damage to the front and top planes from the impact to the rear impact guard and backplane of the trailer (Figure 7). The direct damage at the elevation of the front bumper began at the left front bumper corner and extended to the right front bumper corner (Figure 8). Crush measurements were documented on the bumper beam using a 138 cm (54.3 in) field L. The residual crush values were: C1 = 10 cm (3.9 in), C2 = 22 cm (8.6 in), C3 = 27 cm (10.6 in), C4 = 31 cm (12.2 in), C5 = 34 cm (13.3 in), and C6 = 23 cm (9.0 in). The maximum residual crush of 34 cm (13.3 in) was located 20 cm (7.9 in) left of the right front bumper corner. The collision deformation classification for this damage profile was 12FDAA9. The “A” designation classifies impacts where the vehicle deformation resulted from an overhanging structure.

*Figure 7. Front plane damage to the 2013 Nissan Altima*

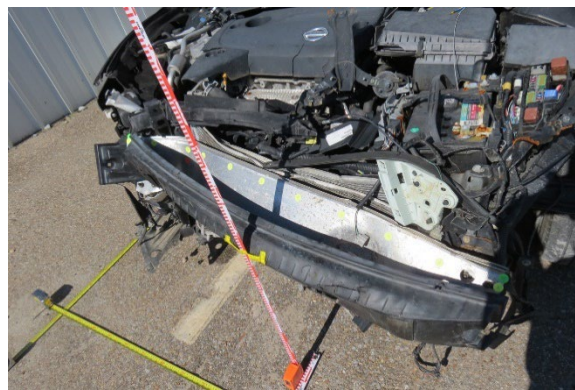
*Figure 8. Frontal plane direct contact damage from impact to the back of the trailer*

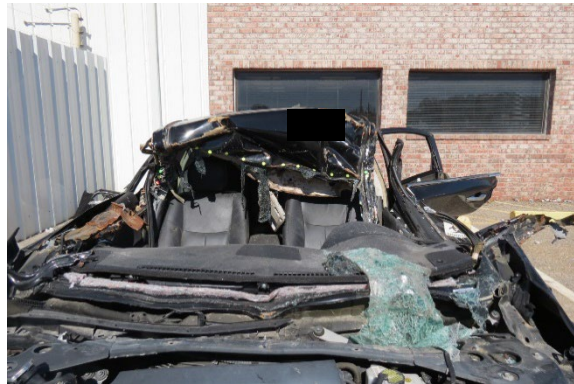
The underride spanned the entire width of the Nissan's frontal plane and resulted in direct contact to the windshield header. The windshield header then crushed to the B-pillar area. The damage continued rearward as the Nissan underrode the tractor-trailer resulting in direct damage to the hood, windshield, and top plane beginning at the left A-pillar and extending across the windshield header to the right A-pillar (Figure 9). The right A-pillar deformed rearward approximately 65 cm (25.5 in) coming to rest against the right B-pillar.

*Figure 9. Underride direct damage from impact to the back of the trailer*

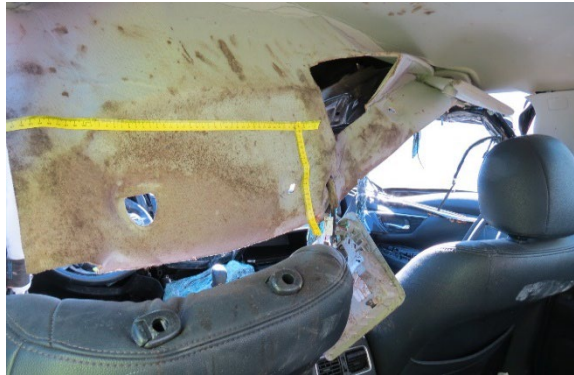
The longitudinal intrusion of the windshield header and forward motion of the restrained driver resulted in the driver impacting the windshield header with his head (Figure 10).

*Figure 10. Driver loading of windshield header*

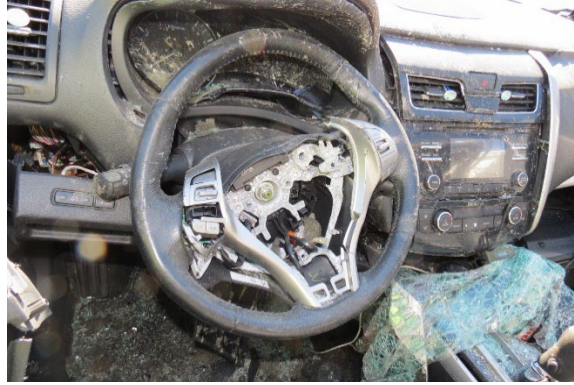
The driver's frontal air bag and module were separated from the steering wheel at the time of inspection and were found in the second row. The rear connectors on the air bag module were damaged upon inspection. The driver's frontal air bag and module likely were separated during the impact sequence due to contact with the back plane of the trailer. (Figure 11). Direct contact from the trailer was observed at the top sector of the steering wheel rim. The passenger's frontal air bag was suppressed and did not deploy.

*Figure 11. View of the Nissan's deformed steering wheel*

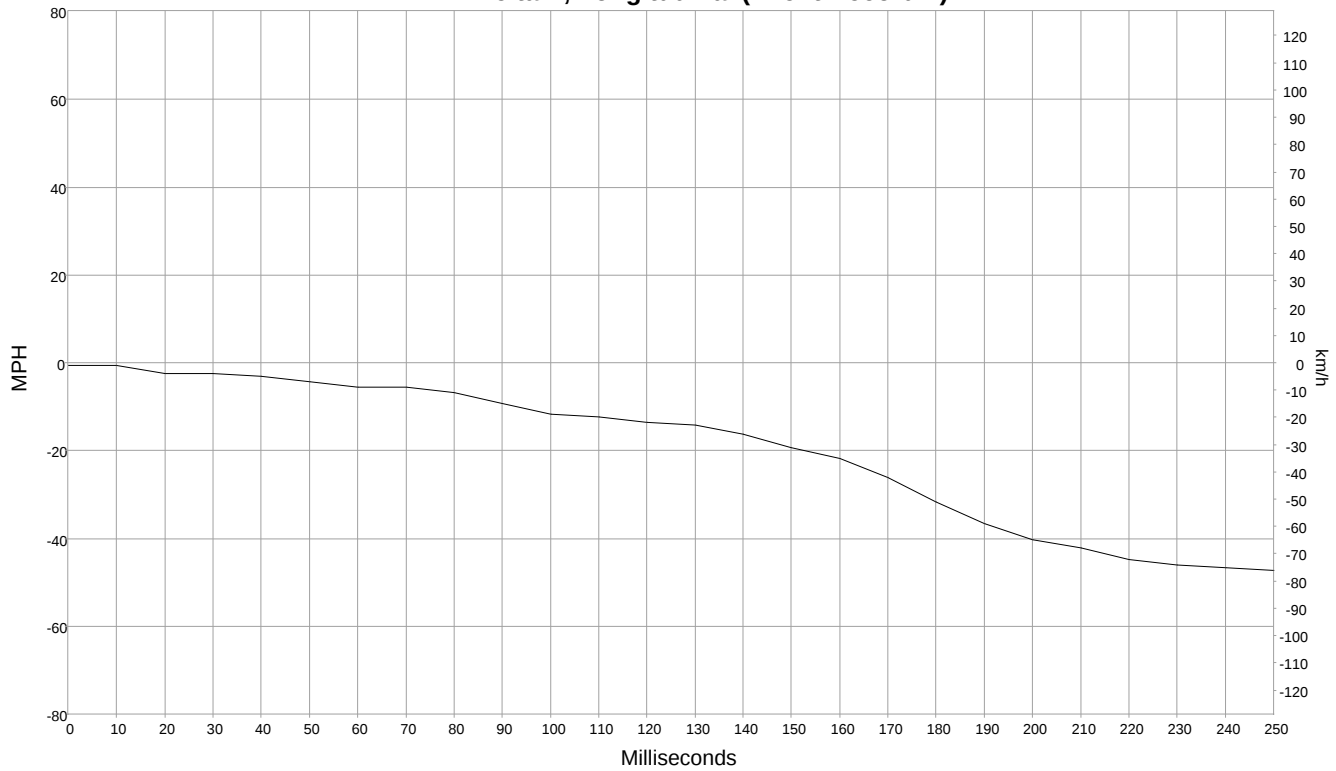
**Delta V, Longitudinal (Event Record 2)**

maximum recorded longitudinal and lateral velocity changes were -77 km/h (-48 mph) and 4 km/h (2 mph), respectively. These occurred at 265 and 207.5 milliseconds (msec). The driver's seat belt pretensioner was commanded to actuate at 23 msec and the driver's frontal air bag was commanded to deploy, with the first stage deploying at 23 msec and the second stage deploying at 26 msec.
