U.S. Department  
of Transportation  
**National Highway  
Traffic Safety  
Administration**

DOT HS 813 374

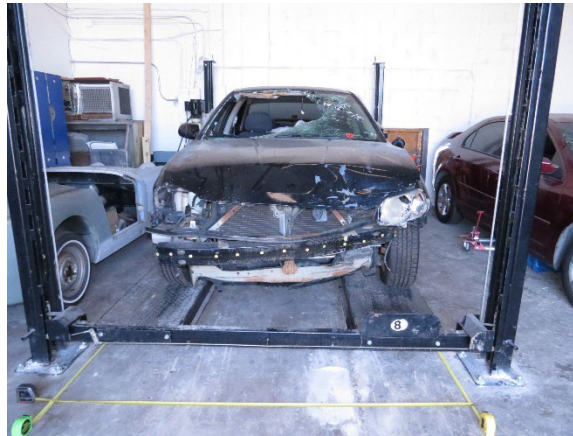
*Figure 1. Front view of the Nissan*

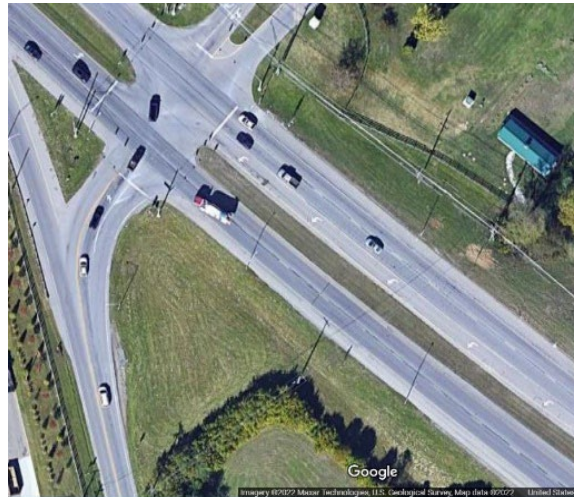
Figure 2. Google Maps © 2022 Maxar Technologies, U.S. Geological Survey Map data

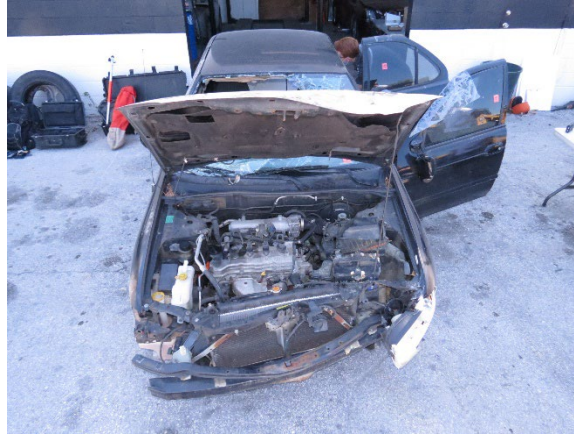
*Figure 4. Overhead view of the Nissan*

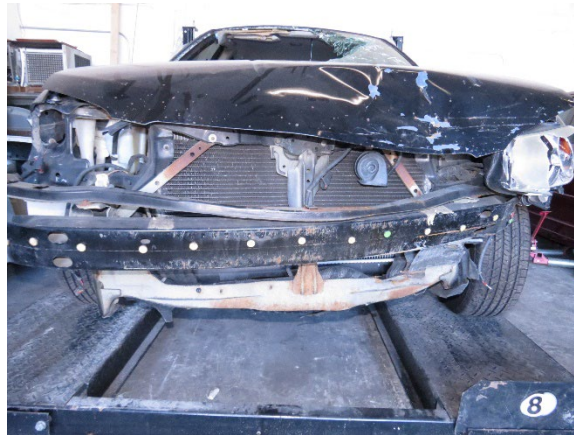
*Figure 5. Front view of the Nissan depicting the impact damage*

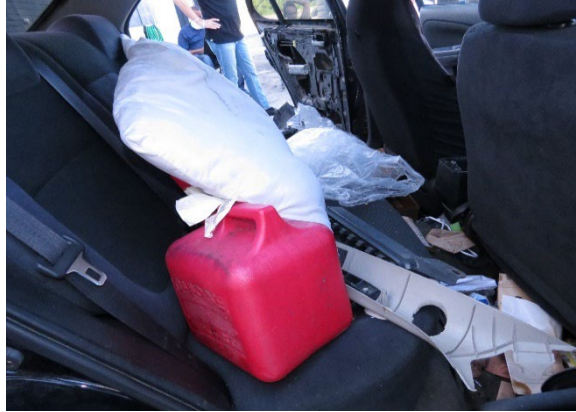
*Figure 6. Crossing view of the Nissan's second row*

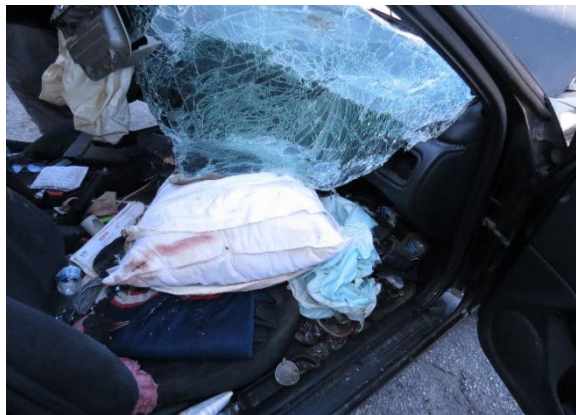
*Figure 7. Crossing view of the Nissan's front right passenger space*

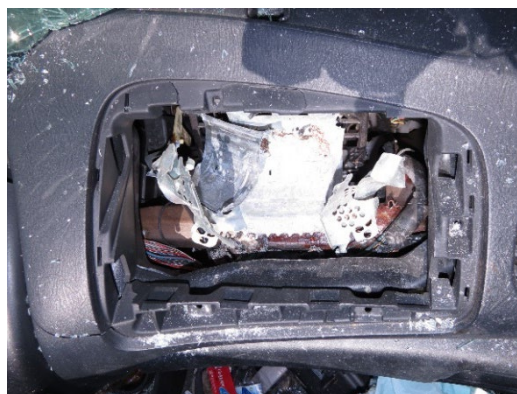
*Figure 11. View into the top right instrument panel and the deformed mounting bracket for the Nissan's passenger frontal air bag module*
