DOT HS 813 378

**Special Crash Investigations:  
On-Site Vehicle Fire Crash Investigation;  
Vehicle: 2013 Volkswagen Passat;  
Location: Missouri;  
Crash Date: March 2020**

**Special Crash Investigations  
On-Site Vehicle Fire Crash Investigation  
Office of Defects Investigation  
SCI Case No: CR20016  
Vehicle: 2013 Volkswagen Passat  
Location: Missouri  
Crash Date: March 2020**

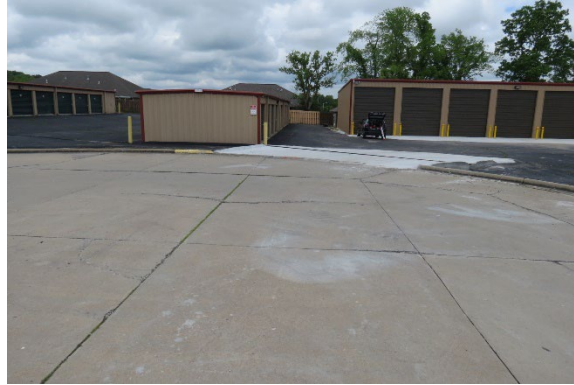
Surveillance video from the storage facility was analyzed by the police and provided to the SCI team. Based on the police report supplements, the Volkswagen turned from a major roadway onto the two-lane roadway at 0218 hours. The driver steered off the roadway to the left and stopped for 44 minutes. At 0302 hours, the driver resumed travel north, but at a very slow speed, and drove onto the right curb, making a stop out of the camera view. He remained there for one hour and 55 minutes. At 0457 hours, the vehicle accelerated and proceeded north, veering to the left, then back right as it passed through the cul-de-sac and into the storage facility property (Figure 3).

*Figure 3. North view, entrance into the storage facility*

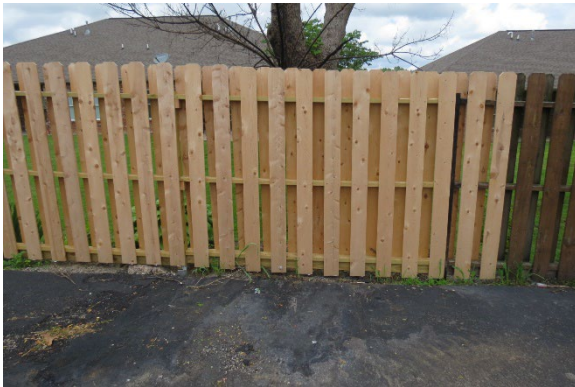
The front left wheel struck the mountable curb (Event 1) at the end of the cul-de-sac, denting the wheel rim. The Volkswagen continued north for 44 m (144 ft) in between the two storage buildings and the front plane struck a wooden fence (Event 2, Figure 4). It penetrated the fence and struck a 63 cm (24.8 in) diameter tree (Event 3, Figure 5) located 110 cm (43.3 in) behind the fence. The vehicle did not rebound significantly and came to rest facing north, with the front plane against the tree. Video evidence did not show the vehicle at the point of impact, as the camera was positioned approximately 150 m (492 ft) away and the view was blocked by one of the storage buildings. According to the police report supplement, the post-crash fire (Event 4) began at 0522 hours, 25 minutes after the crash, and grew into a large fire. Given that the vehicle is not in camera view and flames can only be seen from a distance 25 minutes after impact, it is likely that the fire began prior to the appearance of these visible flames.

*Figure 4. North view, impact with wooden fence (replaced)*

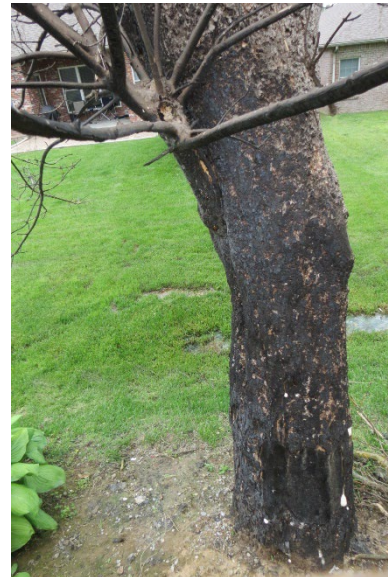
*Figure 5. North view, tree impact*

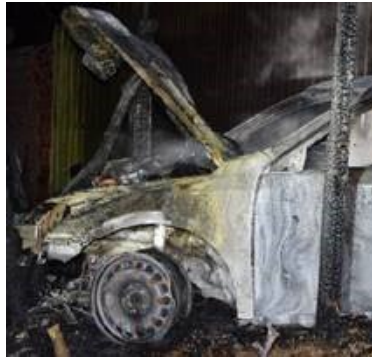
The police supplement stated the first 911 call came in at 0529, though the police crash report stated the police were notified at 0524. The supplement further stated that the primary officer arrived on scene at 0530. Fire and rescue personnel also responded. The driver was not able to exit the vehicle. A fence post adjacent to the left front door (Figure 6) could have impeded the driver from exiting the vehicle. The fire consumed the entire vehicle and the driver was extensively burned. He was pronounced deceased at the scene, removed from the vehicle, and taken to a medical examiner.

*Figure 6. Fence post adjacent to left front door of the Volkswagen at final rest*

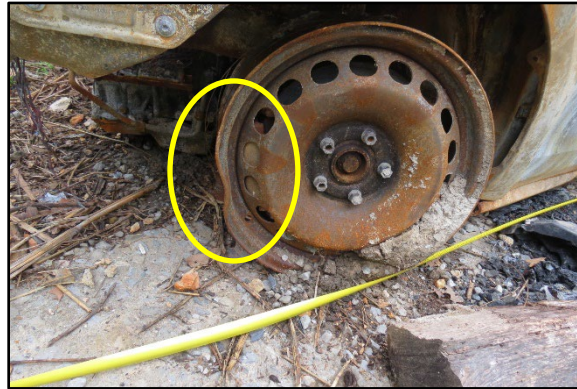
The Volkswagen sustained direct damage to the left wheel during contact to the mountable curb (Event 1, Figure 7). The WinSMASH program could not be used since wheel impacts are out of scope for the program. The collision deformation classification (CDC) for this event was 12FLWN3.

*Figure 7. LF rim damage from curb impact*

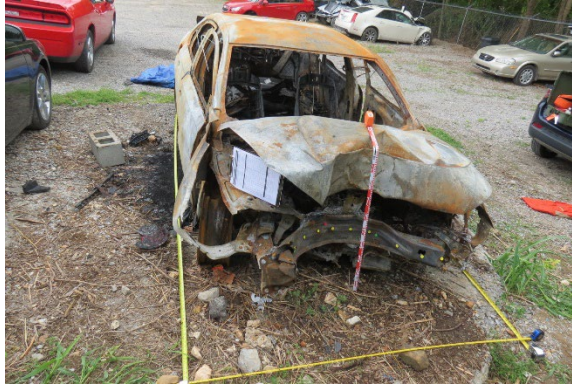
The Volkswagen sustained front plane damage from the impact with the tree (Figure 8), which measured 63 cm (24.8 in) in diameter. The bumper beam, bumper fascia, grille, and hood were directly damaged. The direct damage began 34 cm (13.4 in) right of the left end of the bumper beam and extended 50 cm (19.7 in) to the right. The crush measurements were documented on the front bumper beam and the Field L was 79 cm (31.1 in). The crush values were C1 = 15 cm (5.9 in), C2 = 25 cm (9.8 in), C3 = 54 cm (21.3 in), C4 = 60 cm (23.6 in), C5 = 53 cm (20.9 in), C6 = 24 cm (9.4 in). The maximum residual crush was 60 cm (23.6 in) and was located 66 cm (26.0 in) left of the left end of the bumper beam.

*Figure 8. Front plane damage from tree impact*

The damage algorithm of the WinSMASH program was used to calculate the severity of the crash. The Volkswagen's total delta V was 65 km/h (40 mph). The longitudinal and lateral velocity changes were -65 km/h (-40 mph) and 0 km/h, respectively. The collision fits the model and the results appeared reasonable. The CDC for the front plane impact was 12FYEW3 (0 degrees).

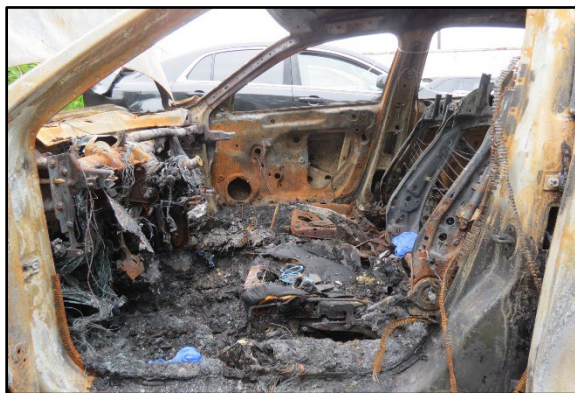
The Volkswagen interior was completely consumed by fire (Figure 9). No glazing remained. None of the doors operated properly due to the fire. No discernable crash damage was noted. All four doors were considered closed and operational at the time of the crash. The left front door was forced open by the first responders. All combustible material in the vehicle's interior, including the seat coverings and cushions, polymer trim panels/fascia, door and floor coverings, headliner, and all other interior components were consumed by the fire. Only a small area of the driver's seat cushion, protected by the presence of the driver, remained. Charred remnants of the various materials covered the floor of the vehicle. All vertical and upper surfaces of the vehicle's interior were burned clean to the underlying metal structure. Soft metals with low combustion temperatures were melted and/or consumed by the intense fire.

*Figure 9. Completely burned front row*

The Volkswagen was consumed entirely by the post-crash fire, which resulted in the death of the driver. SCI investigation of the incident determined that the fire developed as a result of the severe frontal impact with the tree. The fire developed over an extended time period, based on surveillance video from the storage facility where the crash occurred. The vehicle's path of travel toward the fence and tree was observed on the video recording; however, the actual impact was not captured, as the camera's view was obstructed by one of the storage buildings. The video camera was mounted on a building wall, located approximately 150 m (492 ft) from the area of impact. Though flames were first visible on the recording approximately 25 minutes after impact and reached a height of approximately 3 m (10 ft), the fire began prior to this time. The fire continued to develop and proliferate as the video recording continued.

Video surveillance of the Volkswagen revealed that there was no evidence or indication of a fire prior to the crash. Evidence observed by this SCI investigation revealed burn patterns and damage to the vehicle consistent only with a fire that developed in the engine compartment of the vehicle and proliferated under natural fire spread conditions to consume the entire vehicle and all of its combustible material/components. The fire's area of origin was identified as the engine compartment of the vehicle. Due to the level of consumption of materials, the specific cause of the fire could not be determined.
