DOT HS 813 379

# **Special Crash Investigations: On-Site Air Bag Inflator Rupture Investigation; Vehicle: 2002 Volvo S60; Location: Arkansas; Crash Date: April 2018**

**Special Crash Investigations  
On-Site Air Bag Inflator Rupture Investigation  
Office of Defects Investigation  
Case No. DS19026  
Vehicle: 2002 Volvo S60  
Location: Arkansas  
Crash Date: April 2018**

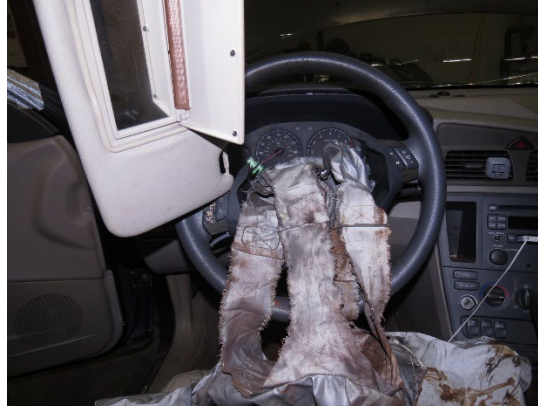
This report documents the on-site investigation of a frontal air bag inflator rupture (Figure 1) in a 2002 Volvo S60 involved in a crash in which the driver sustained fatal injuries. The case was initiated by the Office of Defects Investigation (ODI) of the National Highway Traffic Safety Administration in response to a notification reporting the driver frontal air bag deployed and debris from the air bag module struck the driver, causing fatal injuries. ODI was notified in August 2019. The Special Crash Investigations (SCI) group assigned the case to Dynamic Science in August 2019 and a vehicle inspection was completed that month in a secure facility in Texas. Representatives from Volvo and attorneys for the estate of the decedent were present at the inspection. The Volvo representatives confirmed that the air bags and inflator were original equipment and the inflator did rupture. Vehicle data from the air bag sensor module was imaged by Volvo during the inspection and shared with SCI. The interpretation of the data is discussed later in this report. A search of the NHTSA recall database using the Volvo's VIN showed the Volvo's air bags were not subject to any open or past recalls at the time of the crash. A vehicle history reported the vehicle had no crashes prior to this crash.

*Figure 1. Driver frontal air bag, 2002 Volvo S60*

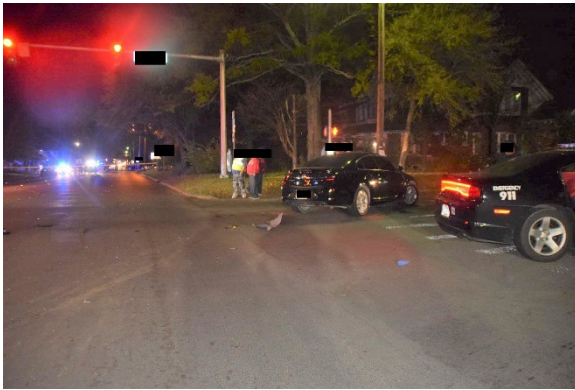
*Figure 3. Final rest for the 2016 Buick Regal, looking southwest (police image)*

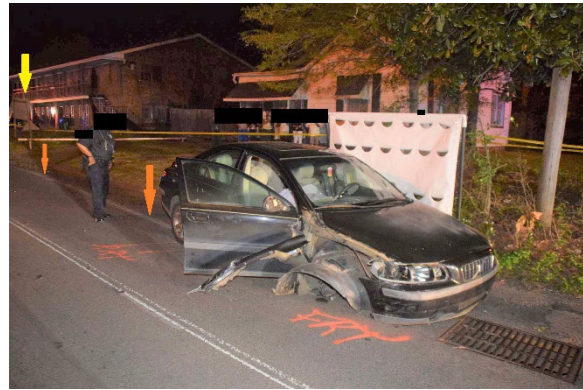
The Volvo front and right planes struck the left plane of the Buick (Event 1). The right front tire and lower control arm were detached from the Volvo. The “missing vehicle” algorithm of the WinSMASH program calculated a total delta V of 17 km/h (11 mph) for the Volvo. The longitudinal and lateral components were -17 km/h (-11 mph) and -3 km/h (-2 mph), respectively. The results were considered borderline. The WinSMASH program calculated a total delta V of 16 km/h (10 mph) for the Buick. The longitudinal and lateral components were 15 km/h (9 mph) and 5 km/h (3 mph), respectively. The results were considered borderline. The Buick was displaced clockwise to the west and came to rest in the west leg of the intersection facing west (Figure 3). The Volvo was displaced to the east and continued through the intersection. The Volvo departed the roadway to the left, struck a metal fence with its front plane (Event 2), struck a metal pole/sign with its left plane (Event 3), returned to the roadway, and came to rest on the roadway approximately 59 m (193 ft) south of the intersection facing south (Figure 4).

*Figure 4. Final rest, 2002 Volvo S60, looking north (yellow arrow shows impacts 2 and 3, orange arrows show undercarriage gouge) (police image)*

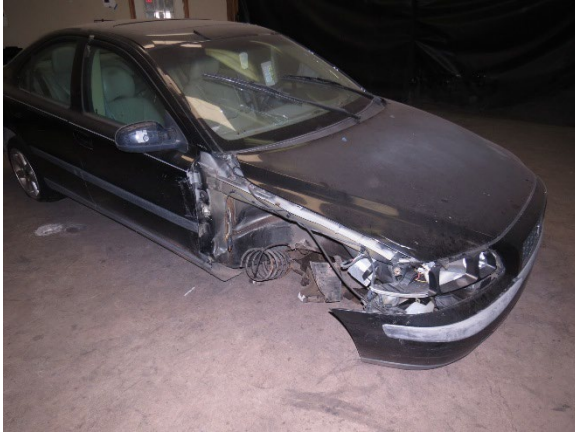
The Volvo sustained moderate front and right plane damage (Figure 5) from the impact to the left plane of the Buick (Event 1). The direct damage began at the right front corner and extended to the left 12 cm (4.7 in). The damage extended 118 cm (46.4 in) along the right side. The right front tire, right lower control arm and right fender were displaced from the vehicle. The Field L extended from bumper corner to bumper corner. Nineteen measurements were taken at bumper level by the Nikon Total Station and the Faro Blitz program computed crush measurement in six increments as follows: C1 = 6 cm (2.3 in), C2 = 4 cm (1.5 in), C3 = 0 cm, C4 = 0 cm, C5 = 0 cm, C6 = 0 cm. The Collision Deformation Classification (CDC) was 12FREE5.

*Figure 5. Front/right damage,  
2002 Volvo S60*

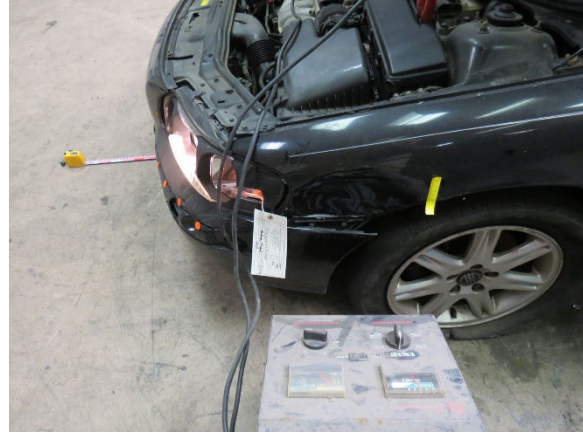
The vehicle sustained minor damage from the impact with the metal rail (Figure 6). There was direct contact to the front left bumper that was 3 cm (1.1 in) wide and extended 41 cm (16.1 in) along the left plane. The left front tire was holed from the rail. The CDC was 12FLEE3.

*Figure 6. Front/left damage,  
2002 Volvo S60*

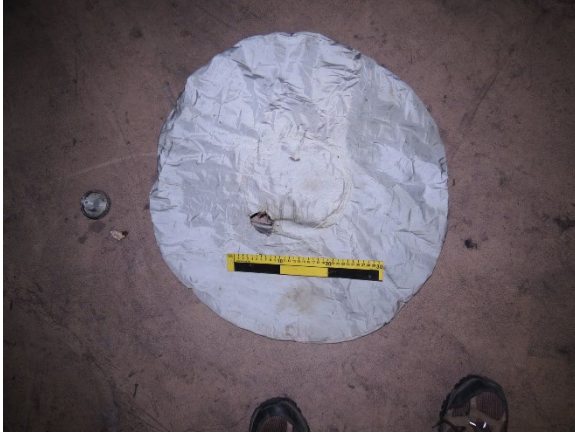
As a result of the front-to-side impact with the Buick, both frontal air bags deployed. The driver frontal air bag deployed at full capacity according to data from the air bag module. The driver frontal air bag deployed from an H-configuration module cover located in the hub of the steering wheel rim (Figure 7). The air bag was circular and measured 61 cm (24.0 in) in diameter in its deflated state. The air bag had rear panel vent ports and was not tethered. The air bag inflator ruptured during the air bag deployment (Figure 8). The air bag face was holed at the 7 o'clock position. The hole measure 6 cm (2.3 in) and was located 20 cm (7.8 in) above the bottom edge and 23 cm (9.0 in) to the right of the left edge.

*Figure 7. Driver frontal air bag, 2002 Volvo S60*

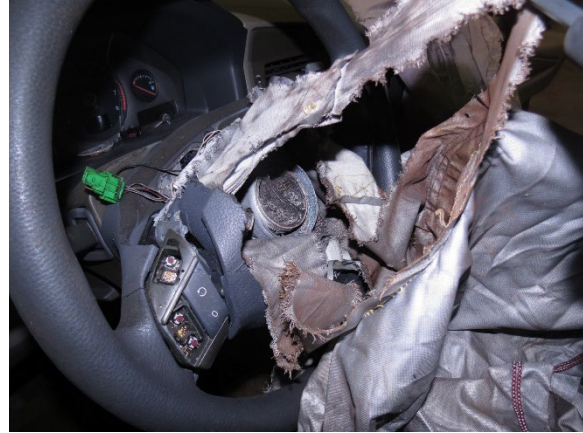
*Figure 8. Driver frontal air bag inflator, attached to the vehicle, 2002 Volvo S60*

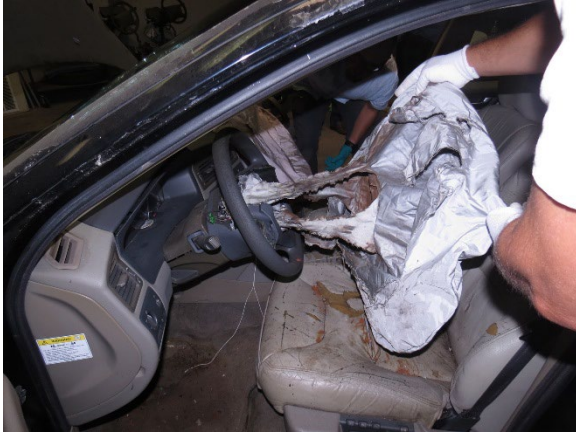
The driver frontal air bag inflator was manufactured by Autoliv/Temic Automotive and was reported by Volvo to be original to this vehicle. At the time of the inspection, the bottom portion of the module was still attached to the vehicle (Figure 9). The top cap of the module (Figure 10) and other pieces were found in the vehicle in several locations. The top cap of the inflator was located on the right front floor. The wiring harness was located on the upper instrument panel near the windshield. The air bag module cover flaps were located on the left front floor. The container mesh on the back of the module was damaged (Figures 11-12). Two metal fragments were extracted from the driver's neck during the autopsy (Figure 13).

*Figure 9. Driver frontal air bag, 2002 Volvo S60*

Based on available evidence, it was determined that the driver frontal air bag inflator ruptured during its deployment and displaced inflator components rearward toward the driver. The Volvo representatives agreed with this assessment. The components penetrated the air bag fabric and struck the driver in the neck and chest, resulting in the fatal injuries.

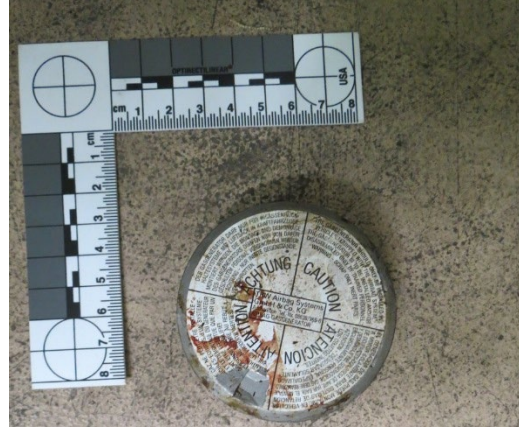
*Figure 10. Air bag module cap, 2002 Volvo S60*

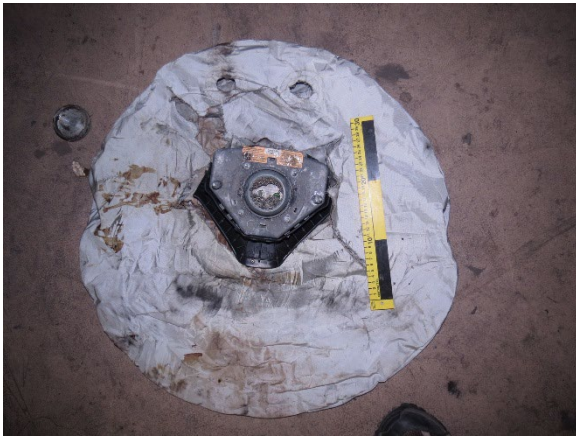
*Figure 11. Back of air bag, air bag module, 2002 Volvo S60*

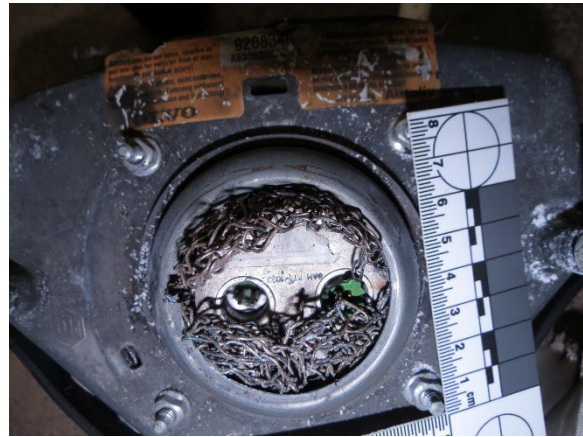
*Figure 12. Back of air bag module (close up), 2002 Volvo S60*

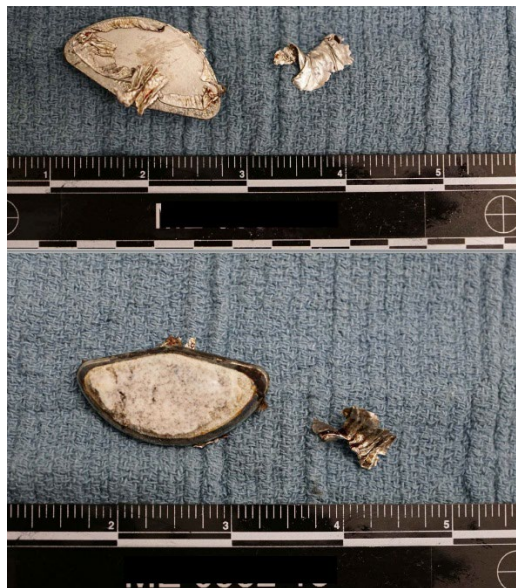
*Figure 13. Metal fragments extracted from the driver's neck during autopsy*

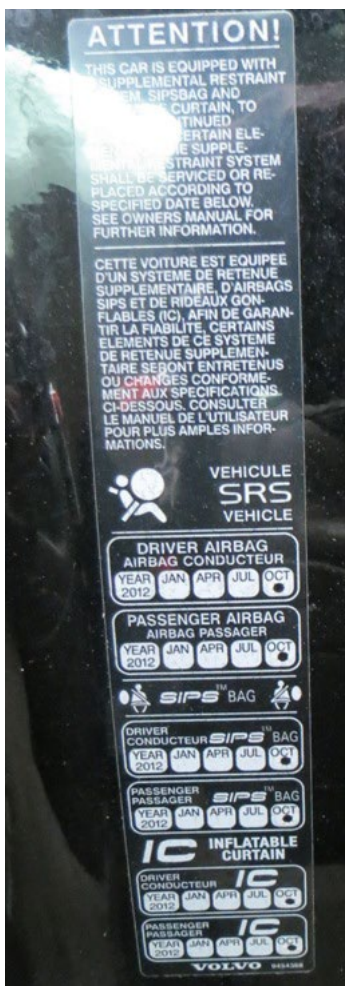
The Volvo was labeled with an informational warning stating the vehicle air bags were to be serviced or replaced by October 2012 (Figure 14). Based on available information, the air bags were never replaced. It is unknown if they were serviced in any way.

Figure 14. Air bag labeling, 2002 Volvo S60

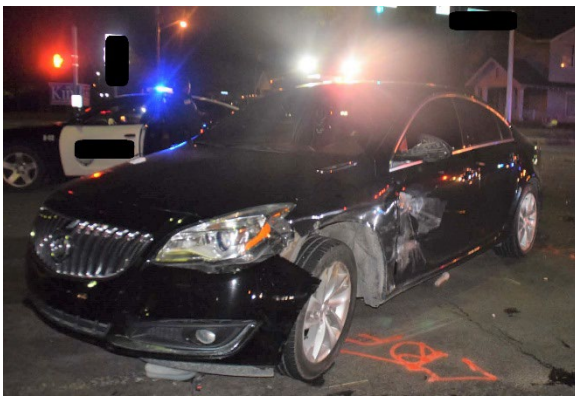
The Buick sustained moderate left plane damage (Figures 15 and 16). The damage began aft of the left A-pillar and extended forward to the left front bumper corner. According to insurance photos, it appears that the vehicle sustained drive axle and wheel damage. The CDC was 07LYEW2.

*Figure 15. Left front, 2016 Buick Regal (police image)*

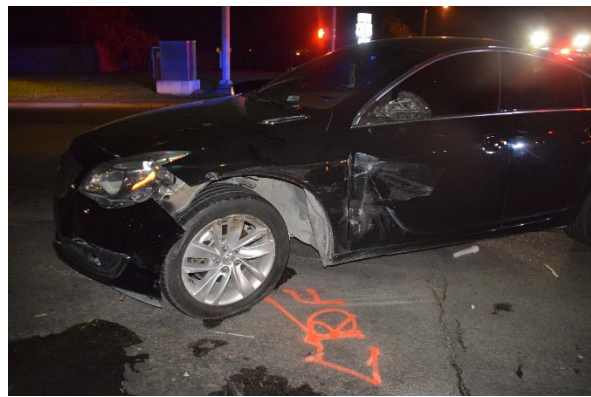
*Figure 16. Left front, 2016 Buick Regal (police image)*
