DOT HS 813 476

# **Special Crash Investigations: On-Site Electric Vehicle Fire Investigation; Vehicle: 2019 Chevrolet Bolt EV; Location: Florida; Incident Date: October 2020**

**Special Crash Investigations  
Office of Defects Investigation  
On-Site Electric Vehicle Fire Investigation  
Case Number: CR20036  
Vehicle: 2019 Chevrolet Bolt EV  
Location: Florida  
Incident Date: October 2020**

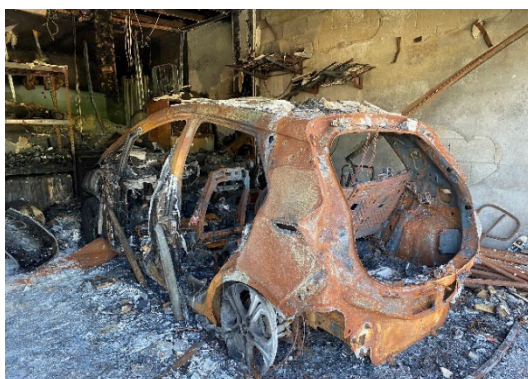
This report documents the on-site inspection of a vehicle fire that developed in a parked 2019 Chevrolet Bolt EV in 2020. The vehicle was unattended, parked, and charging in the owner's garage (Figure 1). The fire reportedly developed during the night. The homeowner awoke to the sound of an explosion and the odor of smoke. There were no injuries.

*Figure 1. The 2019 Chevrolet Bolt EV parked in the garage*

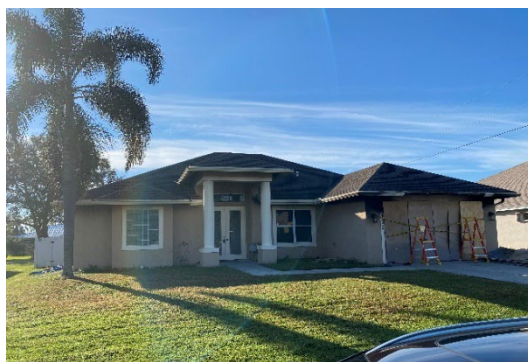
The incident occurred in the garage of a three-bedroom home (Figure 2) located in a residential area. The garage was designed for parking two vehicles. In addition to the Chevrolet, the garage contained personal items including battery-operated lawn equipment, battery-operated tools, a refrigerator, shelving, a workbench, holiday decorations, bikes, and other miscellaneous items. The Chevrolet was parked on the right side of the garage and plugged into a 220-volt outlet that ran to the fuse panel next to the outlet. The second homeowner stated that a local electrician installed the 220-volt outlet when the Chevy Bolt was purchased. The garage was enclosed by a tri-fold metal garage door on a belt-driven pulley system.

*Figure 2. Incident site*

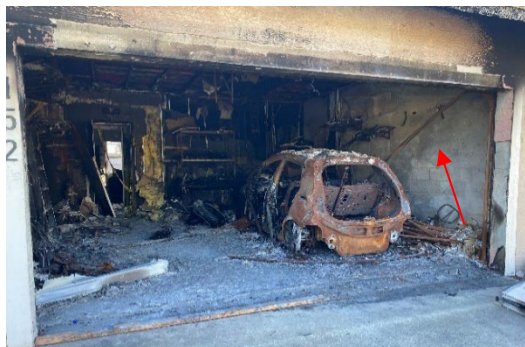
The southern interior wall of the garage, shown in Figure 3, was partially destroyed due to the initial explosion and fire. Damage along this wall resulted in fire access to a child's bedroom in the home. The western exterior concrete block wall, indicated by the red arrow in Figure 3, was pushed outward a maximum of 10 cm (4 in) and damaged by the fire. The movement in these walls was believed to be the result of the initial explosion.

*Figure 3. The 2019 Chevrolet Bolt EV in the garage post-incident*

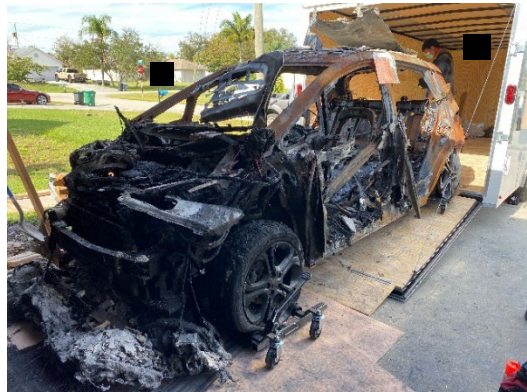
The 2019 Chevrolet Bolt EV (Figure 4) was manufactured in October 2018 and identified by the Vehicle Identification Number (VIN) 1G1FZ6S00K4xxxxxx. The Chevrolet was a front-wheel-drive platform, powered by a permanent-magnet drive motor. Its service brakes were power-assisted 4-wheel disc with antilock brakes. The gross vehicle weight rating was 2,020 kg (4,453 lb). At the time of the inspection the Chevrolet had Michelin Energy Saver tires for the left-front and right-front tires. The left-rear and right-rear tires had been destroyed by the fire. The left-front and right-front tires had at least 6 mm (7/32) of tread. Additionally, the left-front and right-front tires were deflated and burned from the fire.

*Figure 4. The 2019 Chevrolet Bolt EV*

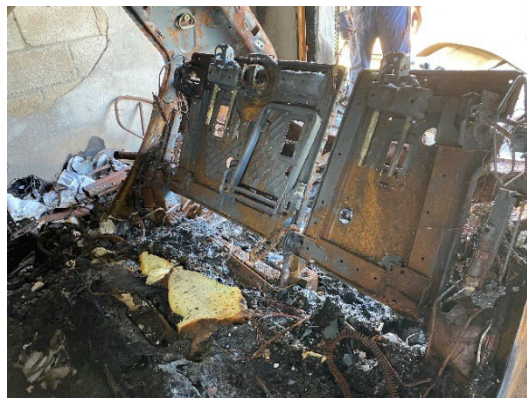
*Figure 5. The 2019 Chevrolet Bolt EV second-row bench seat*

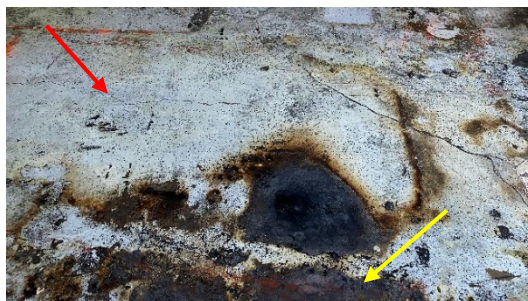
The Chevrolet's interior and exterior were destroyed by the fire. Upon removing the Chevrolet from the garage there was evidence of extreme heat and fire damage on the garage floor (Figure 6) directly under the second-row-left seat. The yellow arrow in Figure 6 indicates the location of the Chevrolet's rear bumper. The red arrow in Figure 6 shows the approximate location of the left rear wheel.

*Figure 6. Fire damage to the garage floor under the left side of the vehicle*

During the fire due to heat and chemical reaction, pressure built up in the battery cells. The GM representative said the initial explosion heard by the homeowner was likely the release of pressure through the rear aspect of the battery's containment. According to the GM representative, the smaller explosions heard by the homeowner were the progressive over-pressure releases of the battery cells in a domino-like effect. Some of the smaller explosions heard could have also been from rechargeable lawn equipment batteries located on top of a tool chest and plugged into a 110-volt outlet.

The GM representative suspected that the fire originated in the left cells of the lithium-ion battery, based on burn patterns on the garage floor. However, the GM representative said an exact determination could not be made at the time of the inspection. Additional evidence could not be obtained during the inspection due to the extent of the fire damage. At the time of this report, the Chevrolet is being stored off-site in a secured trailer by the insurance company's fire consultant.
