DOT HS 813 507

**Special Crash Investigations:
On-Site Electric Vehicle Fire
Investigation;
Vehicle: 2019 Chevrolet
Bolt EV;
Location: Florida;
Incident Date: October 2020**

**Special Crash Investigations
On-Site Electric Vehicle Fire Investigation
Office of Defects Investigation
Case Number: CR20035
Vehicle: 2019 Chevrolet Bolt EV
Location: Florida
Incident Date: October 2020**

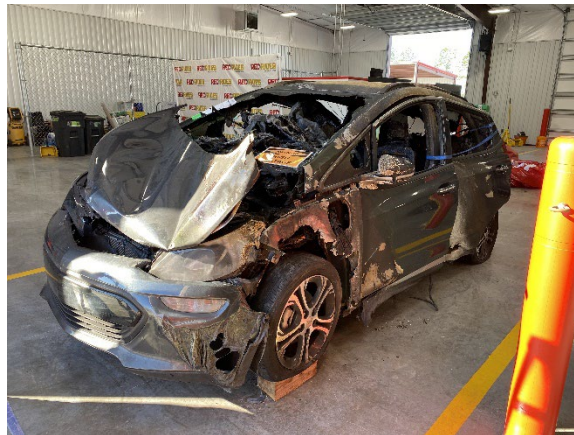
Figure 1. Involved 2019 Chevrolet Bolt

This report documents the on-site inspection of a fire in a parked 2019 Chevrolet Bolt EV (Figure 1) during the morning in the driveway of the owner's residence. The owner was loading personal items into the Chevrolet when she noticed the vehicle was smoking and called the fire department. The owner, her spouse, and their children began removing items from the vehicle when it burst into flames, resulting in a major fire. There were no injuries.

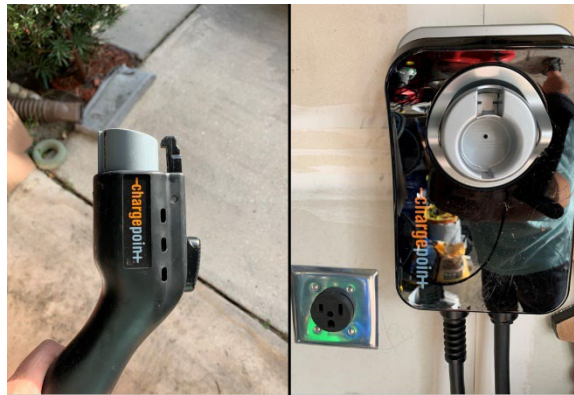
Figure 2. Charger setup for the 2019 Chevrolet Bolt. Image obtained from Chevrolet owner.

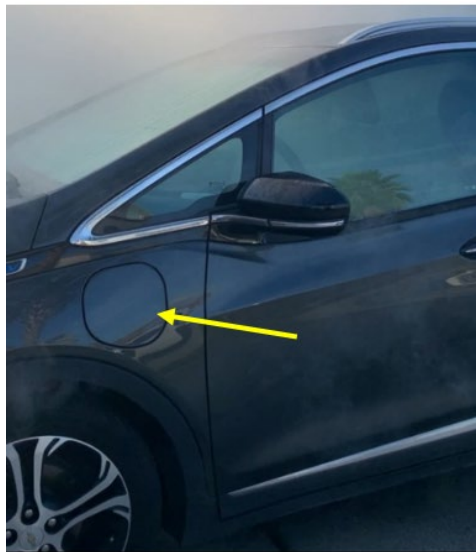
Figure 3. 2019 Chevrolet Bolt charge port. Image captured from video provided by owner.

On the morning of the incident, around 0700 hours, the owner of the Chevrolet plugged the charger cable into the charge port located on the left front fender (Figure 3). At that time, she began moving items from her other vehicle to the Chevrolet with plans to go to the beach with her children. After moving items from her other vehicle to the Chevrolet she proceeded inside

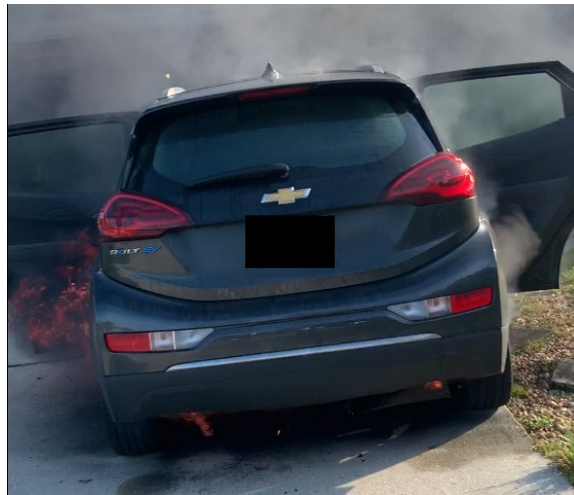
As they were unloading the Chevrolet the owners heard pops and hisses coming from under the vehicle. After approximately 10 minutes of smoke coming from the Chevrolet, the owners opened the rear doors of the Chevrolet and a burst of fire resulted (Figure 4). At that time, the owners and their children moved further away from the vehicle and waited for emergency services to arrive.

Figure 4. 2019 Chevrolet Bolt fire. Image captured from video provided by owner.

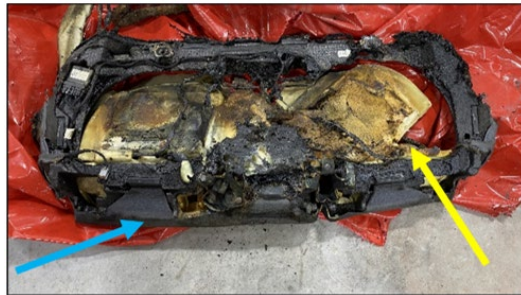
The damage to the rear seat indicated that the fire started under the second-row left seating position. As seen in Figure 7, the underside of the second-row seat cushion shows more fire damage to the left side indicating that the fire originated in the left cells of the battery pack just below the second-row seat cushion.

Figure 7. Underside view of the second-row seat cushion. The left side is indicated by the yellow arrow. The front of the seat cushion is indicated by the blue arrow.

The GM representatives suspect that the fire began in the left cells of the fifth section/row Li-ion battery based on the damage to the second-row bottom seat cushion. However, the GM representatives stated that an exact determination could not be made at the time of the inspection. No additional evidence could be obtained at the time of the inspection due to the inability to remove the 60 kWh Li-ion battery. The vehicle manufacturer expressed safety concerns about its removal due to risks with handling a damaged battery and its unknown state of charge. The Chevrolet was being stored at a local insurance vehicle salvage facility. At the conclusion of the SCI investigation, there was no further information if the battery was removed from the vehicle for further analyses.

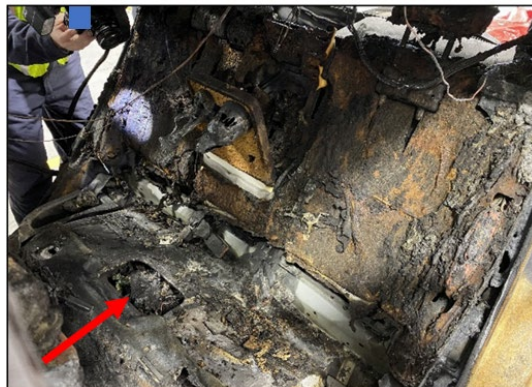
The second-row bottom seat cushion was removed during the inspection to gain access to the service disconnect indicated in Figure 8 by the red arrow. A voltage test was performed on several parts of the vehicle. The voltage rating on the front of the vehicle ranged from 0–700 millivolts whereas the voltage rating on the rear of the vehicle ranged from 0 to 400 millivolts. The rear voltage testing was done at the service disconnect and to the battery cells that were accessible from the underside of the vehicle.

Figure 8. Service disconnect in the second row of the 2019 Chevrolet Bolt after the bottom seat cushion was removed

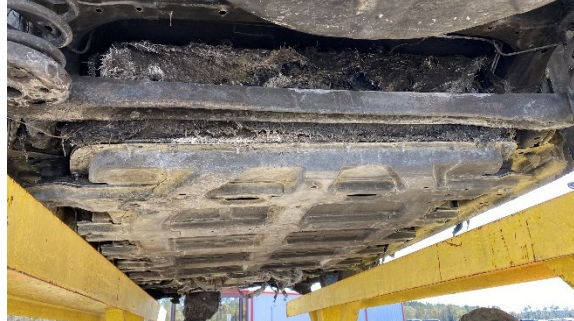
During the fire, due to heat and chemical reaction, pressure built-up within the cells of the battery. This resulted in an expulsion of gases and material content from the rear of the 60 kWh Li-ion battery (Figure 9). Additionally, there were smaller pops and hisses that were reported by the owner. The GM representatives stated that these additional sounds during the fire was the sound of the cells releasing gases due to the extreme heat in a domino-like effect.

Figure 9. Rear view looking forward of the 60 kWh Li-ion battery pack in the involved 2019 Chevrolet Bolt
