DOT HS 813 519

# **Special Crash Investigations: On-Site Ambulance Crash Investigation; Vehicle: 2020 Freightliner M2 Type I Ambulance; Location: Oklahoma; Crash Date: March 2021**

**Special Crash Investigations**  
**On-Site Ambulance Crash Investigation**  
**Case No.: CR21010**  
**Vehicle: 2020 Freightliner M2 Type I Ambulance**  
**Location: Oklahoma**  
**Crash Date: March 2021**

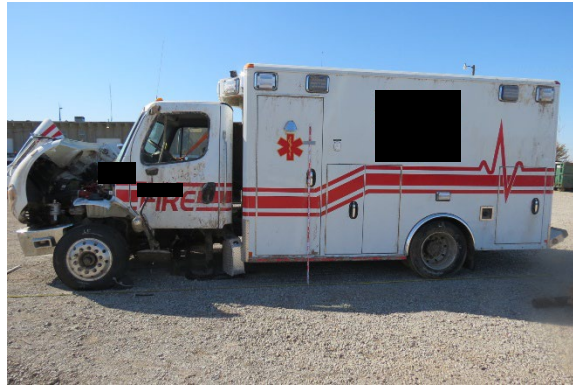
This report documents the on-site investigation of the rollover crash involving a 2020 Freightliner M2 Type I ambulance (Figure 1) that resulted in minor injuries to the driver and serious injuries to the emergency medical technician (EMT) and the female patient being transported. The EMT was attending to the patient at the time of the crash. The investigation was initiated by the National Highway Traffic Safety Administration's Office of Emergency Medical Services who identified the March 2021 crash. The on-site investigation was assigned to the Special Crash Investigation (SCI) team at Crash Research and Analysis, Inc. in March. This single-vehicle crash was investigated by the local State police agency.

*Figure 1. 2020 M2 ambulance*

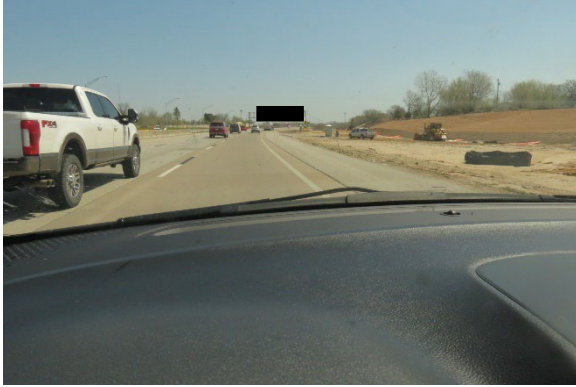
The Freightliner was traveling east (Figure 2) at a driver and witness-reported speed of approximately 80 km/h (50 mph). The vehicle was enroute to a hospital, operating in non-emergency mode with no lights or siren. The driver was unbelted, as was the EMT who occupied the rear-facing captain's chair in the patient compartment. The patient was secured to the cot system with lateral straps across her feet, thighs, and chest with her upper body elevated approximately 20 degrees from horizontal. According to the driver and police crash report, the Freightliner traveled into standing water on the roadway, and began to hydroplane and rotate clockwise. The vehicle veered to the right and traveled off the roadway (Figure 3).

*Figure 2. East view of the Freightliner's travel path prior to roadway departure*

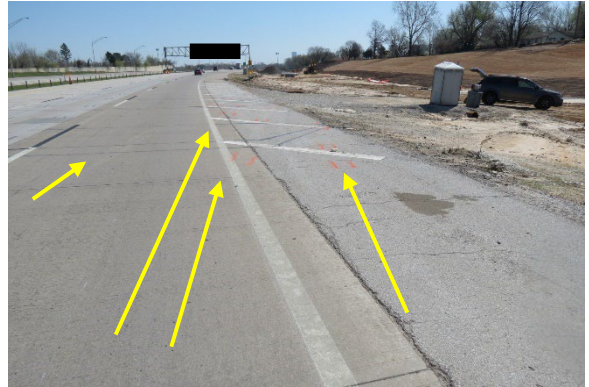
*Figure 3. Tire marks leading off roadway*

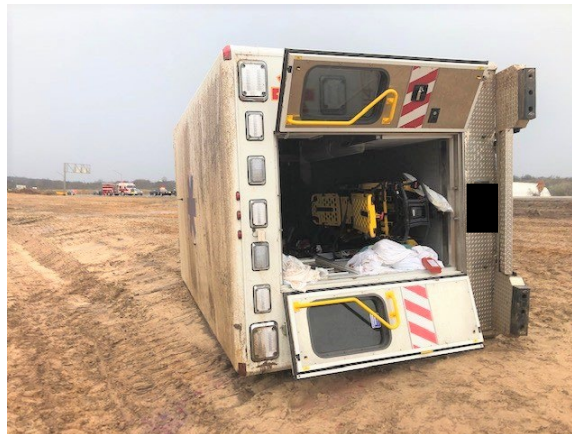
The Freightliner traveled off the roadway into a sand/dirt construction area and continued to rotate clockwise. Due to the ongoing construction, it is unlikely that the crash area was the same at the time of the crash as it was during the inspection. The Freightliner's left wheels tripped in the dirt and the ambulance rolled over, left side leading, one quarter turn and came to final rest on its left side facing west (Figure 4). No air bags deployed during the crash sequence.

*Figure 4. Police image, west view of the Freightliner at final rest*

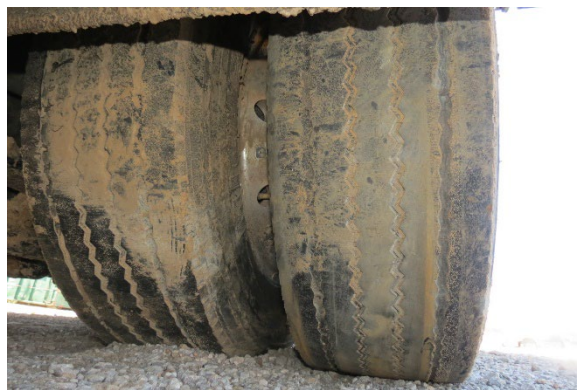
The vehicle manufacturer's recommended tire size was LT245/70R19.5 with a recommended cold tire pressure of 827 kPa (120 PSI) for the front and rear tires. The vehicle was equipped with Falken RI 1919 tires on the front wheels and Michelin XZE tires on the rear outside wheels, all the recommended size. The front tires were in good condition with a minimum of 15 mm (19/32 in) of tread depth. All rear tires showed excessive wear, with 4 mm (5/32 in) or less tread depth (Figure 5). Manufacturer and size of the rear inside tires could not be determined.

*Figure 5. 4 mm (5/32 in) tread on left rear tires*

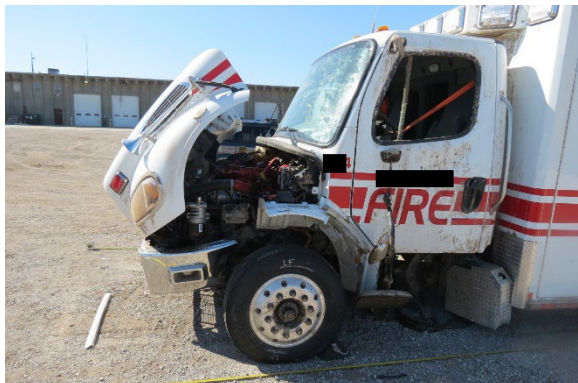
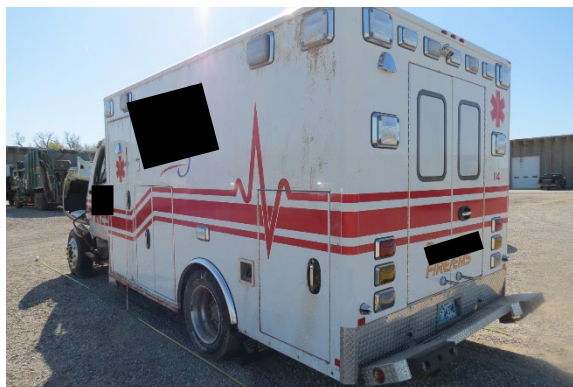
The direct damage from the rollover consisted of body panel deformation and abrasions extending the entire length of the left side of the Freightliner (Figures 6 and 7). There was no lateral or vertical crush to the vehicle. The WinSMASH program could not be used to determine crash severity (delta V) because rollovers are out of the scope for the program. The truck deformation classification assigned to this impact was 00LDAO1.

*Figure 6. Ambulance cab rollover damage*

*Figure 7. Left side of ambulance*

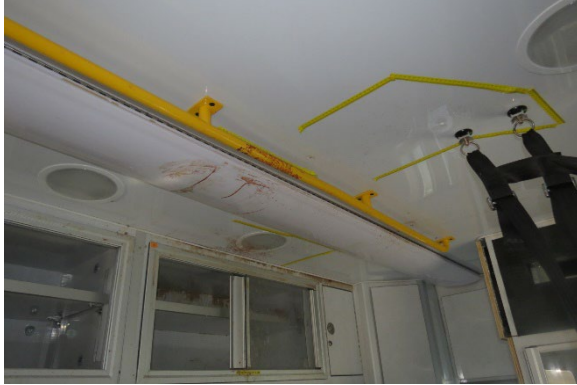
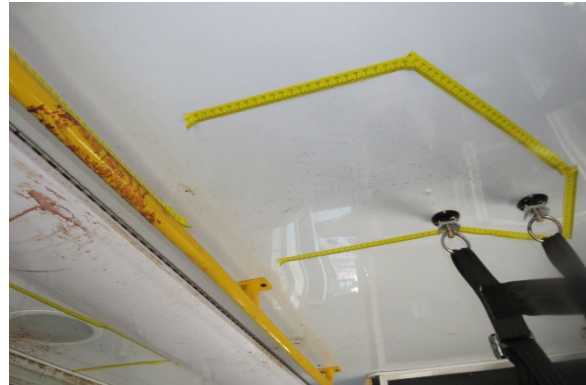
The primary contacts in the patient compartment were attributed to the unbelted EMT and involved the longitudinal roof rail (Figures 8 and 9), which was contacted by his head as he was displaced upward and toward the left cabinetry from the rear-facing captain's chair. Blood splatters were noted on the ceiling near the point of contact with the railing. No contacts were attributed to the patient, who remained belted throughout the crash sequence. However, the patient did sustain a significant head injury, possibly from contact with the left side cabinetry. It is also possible that the patient's head injury was caused by contact with the EMT.

*Figure 8. Patient compartment looking forward and left at the ceiling rail contact*

*Figure 9. Closeup of contact to ceiling rail and blood mist/splatter on ceiling*

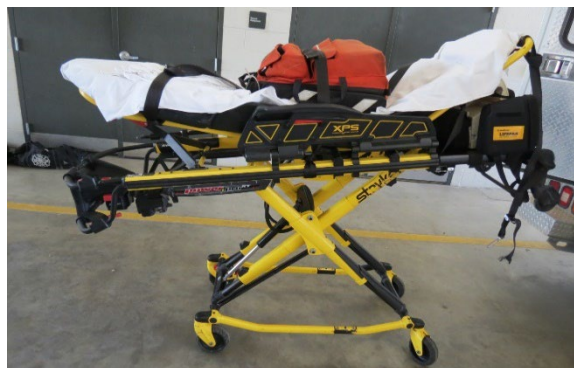
The 6500 Power Pro-XT patient cot (Figure 10) was manufactured by Stryker, serial number: 101041xxx. It was constructed with a tubular aluminum frame with an X-frame supporting the mattress and featured power lift capabilities. The cot had a height range of 36 cm (14.2 in) to 105 cm (41.5 in) and a maximum load capacity of 318 kg (700 lbs.). The weight of the cot with one battery pack, no mattress or restraints was 55 kg (122 lbs.). The backrest could be adjusted from

*Figure 10. Stryker 6500 Power Pro-XT patient cot and defibrillator unit*

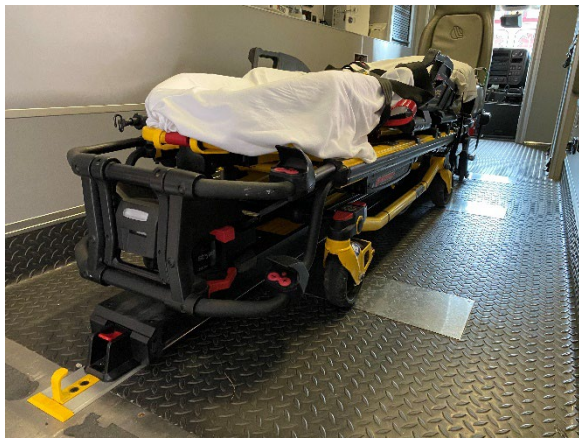
The Stryker cot was secured to the floor of the patient compartment via a Stryker Power-Load system (Figure 11). The fastening system consisted of two components, including the bracket/assembly that attached to the cot and a continuous bracket that mounted to the floor of the patient compartment. The floor bracket measured 241 cm (94.9 in) long and was 62 cm (24.4 in) wide. Manufacture specifications indicated that the complete system weighed a total of 95.9 kg (211.5 lbs.). The cot was secured to the fastening system with two latches at the head and one at the foot. The floor-mounted bracket (Figure 12) guided the cot into and out of the patient compartment of the ambulance. This latching system secured the cot longitudinally and laterally to the floor during vehicle operation.

There was no damage to the patient cot or loading system due to the crash. The cot was inspected by a manufacturer representative and approved for return to service.

*Figure 11. Image of an exemplar patient cot secured to the Stryker Power-LOAD cot fastening system*

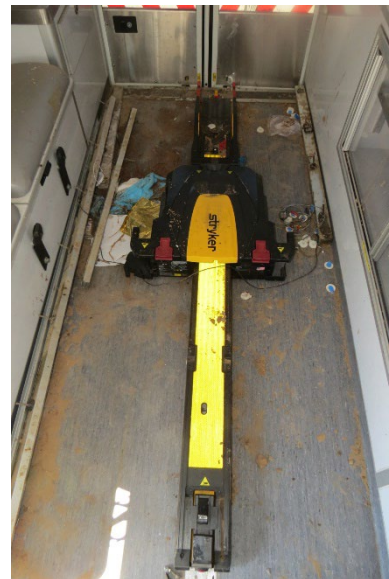
*Figure 12. Stryker Power Load cot securing system*
